PEACE RIVER DEVELOPMENT SITE C PROJECT

REVIEW OF UPSTREAM AXES

Report No. 5032A01 02
May 2006

APPENDIX A
PHOTOGRAPHS AND NOTES
FROM THE
NOVEMBER 2005 SITE RECONNAISSANCE

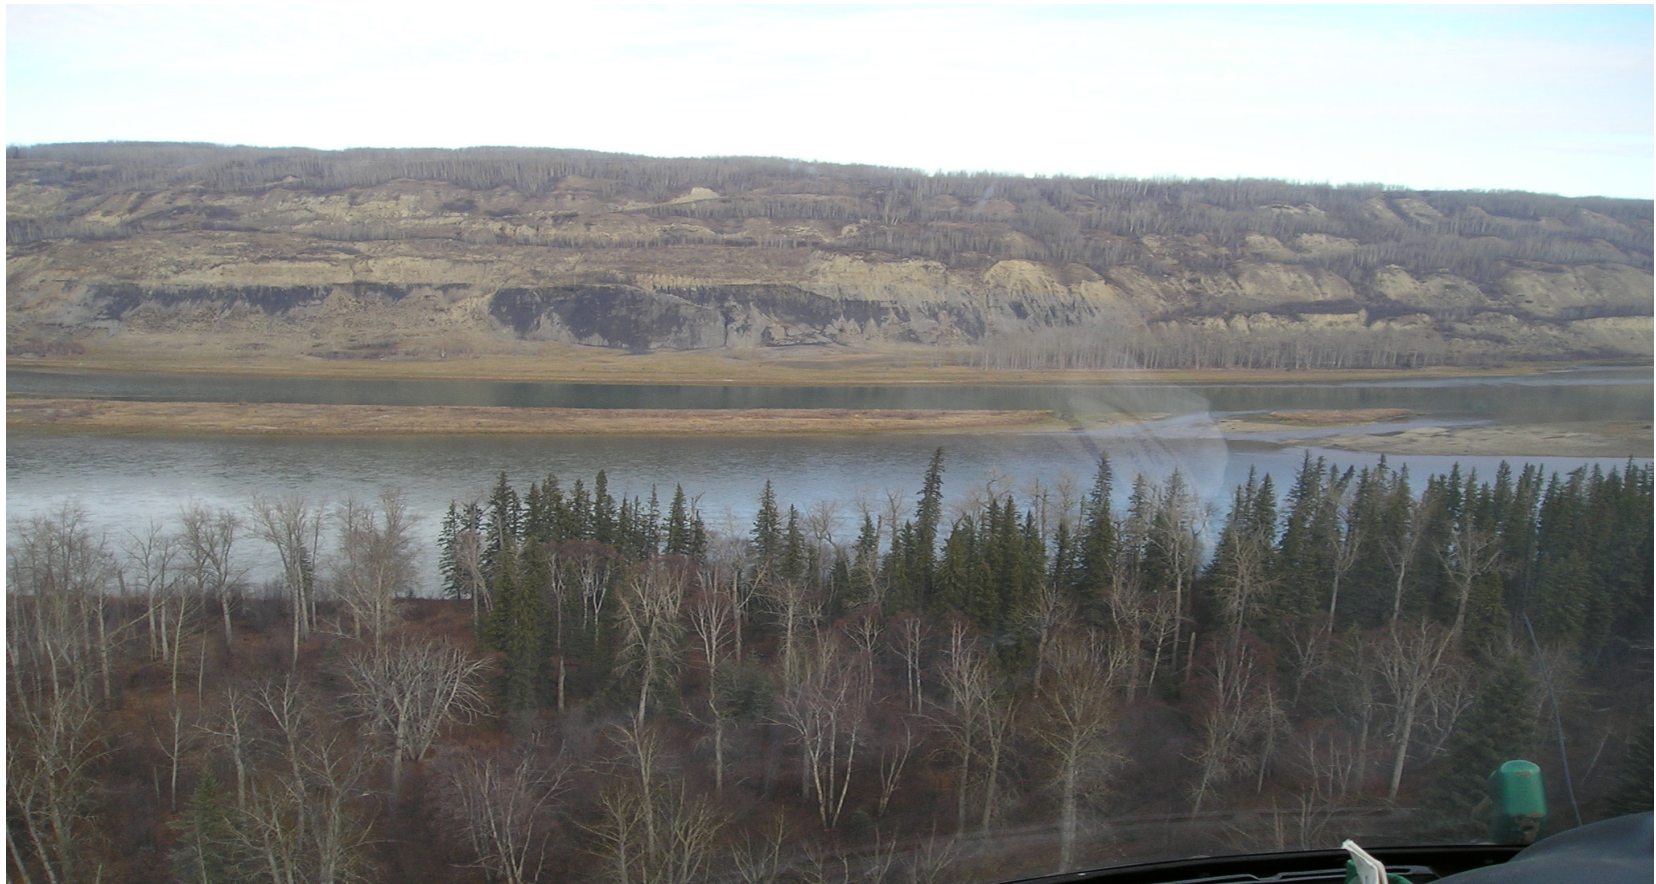
Site C3 – Over right bank structures area looking to the left bank. Shale outcropping on left bank very visible.

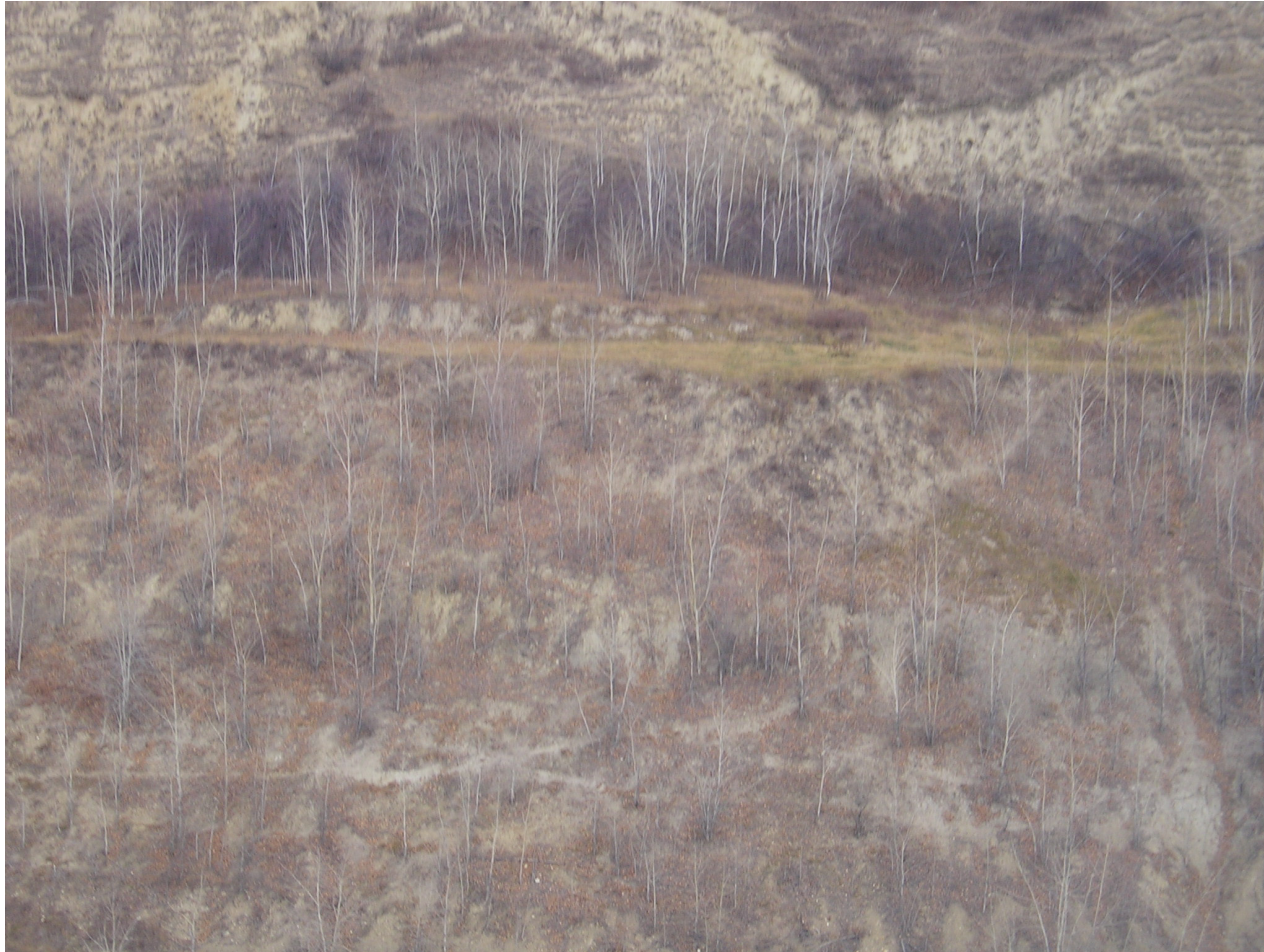
Site C3 – Upper portions of the left bank showing access road and sloughing that has occurred.

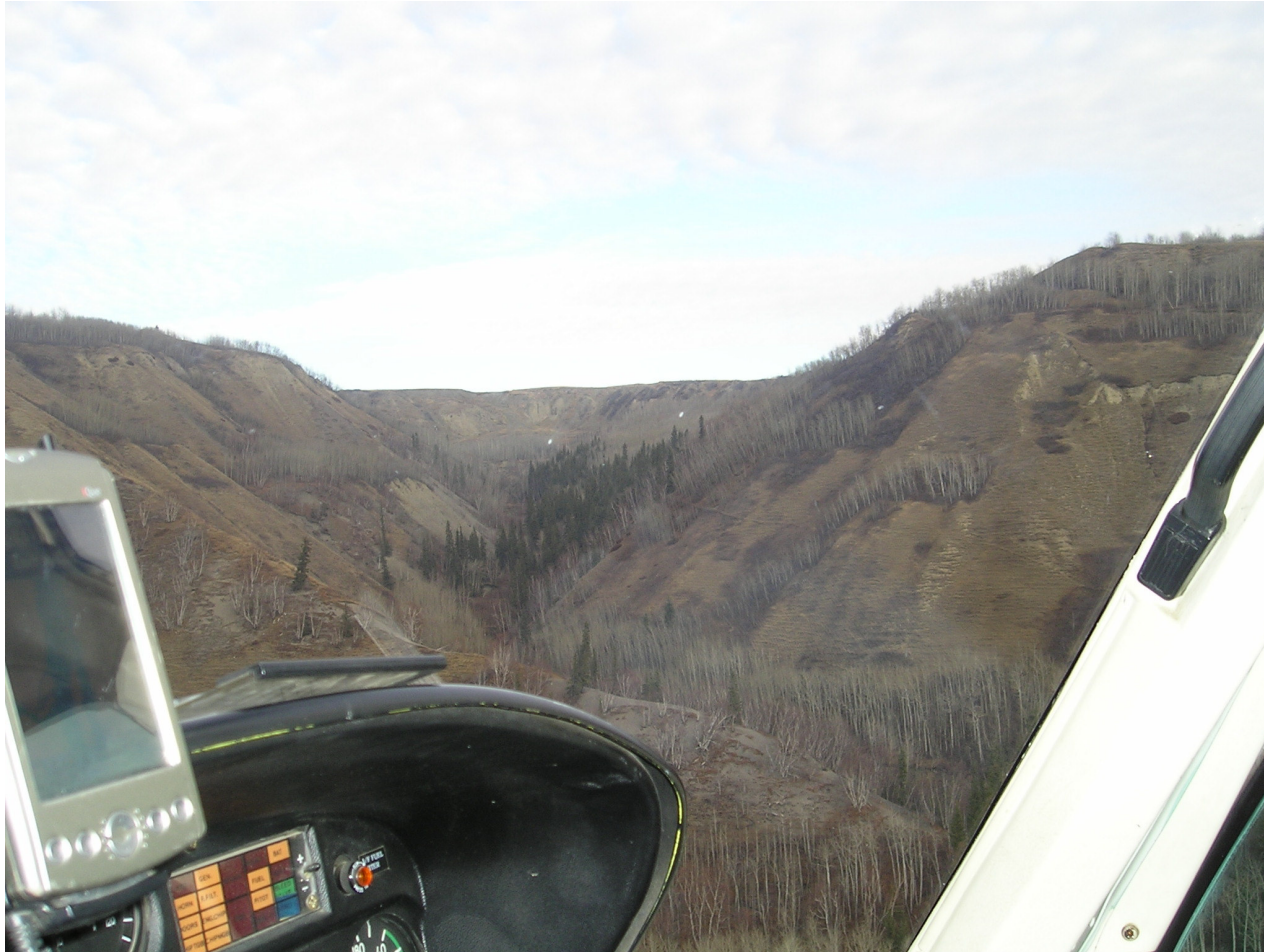
Garbage Creek – Just upstream of Site C3 on the left bank. Site C3 Left Bank excavation daylights into Garbage Creek. Has potential for a spoil area.

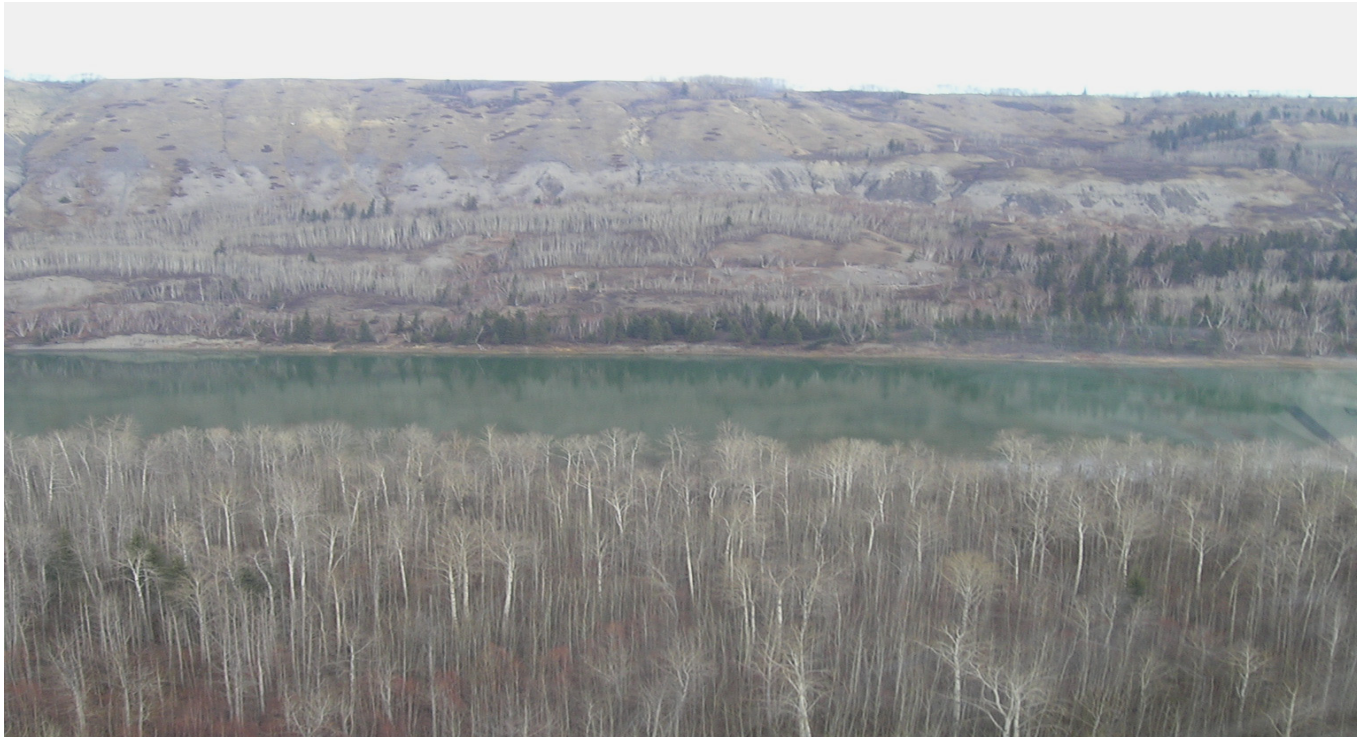
Site C2 – Hovering over the right bank looking across on the dam axis.
Note the slides over the left abutment.

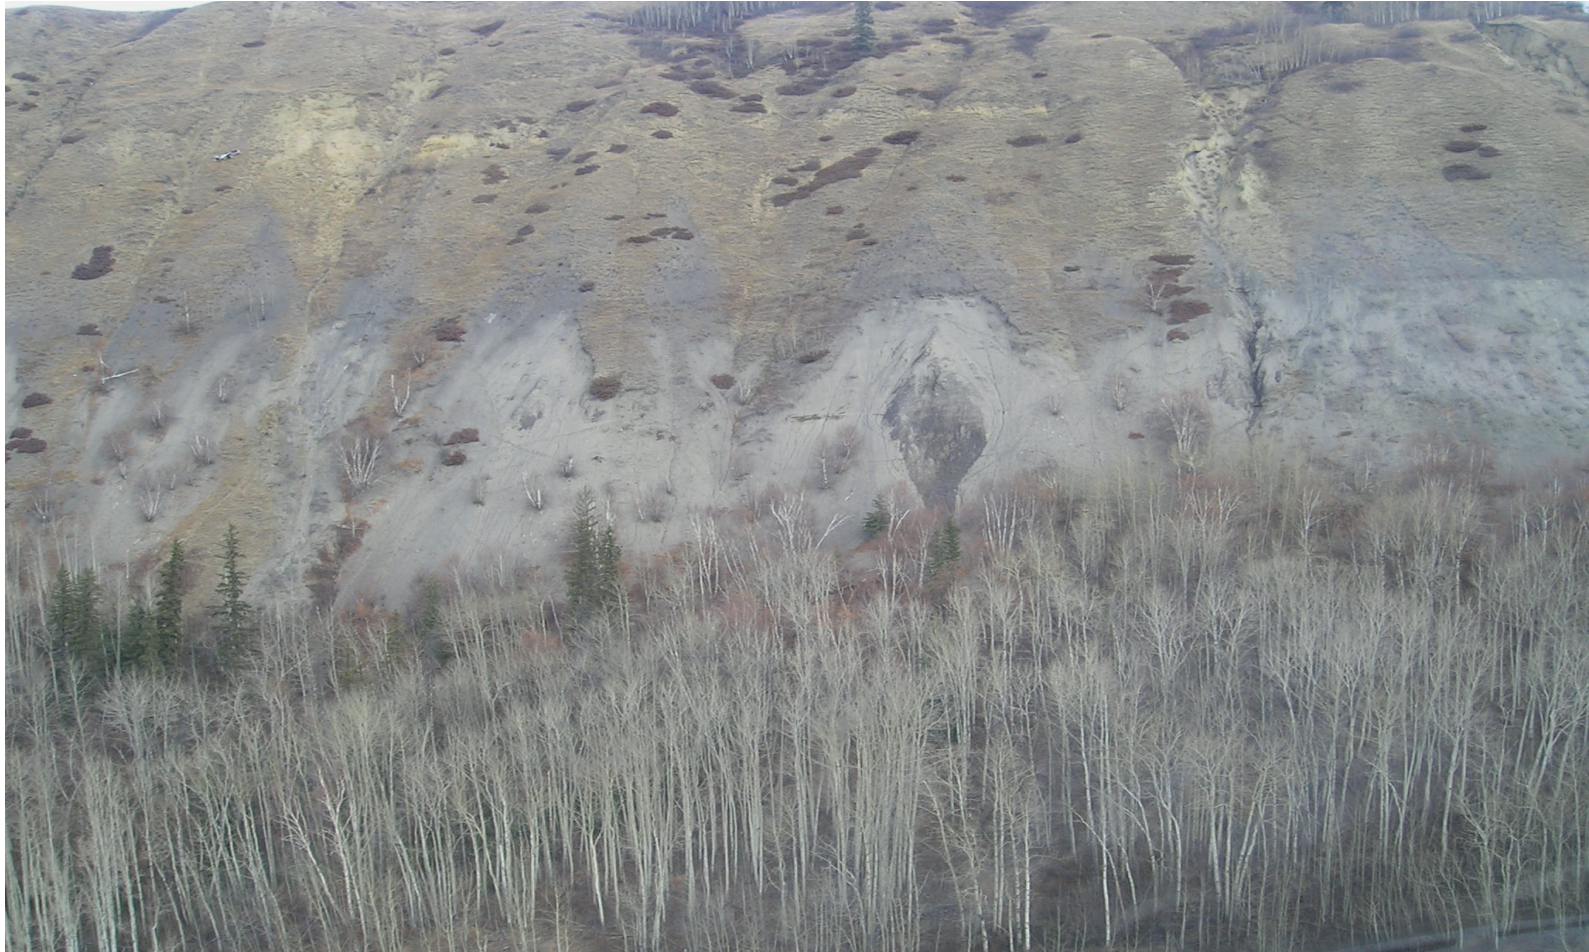
Site C2 – Left abutment where some shale is exposed.

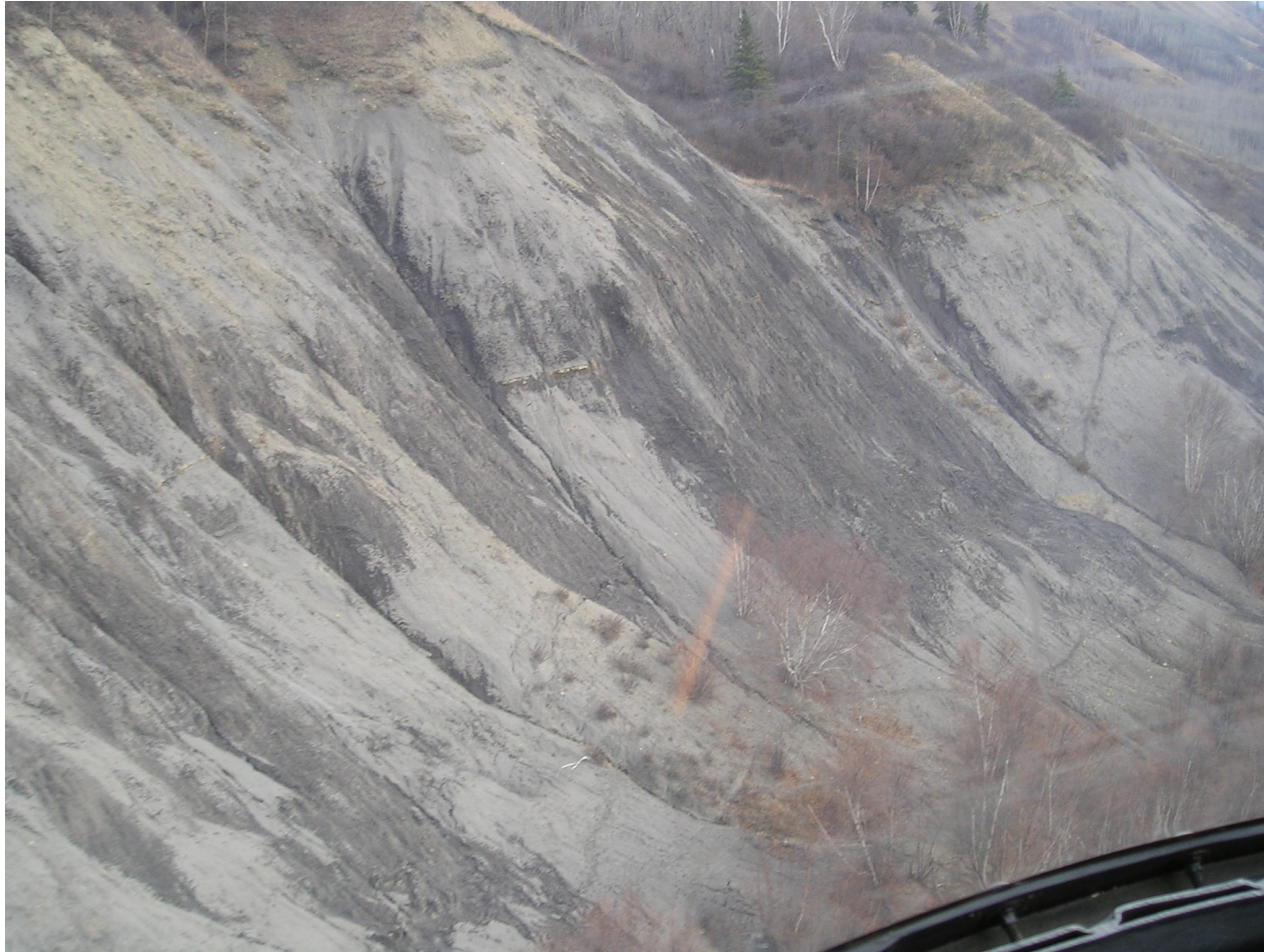
Site C2 – Close-up of the Left abutment where slides have occurred.

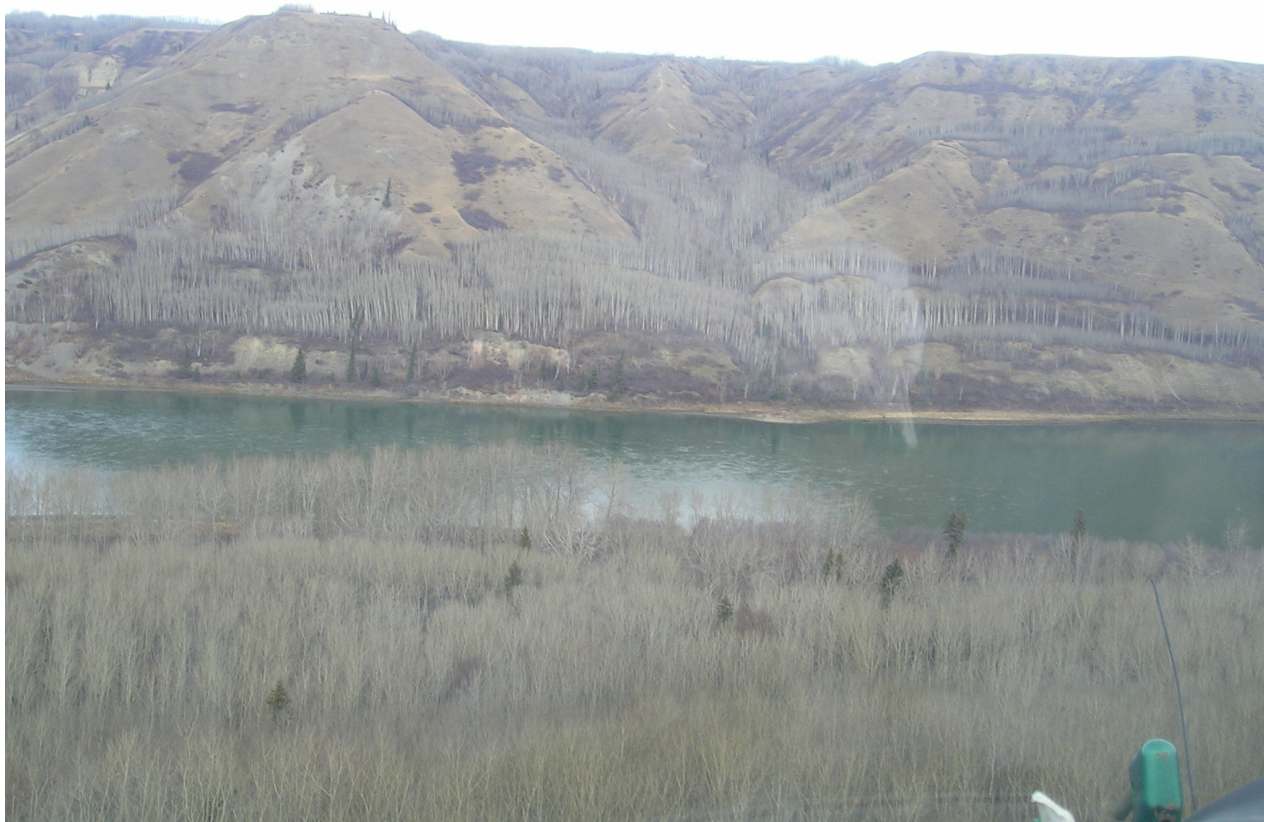
Site C1 – Looking from right abutment to the left on the dam axis. Again note the sloughing at toe of the left abutment,
