Site C Clean Energy Project

Site C Total Dissolved Gas Monitoring Program (Mon-11)

**Site C Total Dissolved Gas Monitoring Program
(Mon-11)**
2022 Feasibility Study

20136470-028-R-Rev1

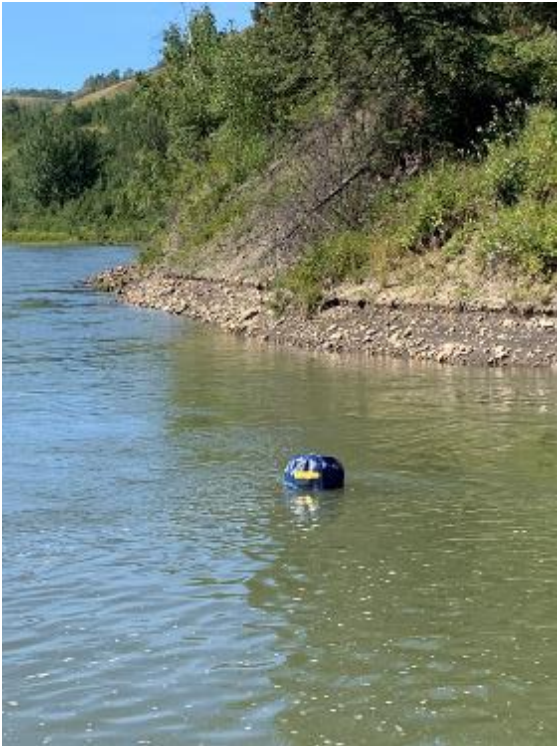
Deployment of the TDG station at Rkm 112.5 was conducted by boat on 17 August 2022 at approximately 14:00. Mean hourly river discharge was approximately 854 m³/s during deployment. The station deployment went as planned and the TDG station was successfully positioned within the center of the eddy that was located at the site. After deployment, flows varied substantially from 17 to 19 August from a low of 779 m³/s to a high of 1,555 m³/s; this change in flow (i.e., discharge levels were twice as high as during deployment) tested the ability of the station design early on in the study to accommodate substantial flow changes and continue to function (Figure 7). During deployment, and from 17 August to 6 October, opportunistic observations of the station by field crews verified its integrity (i.e., above the surface of the water, protective cover in place) and that it was holding stationary within the center of the eddy where it had been originally deployed.

Figure 7: Deployment of the TDG station at Site Rkm112.5L, 17 August 2022.

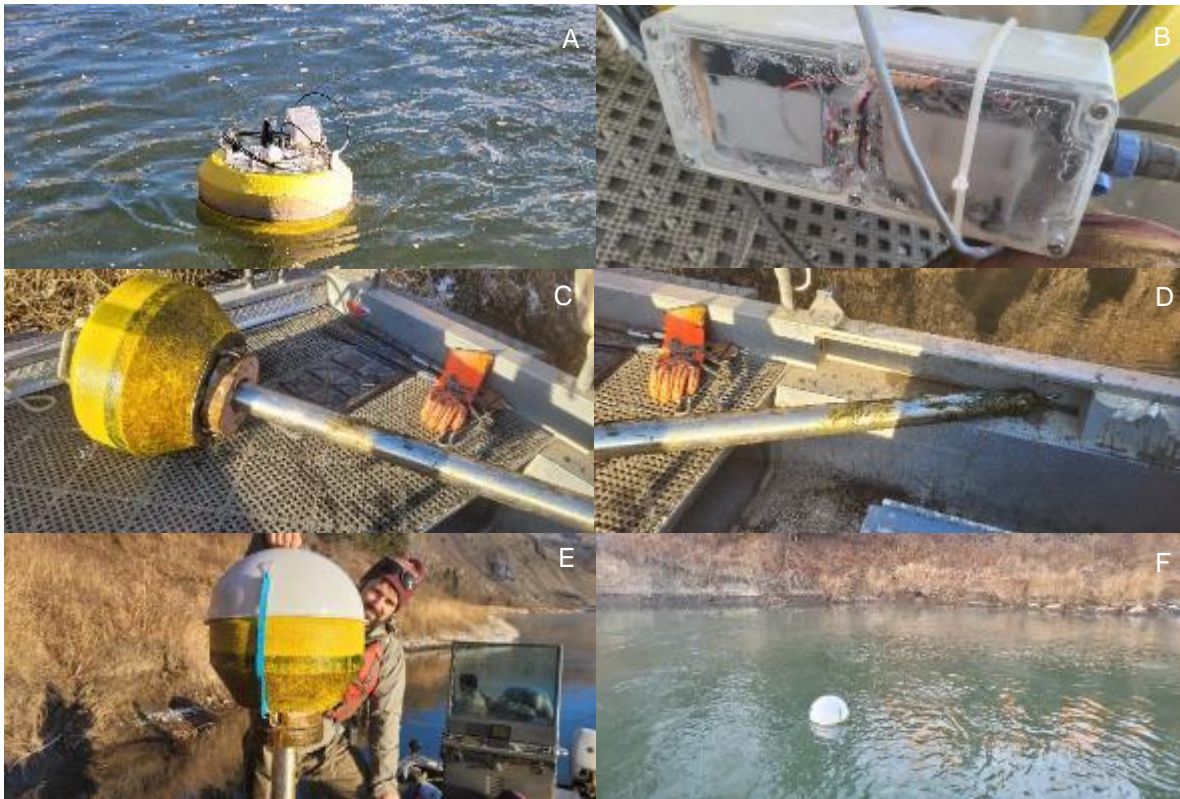
The station functionality remained unchanged from 6 October to the first required service on 18 and 19 November; however, increased variability in TDG data was evident when total river discharge exceeded 1,500 m³/s. Although the station had previously experienced flows of similar magnitude and higher and was not affected, the change in the TDG data suggest that the station had been displaced into deeper water or by higher current and was getting submerged. This assumption was later confirmed during the November service when field crews observed the station periodically becoming submerged by up to 0.5 m during their site visit. Periodic submersion, and possible entanglement of the station with floating woody debris, was assumed to be the cause

for the loss of the fabric station cover and saturation of the desiccant filter on the barometer air reference line (Figure 9; Panel A). Even though the station was still functioning at the time of the service, inspection of the battery compartment determined that the single O-ring waterproof seal had not been sufficient to prevent moisture from entering the case when submerged (Figure 9; Panel B). The DCP canister had a double O-ring seal and, as it was still transmitting, was assumed water-tight and was not removed or opened. Removal of the station from the water allowed direct inspection of the mooring connections, buoy, instrument tube, and the probe's TDG membrane. The inspection revealed that, despite the high turbidity of the water and the deployment of the probe to approximately 1.5 m depth, a small amount of bio-fouling (algae) covered most surfaces (Figure 9; Panels C and D). The extent of biofouling on the probe's TDG membrane was not substantial and subsequent comparisons between the station's barometric pressure and total pressure readings indicated that the TDG sensor was still responsive. Upon completion of the final service on 19 November, and in preparation to monitor over the winter, the field crew relocated the station mooring to a shallower location (~4.5 m deep) and installed a new battery pack, a new air reference desiccant filter, added additional flotation to the station, and installed a hard dome cover to protect the instrumentation from ice and snow build-up (Figure 9; Panels E and F). On re-deployment, crews confirmed that the station and mooring were shallow enough to have sufficient scope to self-adjust to future changes in water level.

Figure 9: TDG station at Stn_112.5L without its fabric cover (A), water-damaged power supply (B), biofouling of station buoy, instrument tube, and TDG probe (C and D), new acrylic dome cover (E), and the deployed station after servicing (F).

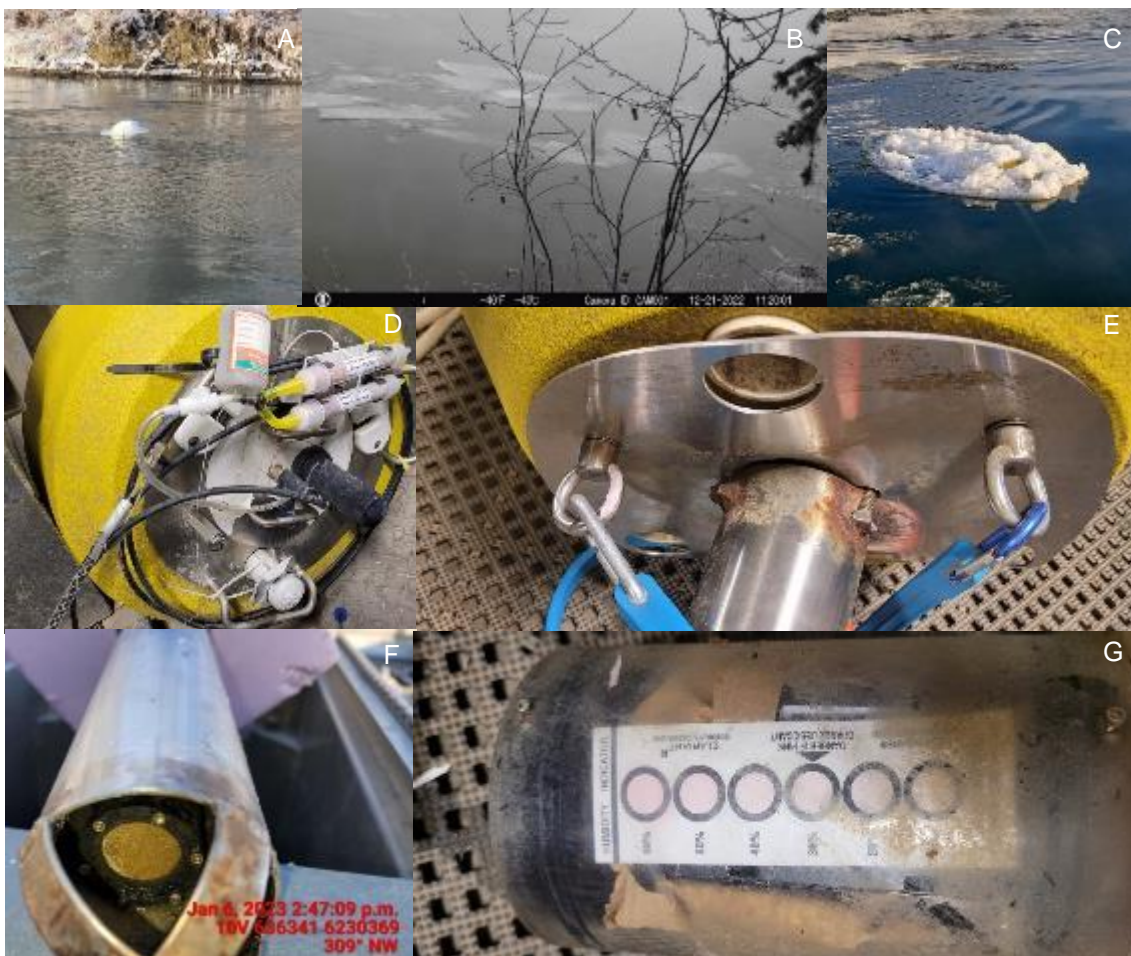
During an opportunistic site visit on 15 December to inspect the station and deploy a trail camera to monitor the station, crews noted a substantial amount of ice formation on the station's acrylic dome (Figure 10; Panel A). The field crew was not equipped to retrieve the station and decided against attempting to remove the ice and risk damage to the dome. By 21 December, extreme cold resulted in the continued build-up of ice, which added weight and drag to the station. The additional weight, combined with increased total river discharge that approached 2,000 m³/s, likely resulted in more frequent submersions of the station. Subsequent review of the trail camera imagery recorded on 21 December confirmed the presence of large chunks of ice floating through the TDG monitoring site (Figure 10; Panel B). From 21 to 26 December, the station experienced several periods of poor satellite connectivity when the station failed to upload hourly data. During this time, demand on the power supply increased and battery voltage dropped due to the continual reconnection attempts by the DCP, combined with the extreme cold. On 27 December, satellite connectivity was intermittent and all communication with the station was lost.

On 6 January 2023, air temperatures increased enough to facilitate recovery of the station. When the crew arrived on site, they noted that the acrylic dome cover was missing and that the station was covered in a layer of ice that had to be removed before the station could be lifted into the boat (Figure 10; Panel C). Once recovered, the crew noted that the air reference desiccant was saturated, and that the power supply had snapped free of its base and was missing (Figure 10; Panel D). The base of the stainless-steel instrument tube was bent at an approximately 15° angle and the stainless-steel mounting plate on the buoy was bent and had a slight buckle. The TDG probe itself was undamaged (Figure 10; Panel E and F). Moisture was evident inside the water-proof canister that housed the GolderWatch™ and satellite modem of the DCP. This moisture likely seeped into the cannister through a damaged electronic connector (Figure 10; Panel G). Based on the above evidence, the eventual failure of the station was attributed to a combination of frequent submersion to depth due to ice build-up and physical damage to station components due to floating ice that collided with the station.

Figure 10: TDG station at Stn_112.5L with ice build-up on its dome cover (A), ice floating through the monitoring site on 21 December (B), the station without its dome cover and encased in ice on 6 January (C), damage to the topside station components (D and E), the TDG probe with biofouling (F), and moisture inside the DCP cannister (G).

- A buoy-based TDG station is not appropriate at locations with high debris loading.
 - A buoy-based TDG station should be removed prior to winter flow conditions to avoid damage from river ice.
