**RE: British Columbia Utilities Commission (BCUC or Commission)
British Columbia Hydro and Power Authority (BC Hydro)
Site C Clean Energy Project
PUBLIC Quarterly Progress Report No. 16 – April to June 2019 (Report)**

Site C Clean Energy Project

Quarterly Progress Report No. 16

April 2019 to June 2019

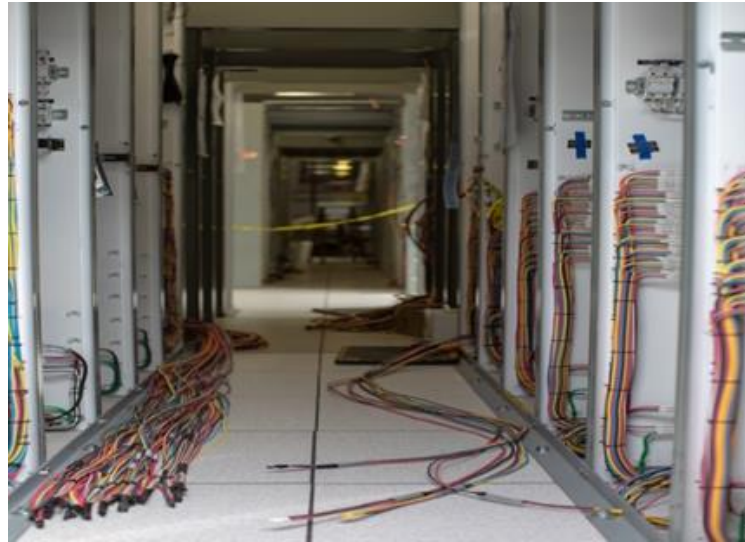
Figure A-1 Twenty-two new protection and control panels at Peace Canyon have been added and/or upgraded in preparation to receive the transmission from Site C (April 2019).

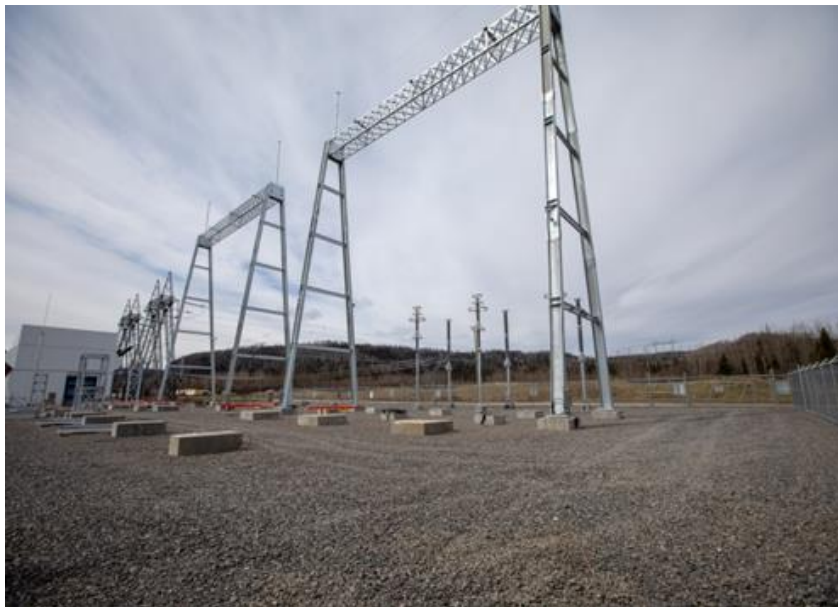
Figure A-2 Two new 500 kV gantries (5L5, 5L6) have been installed at the Peace Canyon Substation to receive the 500 kV lines from Site C. A gantry is where the transmission lines tie onto and anchor at the substation (April 2019).

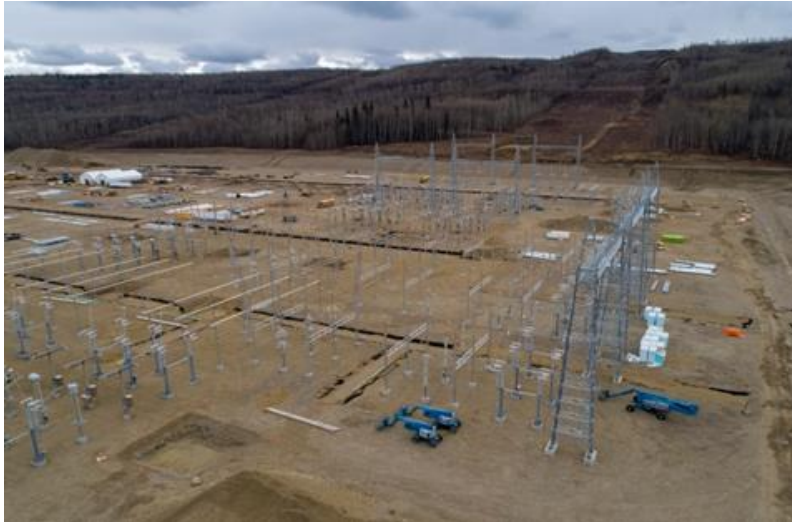
Figure A-3 Construction of the 500 kV Site C Substation on the right bank. The structural steel and equipment installations are in progress (April 2019).

21 Substation construction continued between April and June 2019, including the
22 construction of concrete foundations and the installation of cable trenches and
23 protection and control wiring to connect the 500 kV equipment to the control building.
24 The substation contractor completed the installation of the telecommunication
25 system (steel tower, microwave antenna and waveguide and telecommunications
26 panels), meeting a contract milestone. Substation construction remains on schedule.

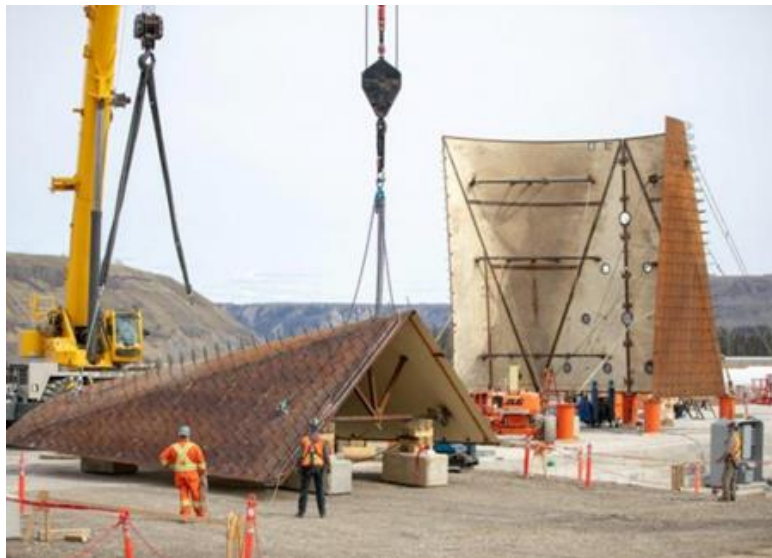
Figure A-6 After moving individual sections from a fabrication shop in Fort St. John, we assemble the penstocks on site. This is one of the six transition pieces which will funnel water from the river into our generating station (May 2019).

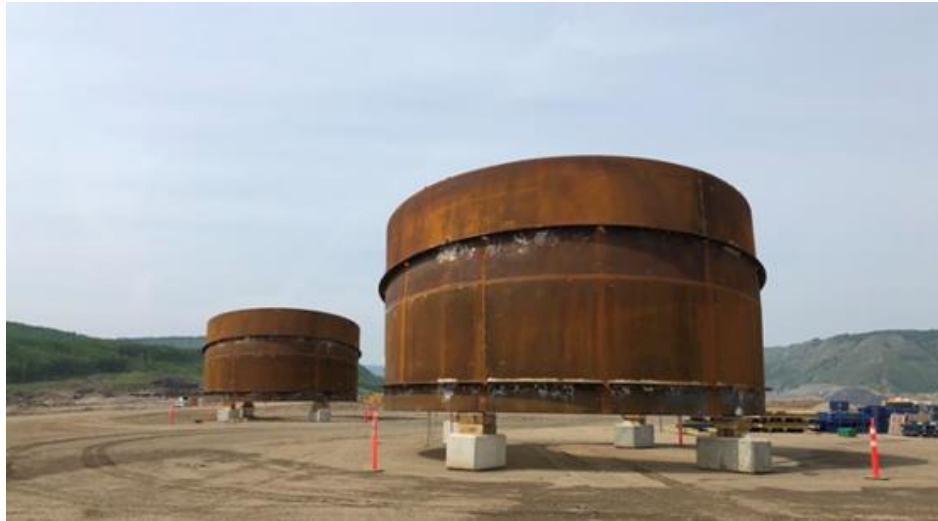
Figure A-7 We will be building and assembling 84 of these penstock sections over the next few years, to create the six penstock pipes for Site C's generating station (May 2019).

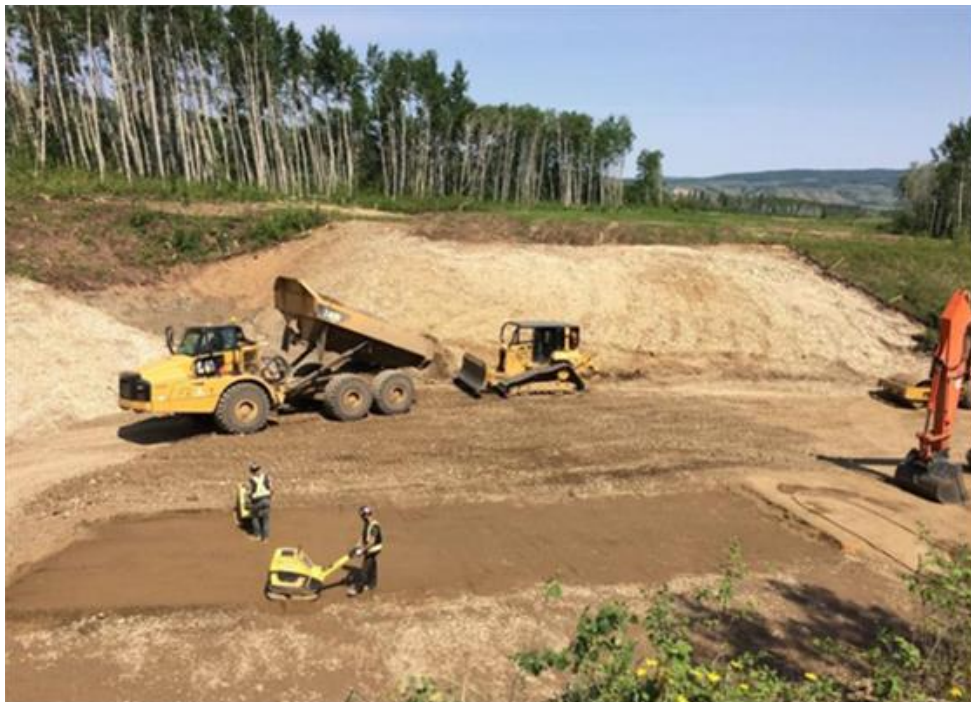
Figure A-8 Grading and levelling is occurring on the new alignment of Highway 29 at Cache Creek West (June 2019).

10 Construction of the four kilometre highway realignment at Cache Creek West
11 resumed in May 2019 after shutting down for winter conditions. The construction
12 activities for this initial partial scope of work was completed in spring 2019.
13 Construction of this segment is expected to be complete on schedule in
14 summer 2020.

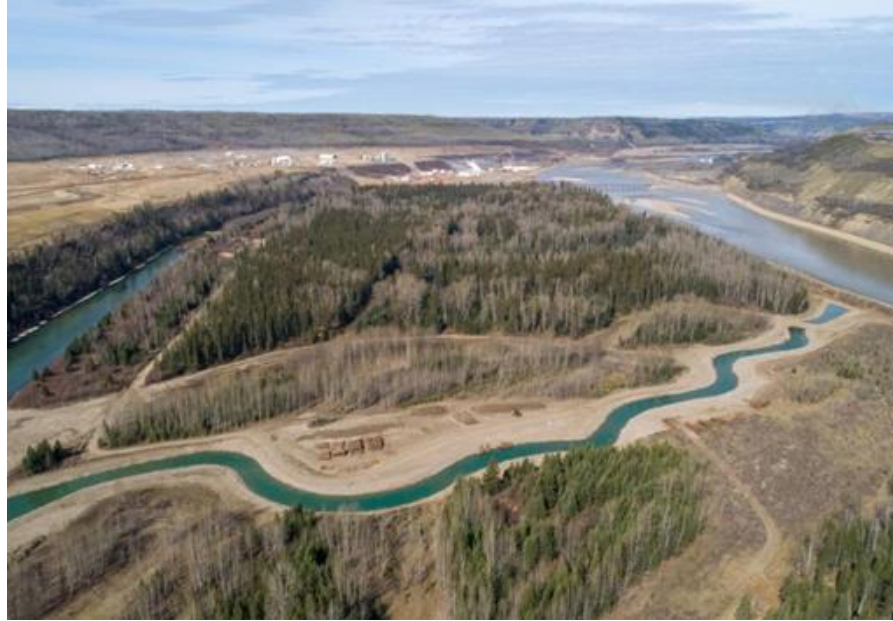
Figure A-9 Newly built side channels on the Peace River provide fish habitat (June 2019).

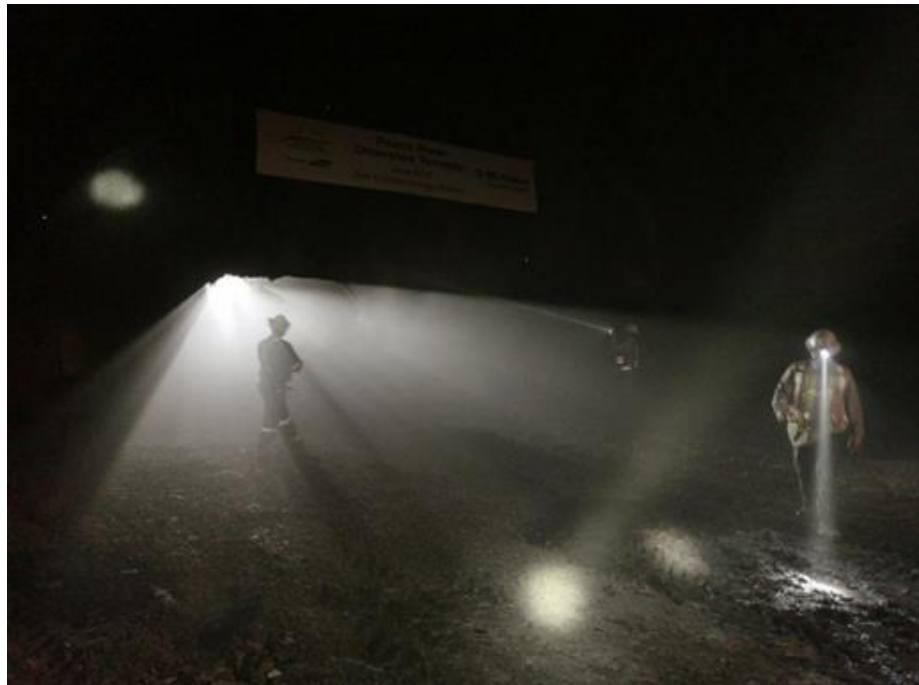
Figure A-10 Crews inspect the opening that connects both ends of the diversion tunnel excavations shortly after breakthrough in Tunnel 1 (June 2019).

- 7 • In late June 2019, the Site C project completed the successful breakthrough on
8 the excavation of the first of two river diversion tunnels. Subsequent to the
9 reporting period, breakthrough on the longer second tunnel occurred in
10 July 2019. The achievement of this milestone reduces the uncertainty related to
11 the geological conditions around the tunnels. For more information, refer to
12 section [1.2.1.1](#).
