**RE: British Columbia Utilities Commission (BCUC or Commission)  
British Columbia Hydro and Power Authority (BC Hydro)  
Site C Clean Energy Project PUBLIC Quarterly Progress Report No. 27**

Today, we are filing Site C Quarterly Progress Report No. 27 that covers the period of July 1 to September 30, 2022.

2 **1.1 Overview and General Project Status**

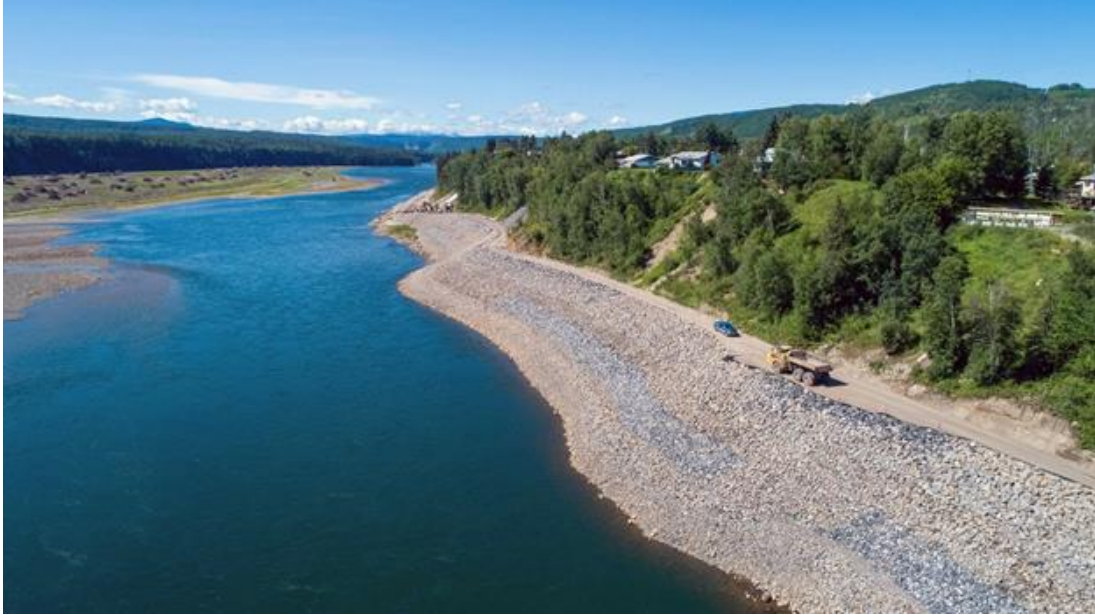
**Figure A-1** Progress on the Hudson’s Hope shoreline protection berm (July 2022)

We continue to make good progress on a number of off-dam site activities. In November 2022, work on the Hudson's Hope shoreline protection berm was completed. This is an important milestone as the 2.6-kilometre-long berm will reinforce and protect the Hudson's Hope shoreline once the reservoir is filled.

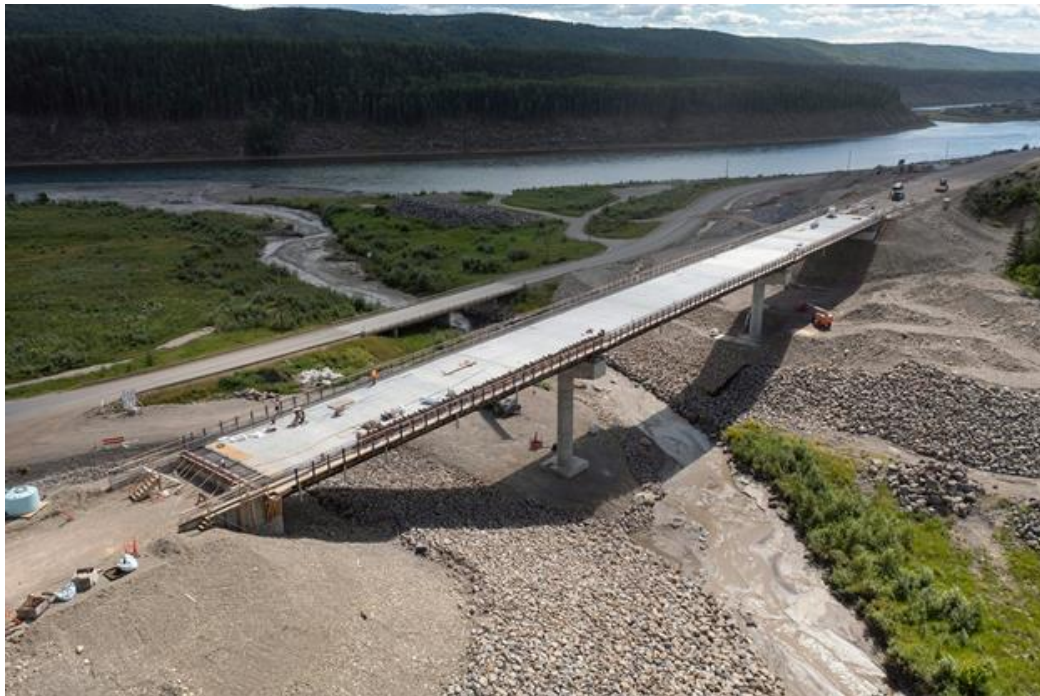
**Figure A-2** Concrete deck placements being completed for the Lynx Creek bridge on Highway 29 (July 2022)

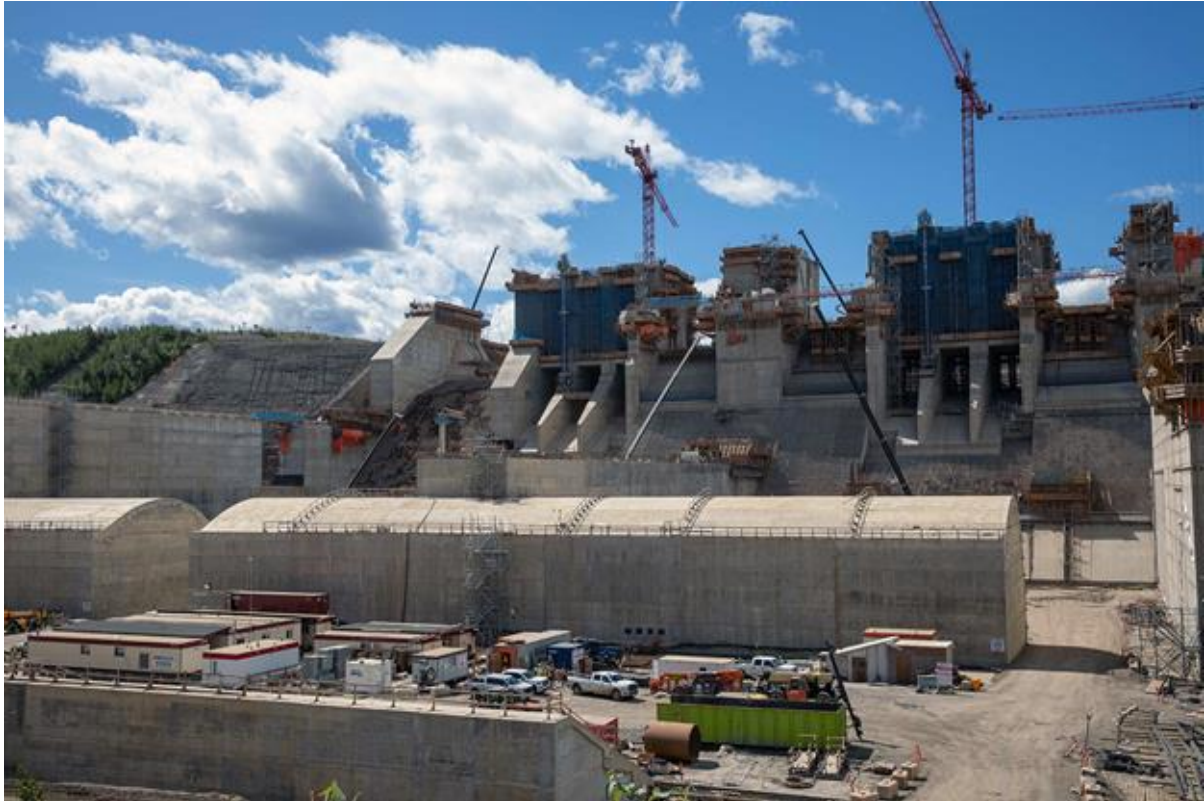
**Figure A-3 Construction of the spillway upper headworks and stilling basin (July 2022)**

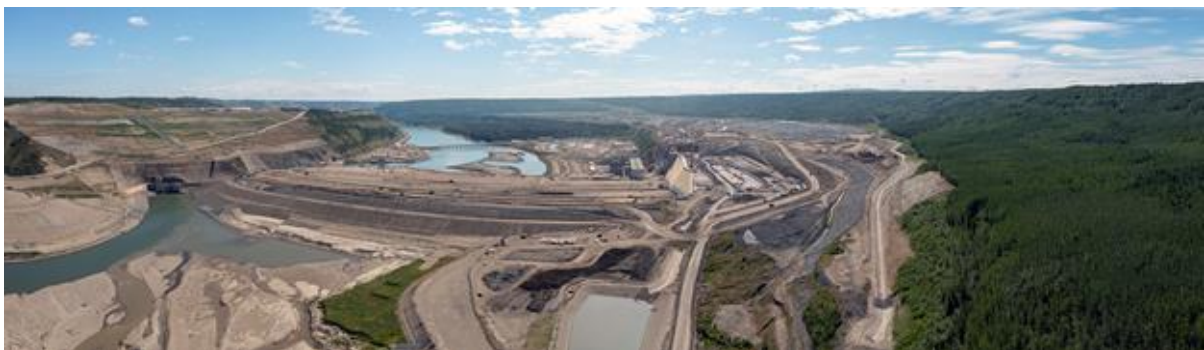
**Figure A-4 Panorama view, looking downstream, over the diversion tunnel inlet portals on the left, the earthfill dam in the centre, and the approach channel on the right (July 2022)**

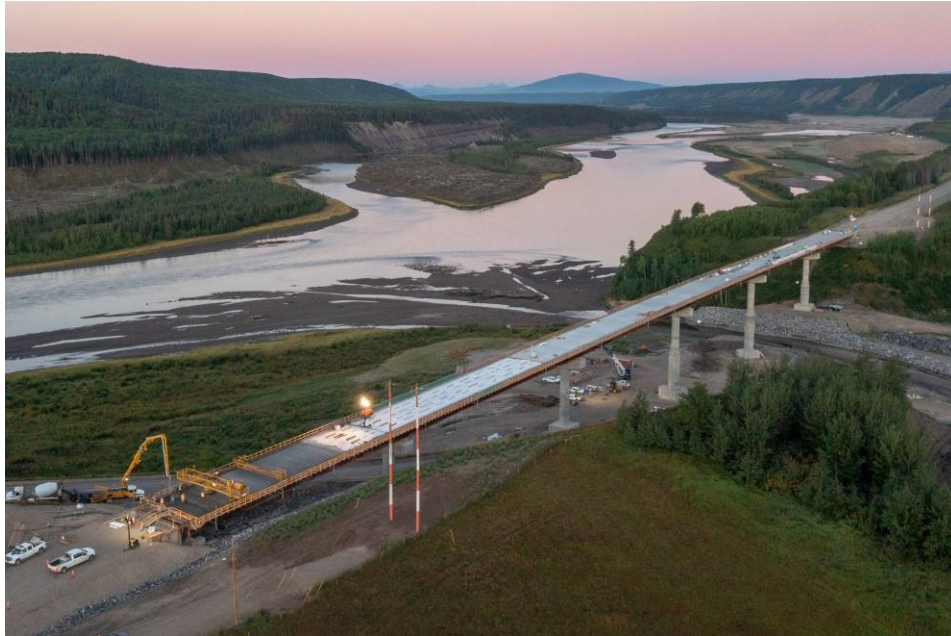
**Figure A-5** Farrell Creek final concrete placement (August 2022)

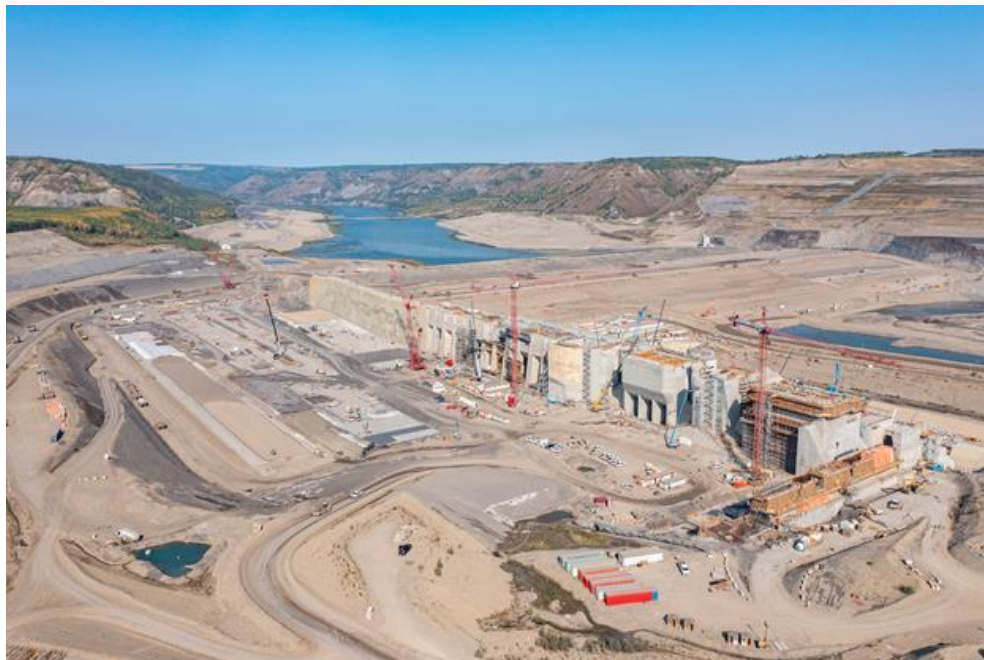
**Figure A-6** The ongoing construction of the approach channel, looking upstream (September 2022)

7 Detailed geological mapping of the excavations in the approach channel continues.  
8 This geological information will continue to be used to update the design parameters  
9 for the site geology and foundations.

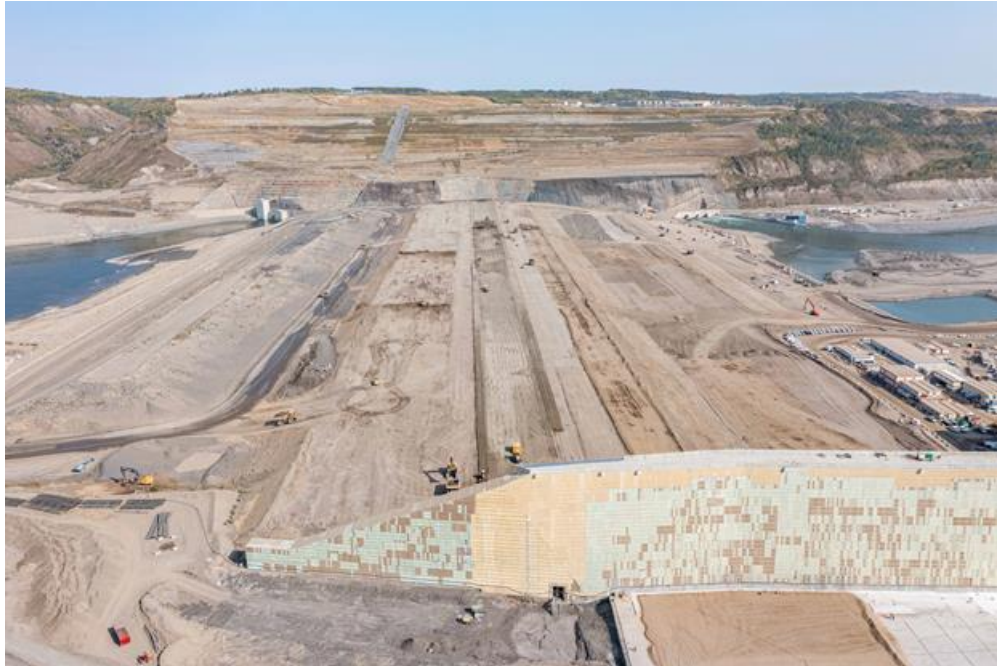
**Figure A-7** The Site C dam under construction, looking north (September 2022)

In late November 2022, the Site C project reached elevation 445 metres across the entire earthfill dam. The earthfill dam is now 87 per cent complete and puts us in a good position to complete the remaining work on the dam next year.

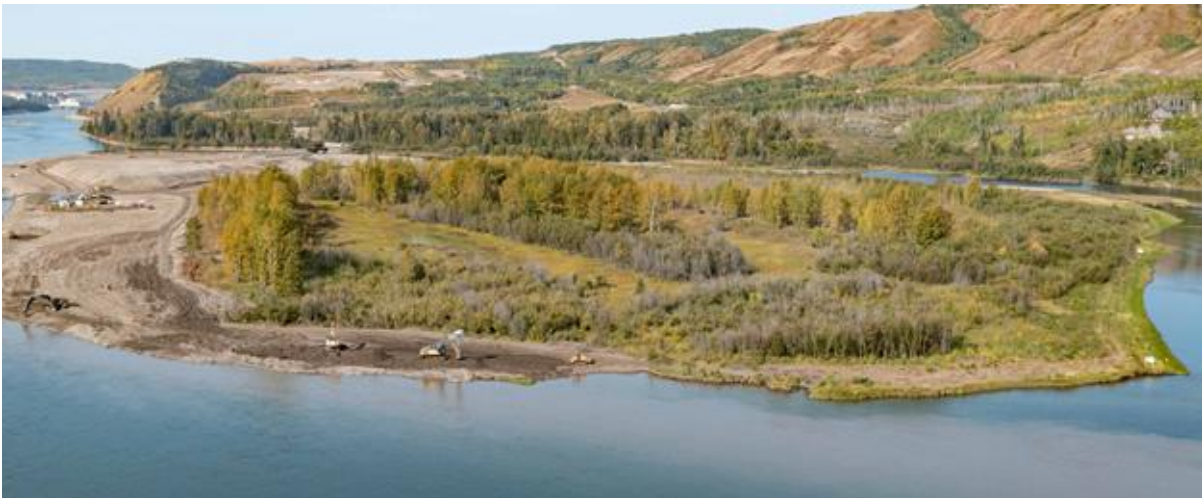
**Figure A-8** Fish habitat enhancements downstream of the dam site (September 2022)

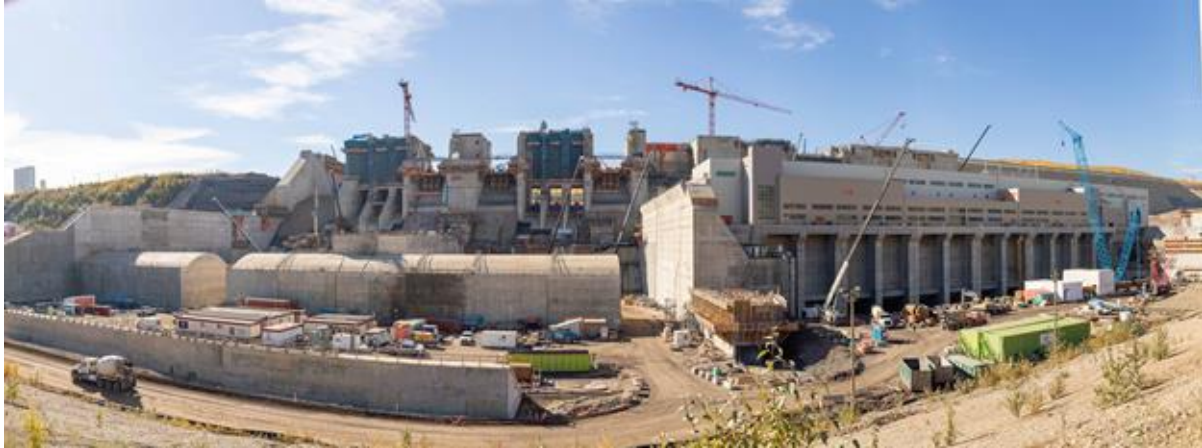
**Figure A-9 Construction of the Site C spillways and stilling basin, powerhouse and tailrace (September 2022)**

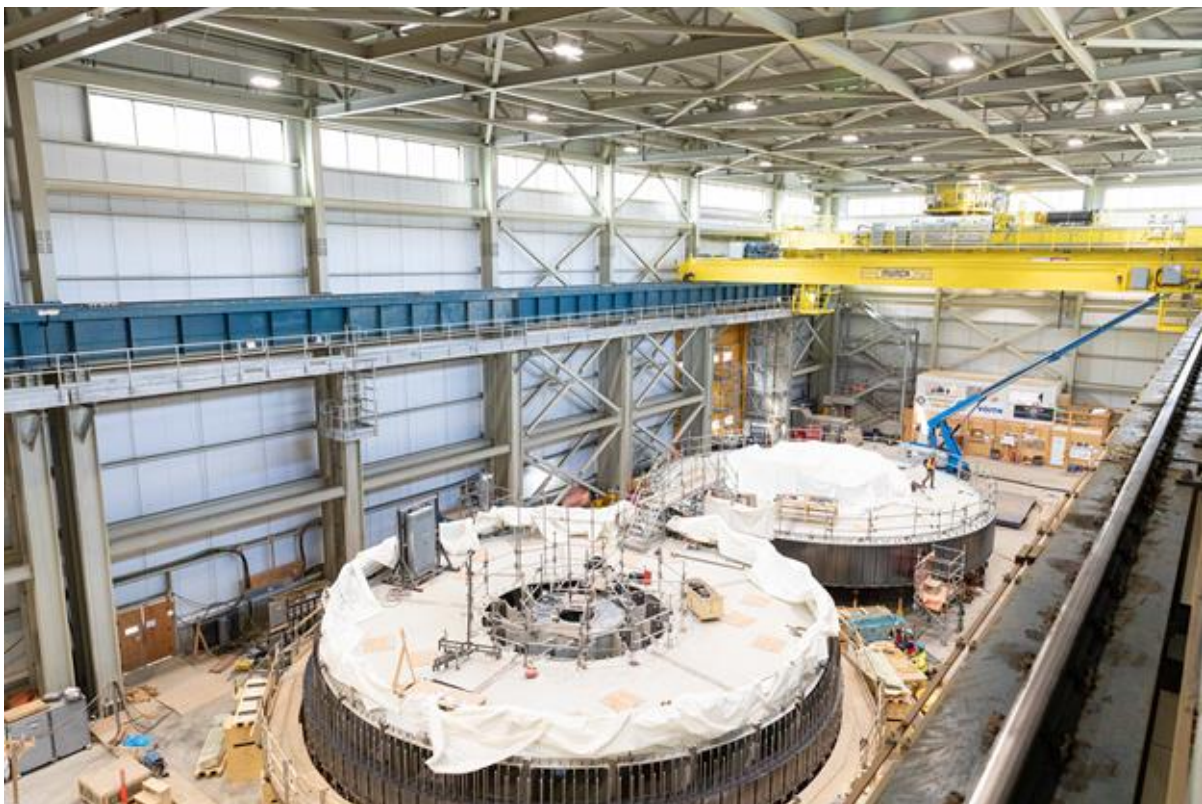
**Figure A-10 Generator rotors for units 1 and 2 being assembled in the powerhouse service bay, as an additional bridge crane is assembled in the background (September 2022)**
