*Fisheries and Aquatic Habitat
Management Plan
Annual Report:
Jan 1, 2020 to Dec 31, 2020*

*Site C Clean Energy Project
March 31, 2021*

Temporary Upstream Fish Passage Facility
Operations Report

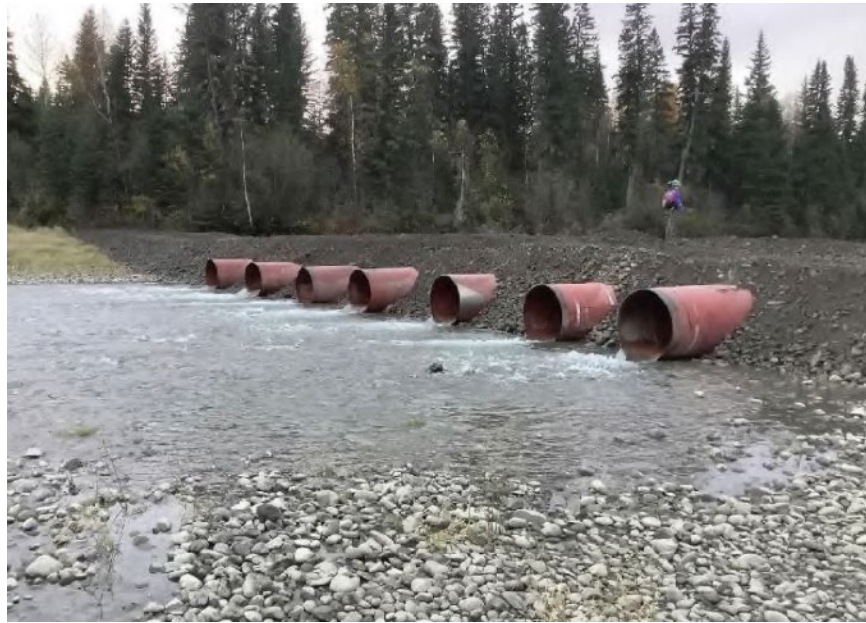
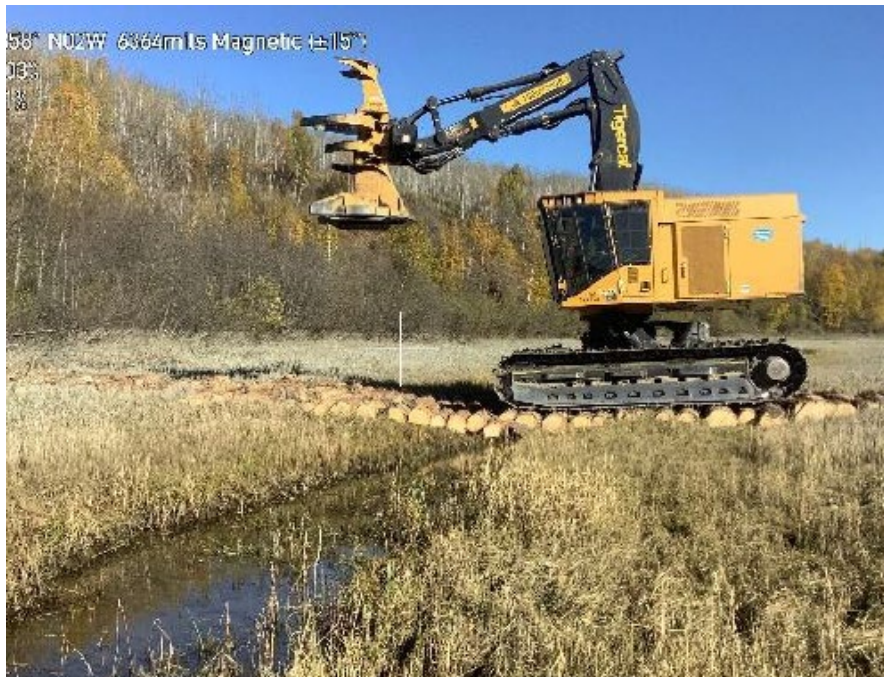
Figure 1. Temporary Peace River side channel crossings within middle reservoir clearing area. On site Qualified Environmental Professionals in place and site specific mitigation plans (September 26, 2020).

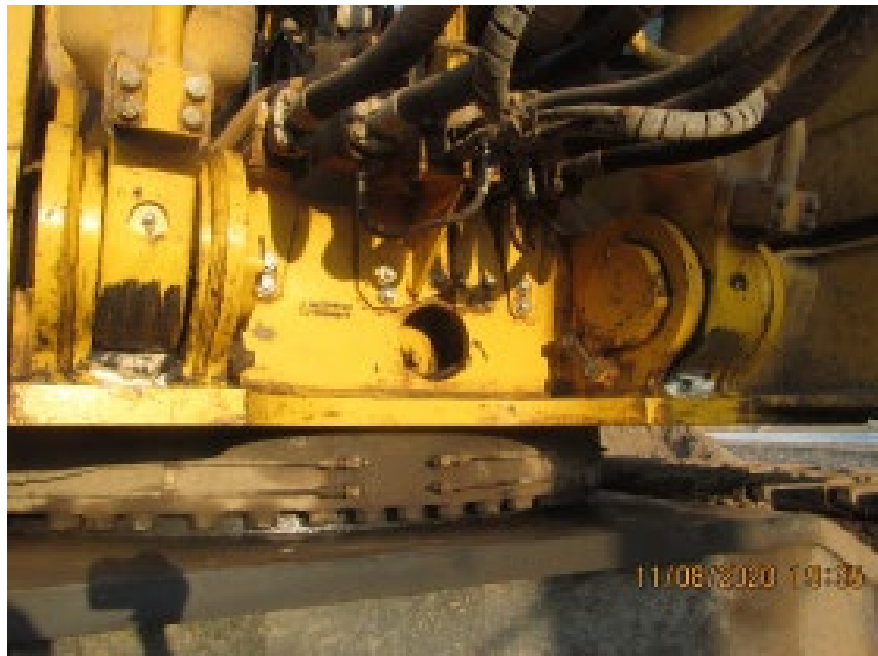
Figure 2. Within the dam site construction area all in-river machines are regularly checked for any signs of over greasing (August 11, 2020).

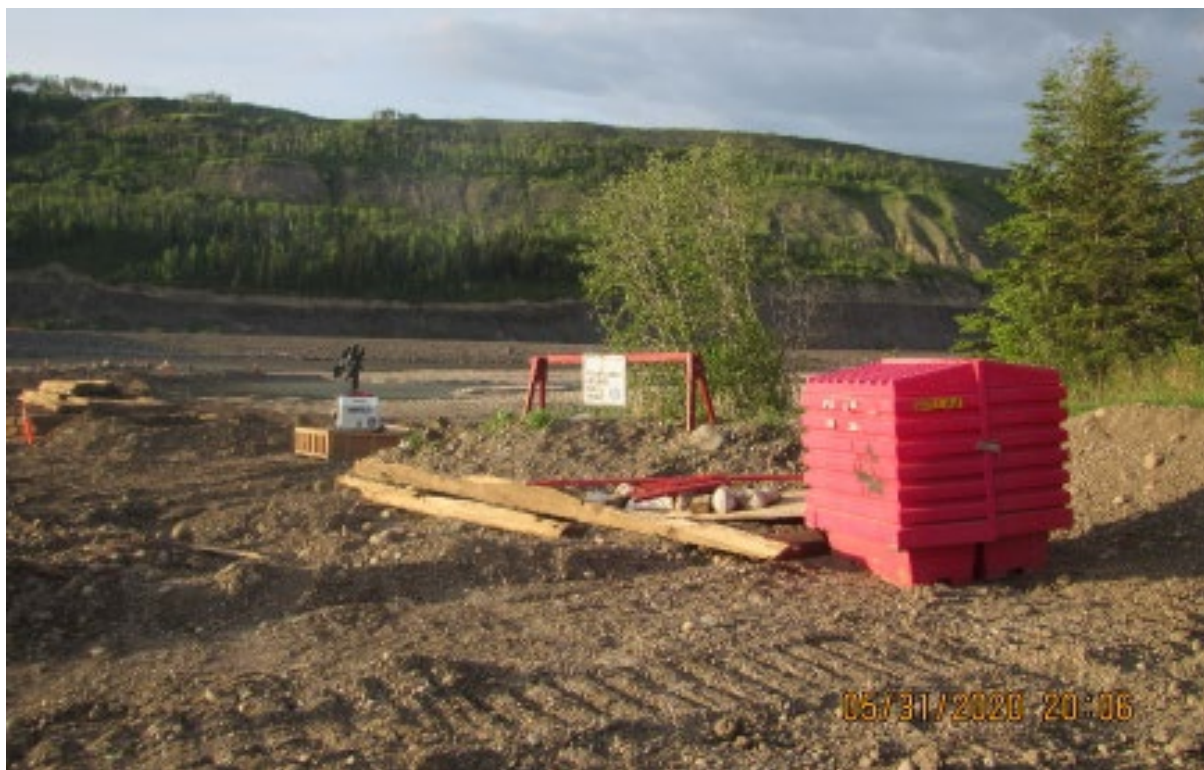
Figure 3. Spill prevention measures, including floating boom, within the dam site construction area adjacent to the Peace River (May 31, 2020).

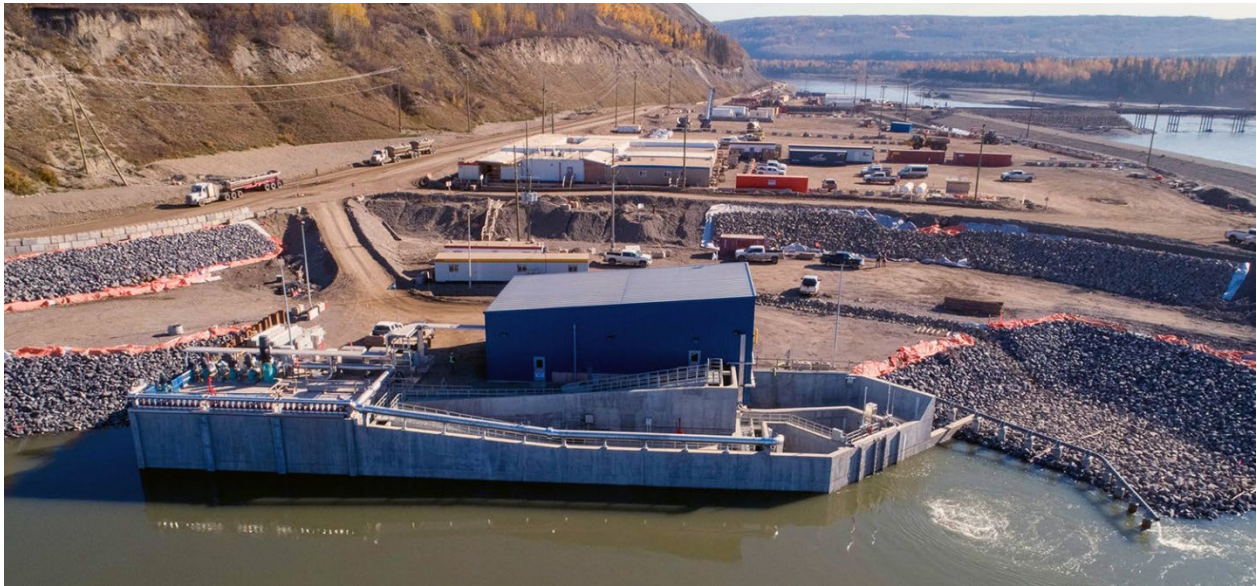
Figure 4. BC Hydro operated the temporary upstream fish passage facility during the month of October (October 2, 2020).

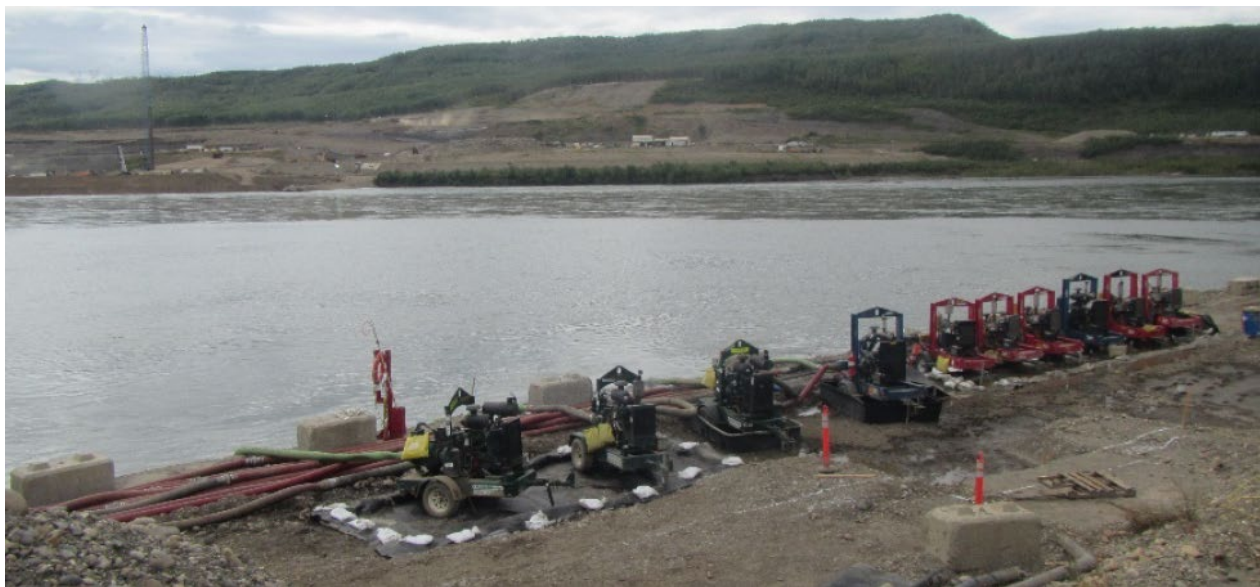
Figure 5. Diversion inlet pumps and containment. Water was pumped from the Peace River into the diversion inlet cofferdam area to balance water levels in preparation for removal of the inlet cofferdam (August 29, 2020).

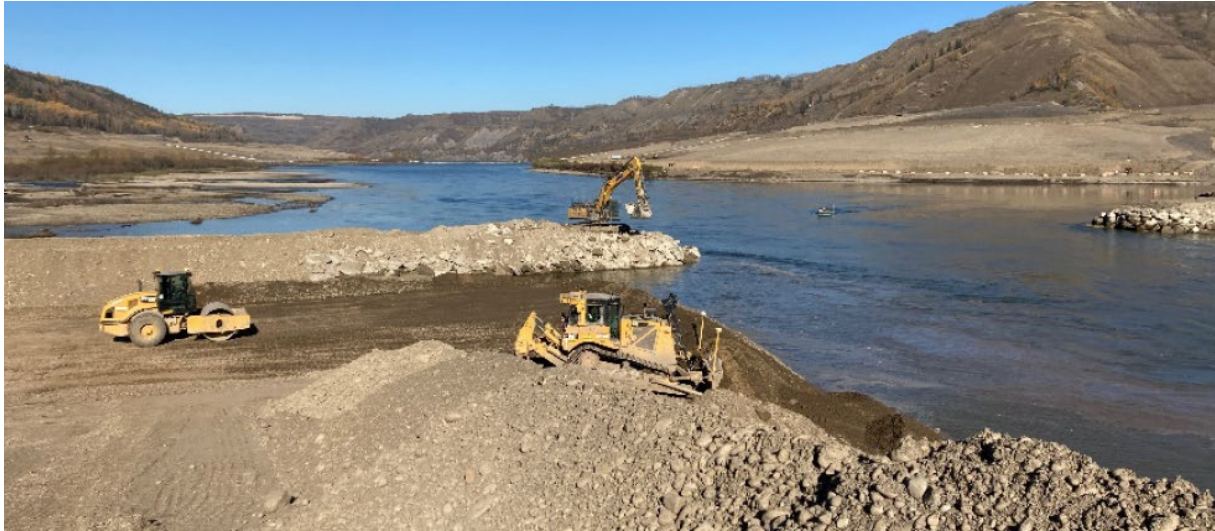
Figure 5. Rockfill berm extends from each bank of the Peace River to support river diversion. On site Qualified Environmental Professionals in place to ensure measures, including slow starts, controlled pace, and continuous of advancement, were being following to deter fish from active work areas (September 30, 2020; from south bank looking west).

A combined approach of water velocity monitoring and radio telemetry confirmed that fish passage conditions were maintained in the Peace River during the installation of the rockfill berm and upstream and downstream cofferdams prior to Peace River Diversion.

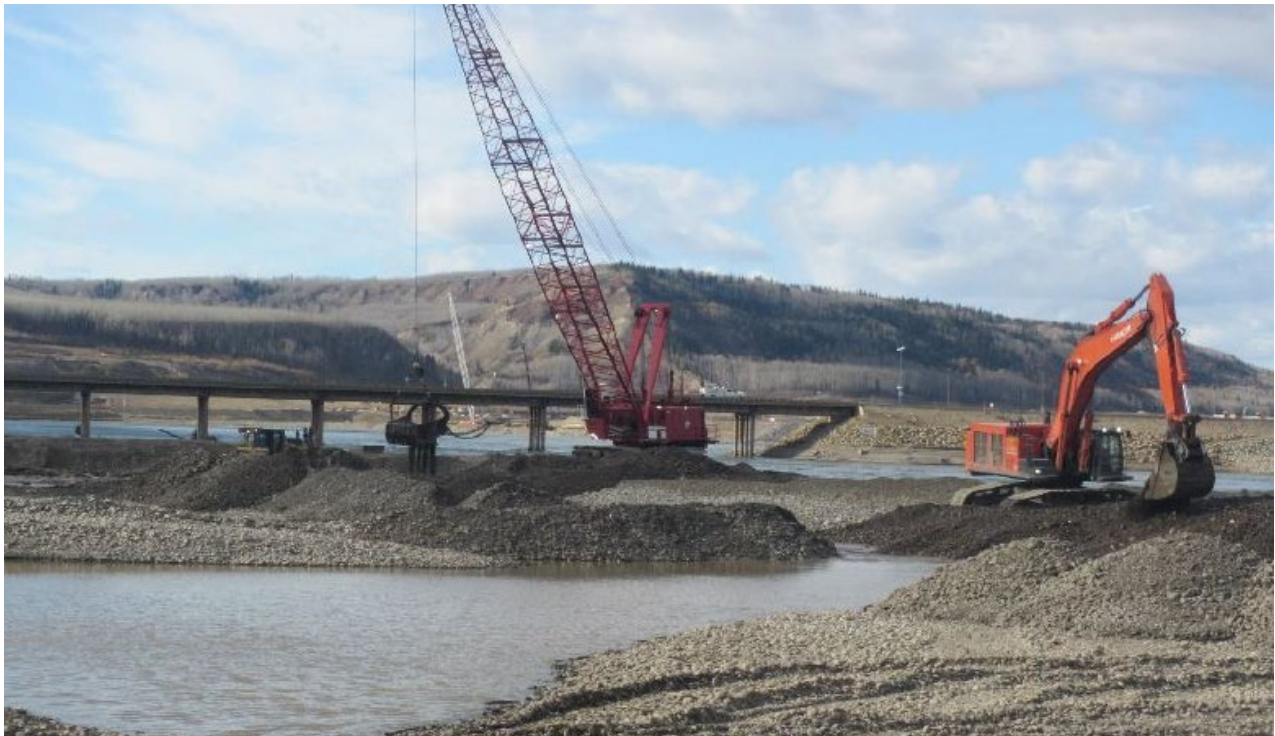
Figure 6. Contouring of Peace River mainstem bar downstream of the dam site (October 5, 2020; from south bank looking west).

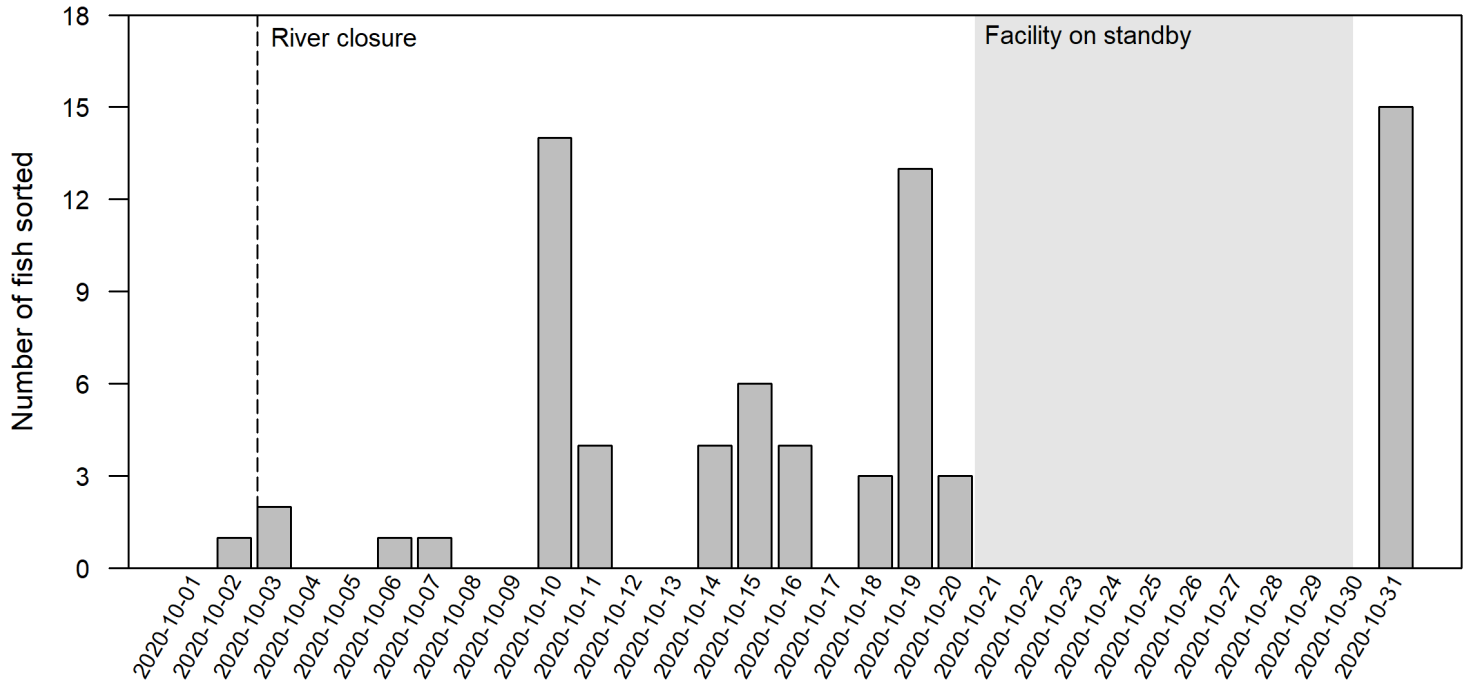
Figure 1. Daily number of fish sorted in the temporary facility during the reporting period.

The facility operator sorted the first fish – a Longnose Sucker – in the temporary facility on October 2 (Photo 7). Between zero and 15 fish were sorted daily during the reporting period (Figure 1). Note that the facility was on standby from October 20 to 30 due to cold weather conditions⁶, as shown in Figure 3 and described in Table 3.

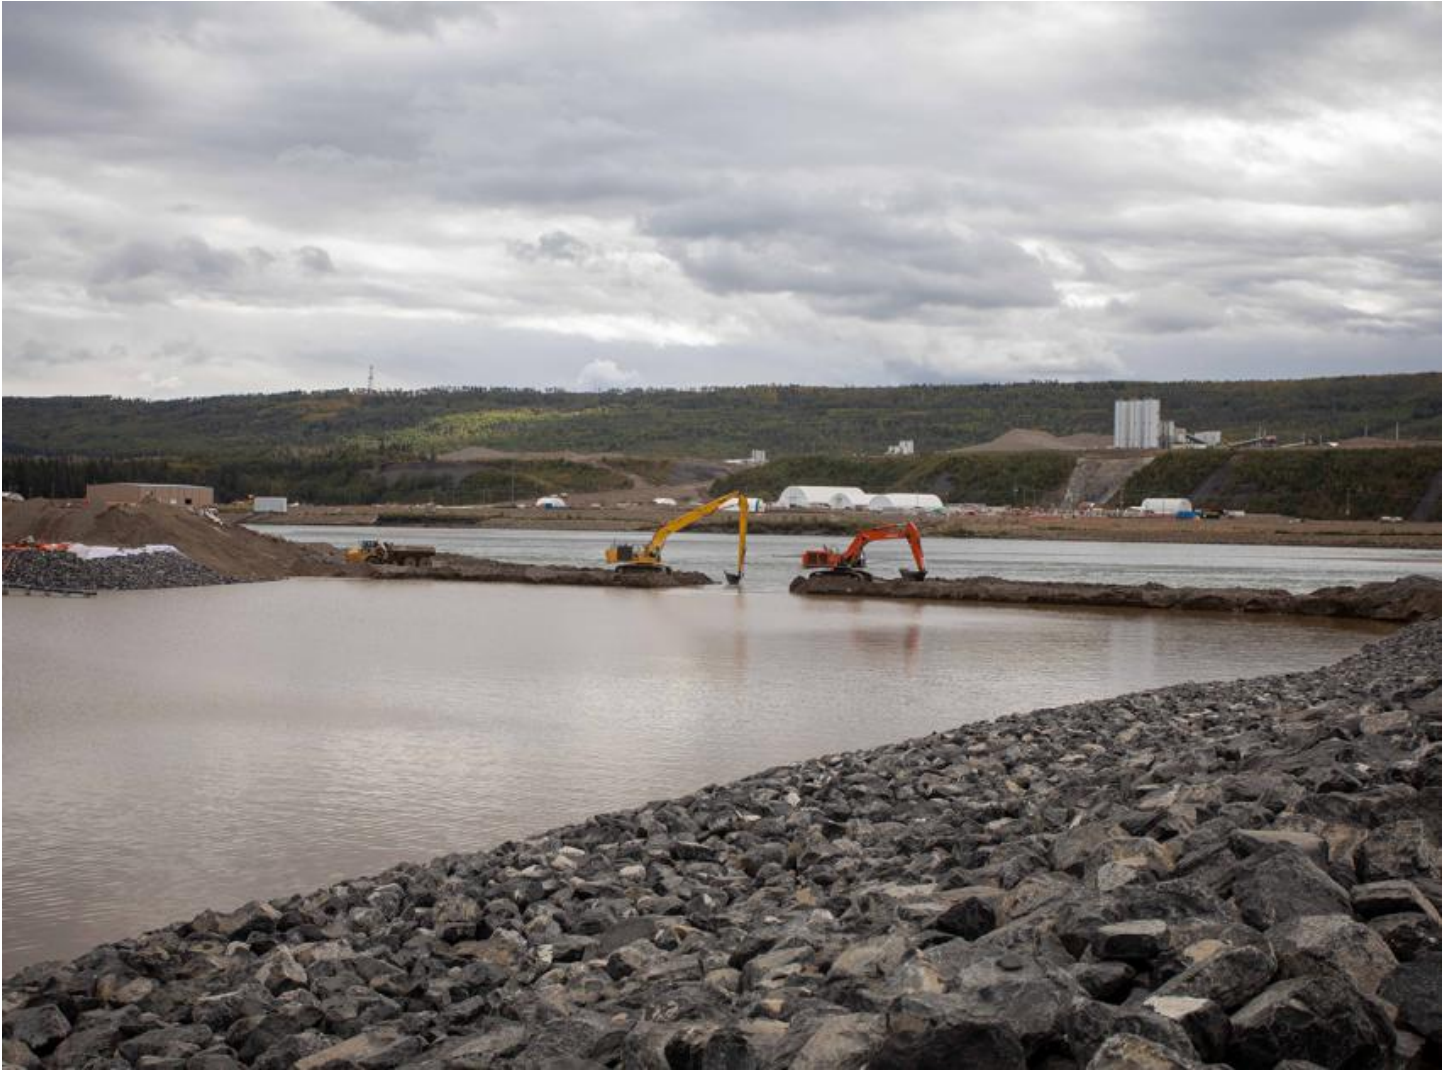
Photo 1. Excavators breach the Stage 1 Downstream Cofferdam to connect the diversion tunnel outlet with the Peace River (September 11, 2020).

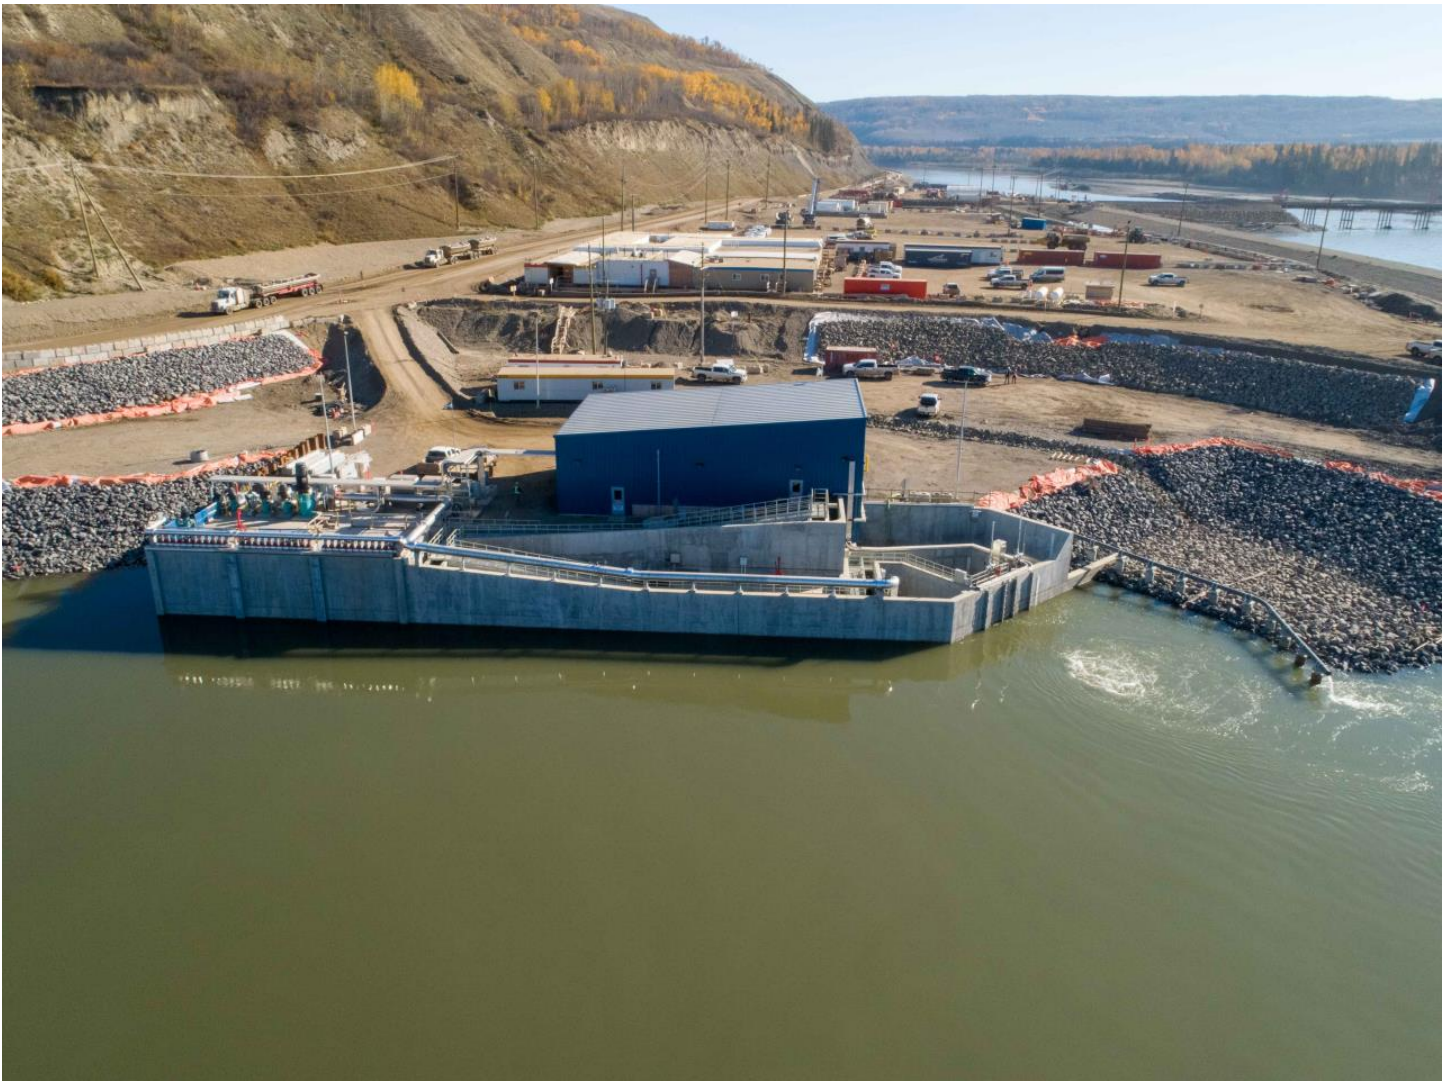
Photo 2. Overview of the temporary facility located at the outlet of the diversion tunnels (October 2, 2020).

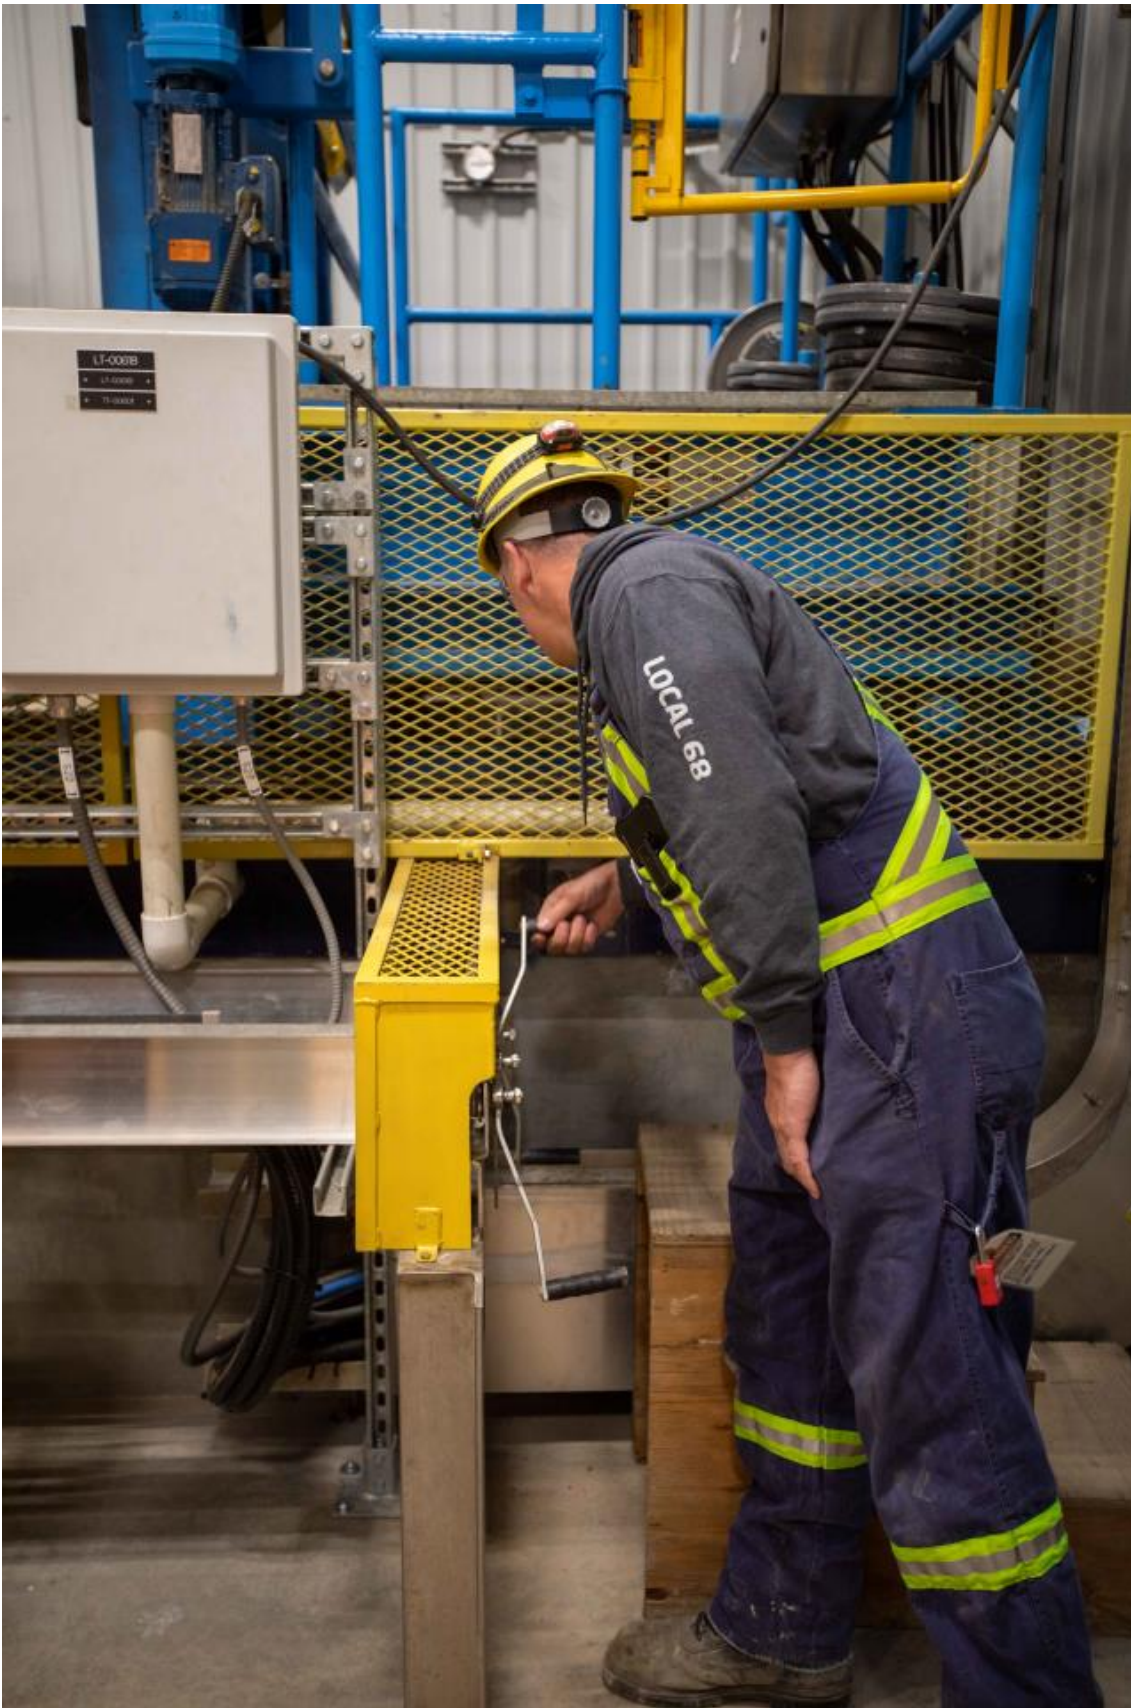
Photo 3. Worker opens the vee-trap on the first day of commissioning (September 23, 2020).

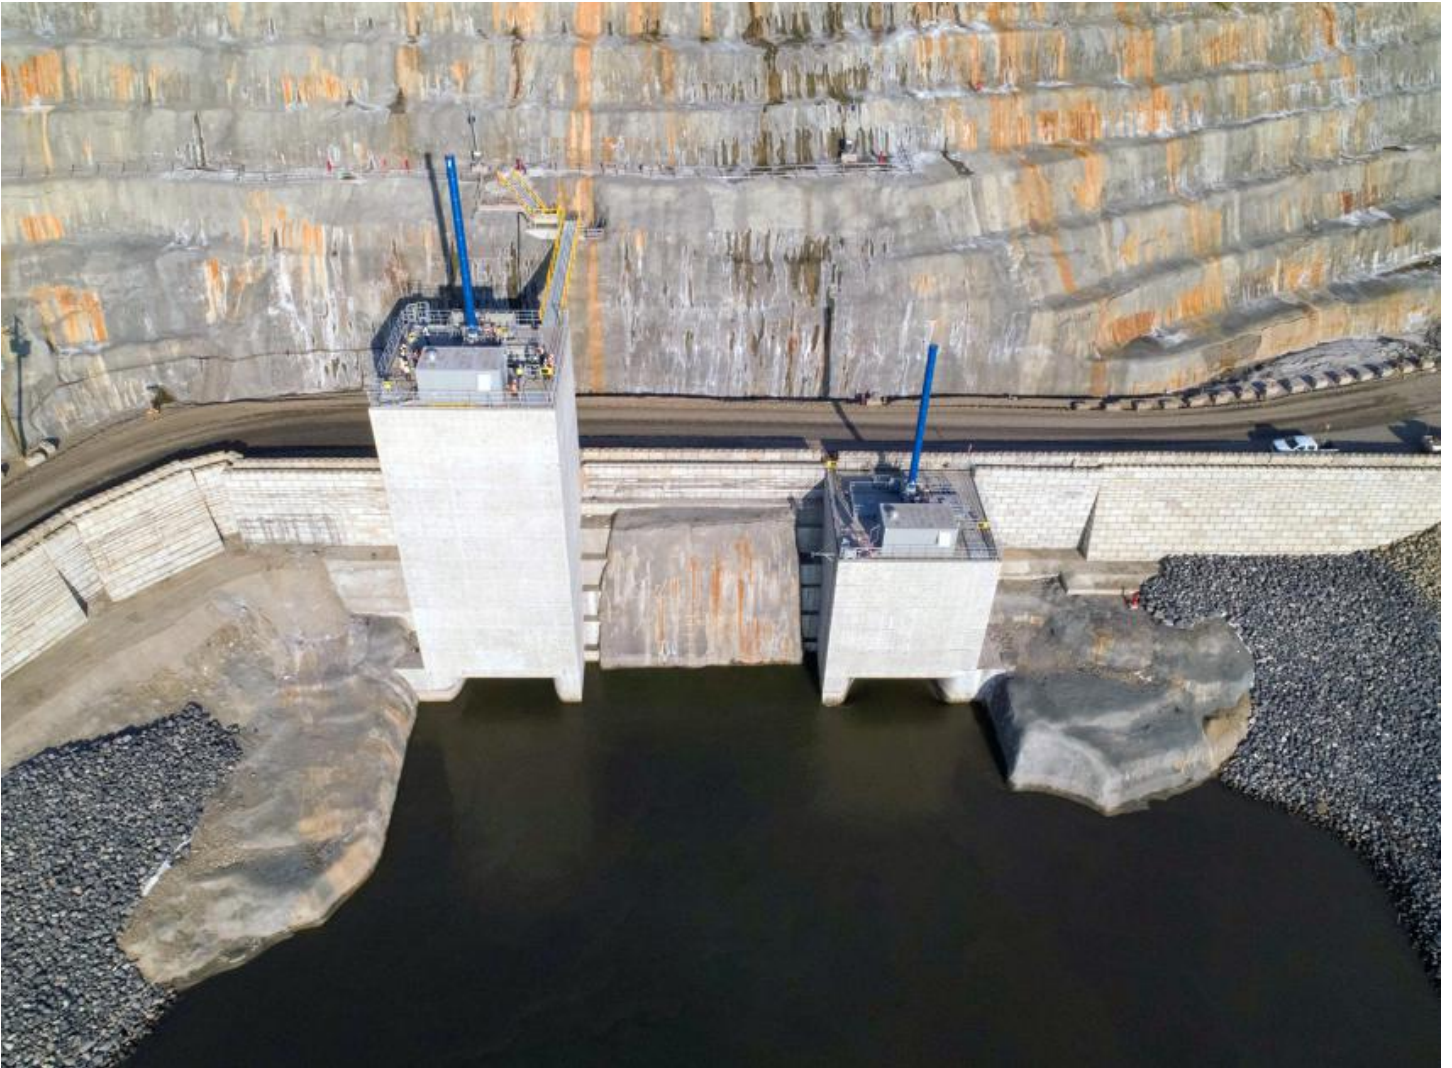
Photo 4. Diversion began on September 30, 2020, when the diversion tunnel gates were opened.

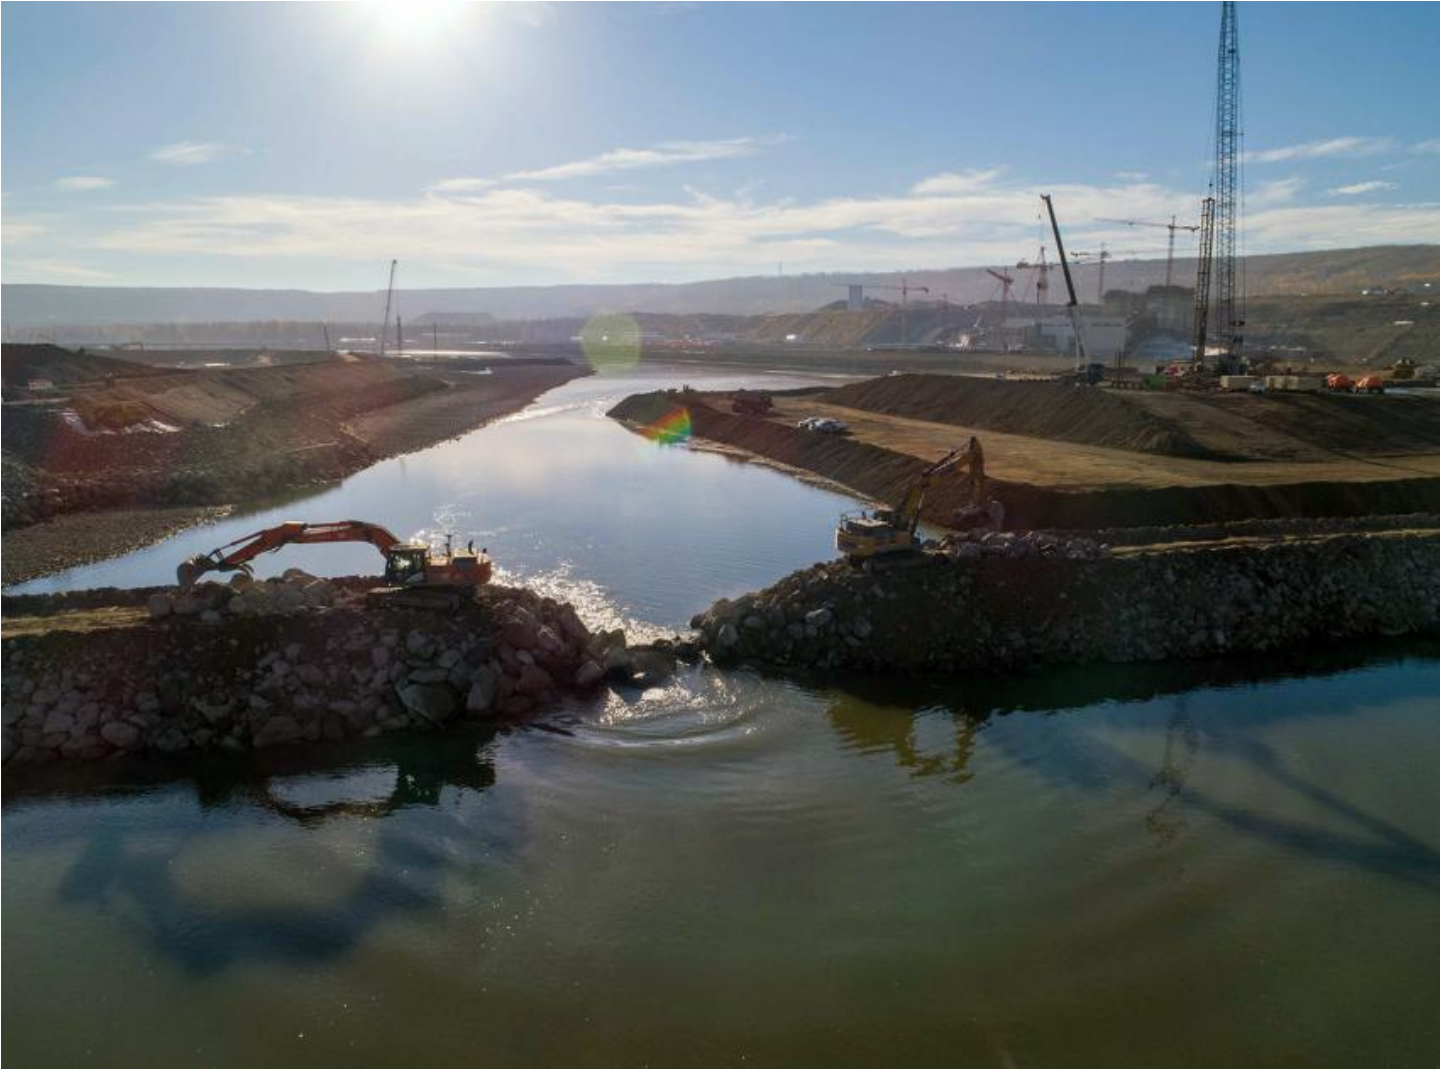
Photo 5. Final rip rap is placed on the rockfill berm (center) to close the Peace River on October 3, 2020 (looking downstream).

Discharge in the Peace River was held low (approximately 400 cms) from September 29 to October 3 to support placement of the final rip rap at the rockfill berm (Photo 5). Following river closure on October 3, flows increased to approximately 800 cms and remained above this level until a planned ramp down event at Peace Canyon Dam on October 31 to support Highway 29 construction activities at the Halfway River (Figure 2).

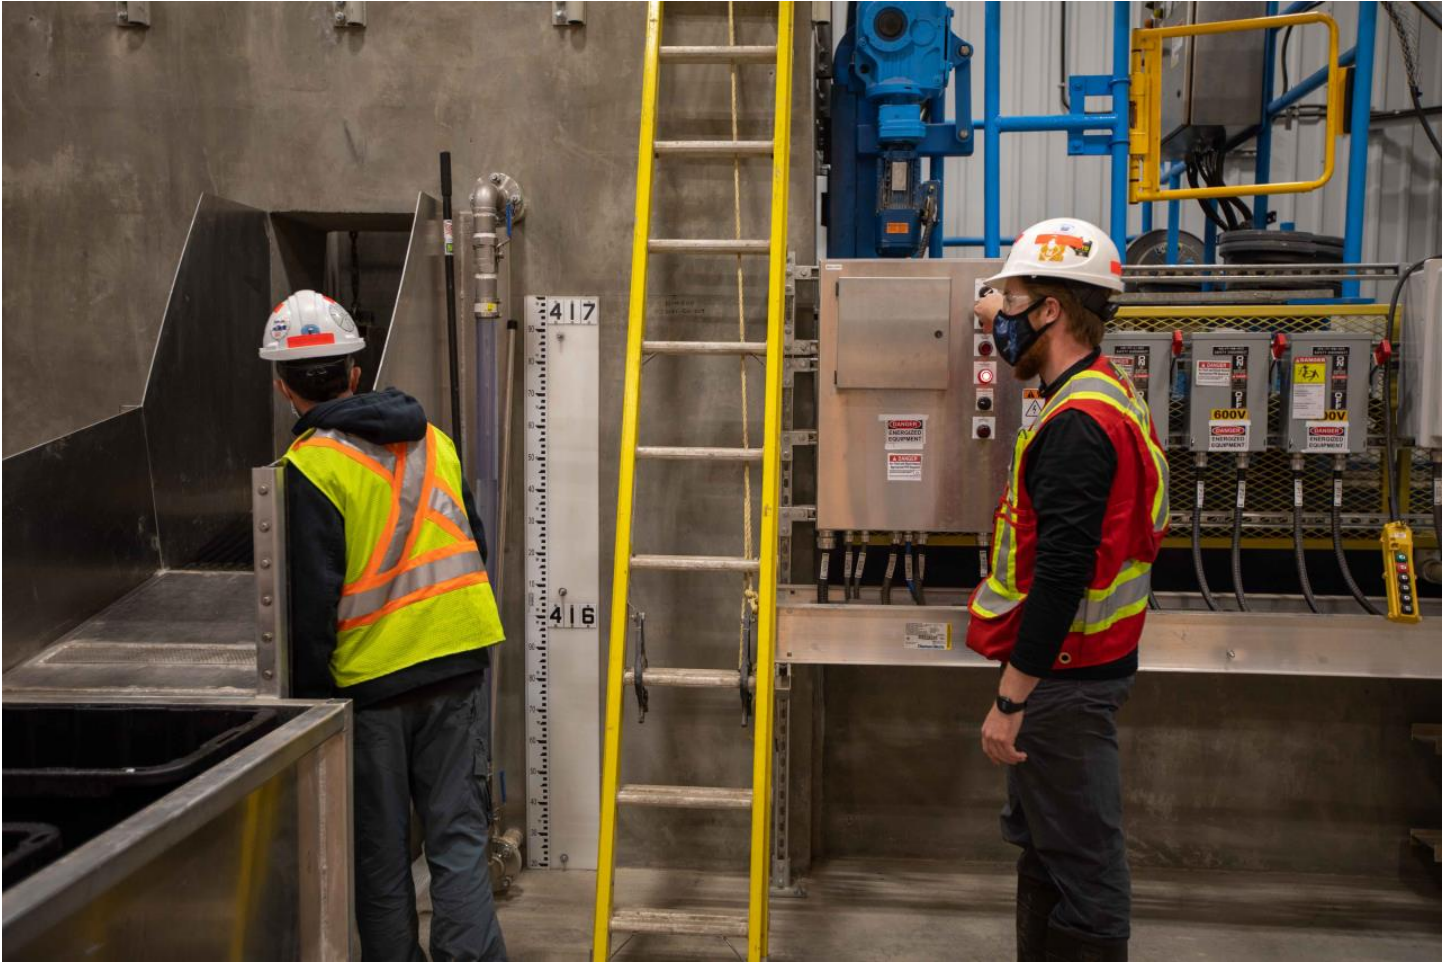
Photo 6. Workers conduct a crowding cycle during the first day of commissioning the temporary facility (September 23, 2020).

Fish were crowded daily from the pre-sort holding pool into the fish lock. Operators then proceeded to raise crowded fish to the elevation of the sorting facility. Note that this process is referred to as a “sorting cycle”.

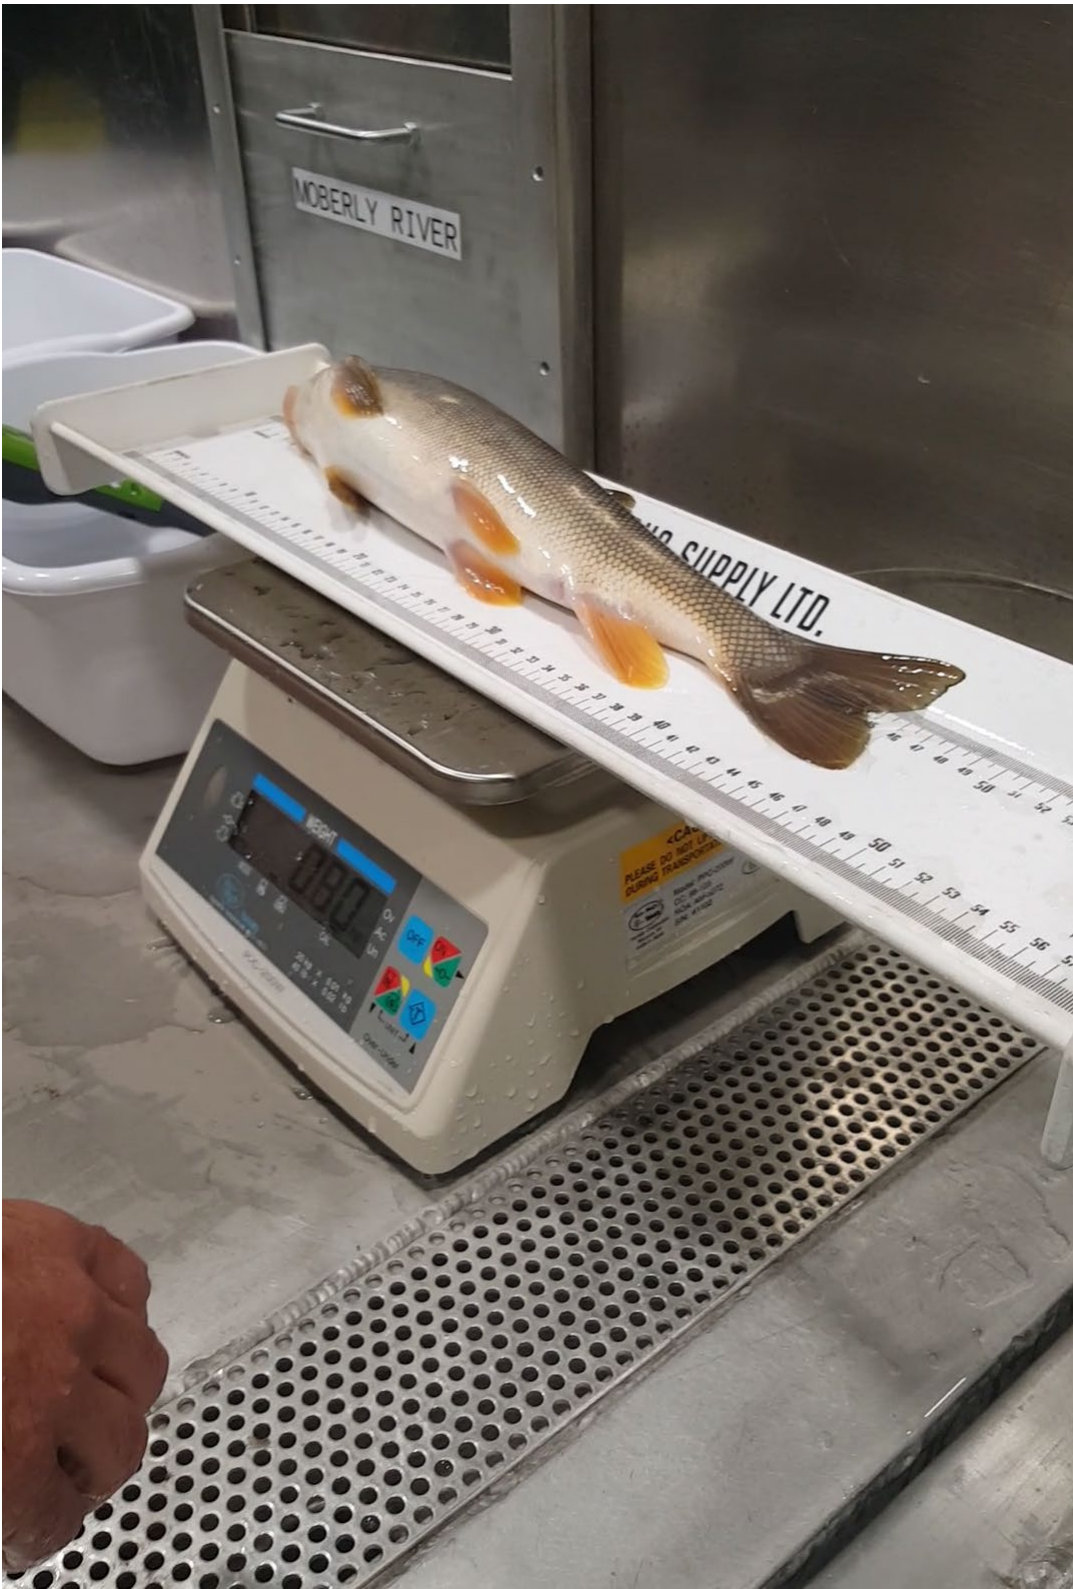
Photo 7. Weighing the first fish – a Longnose Sucker – on the second day of operations (October 2, 2020).

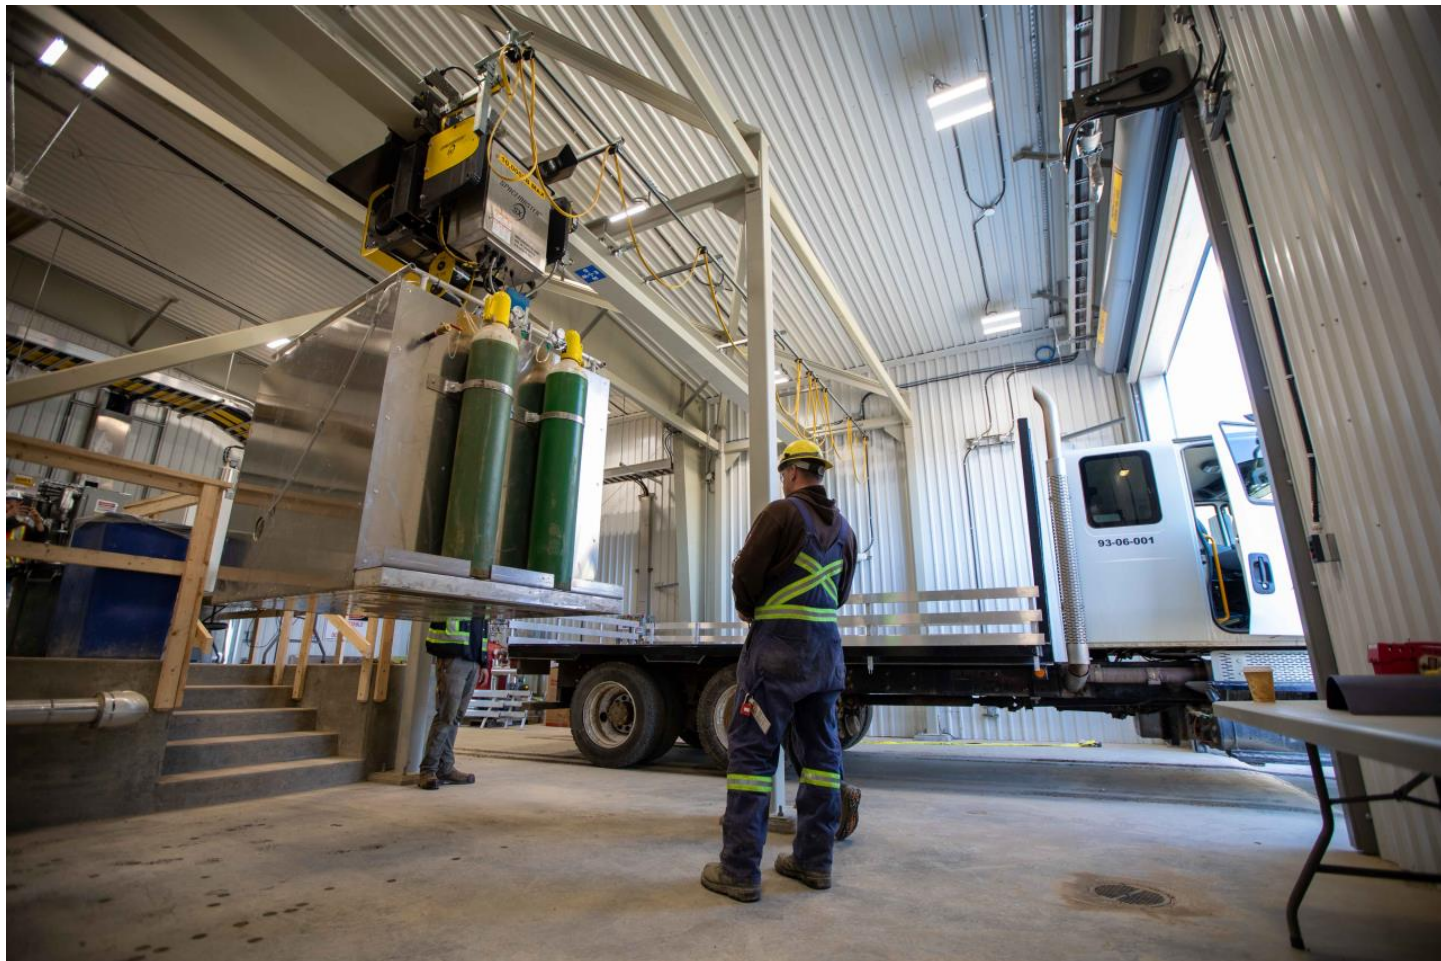
Photo 8. Workers load a transport pod onto the transport truck using the monorail crane hoist inside the sorting facility (October 2, 2020).

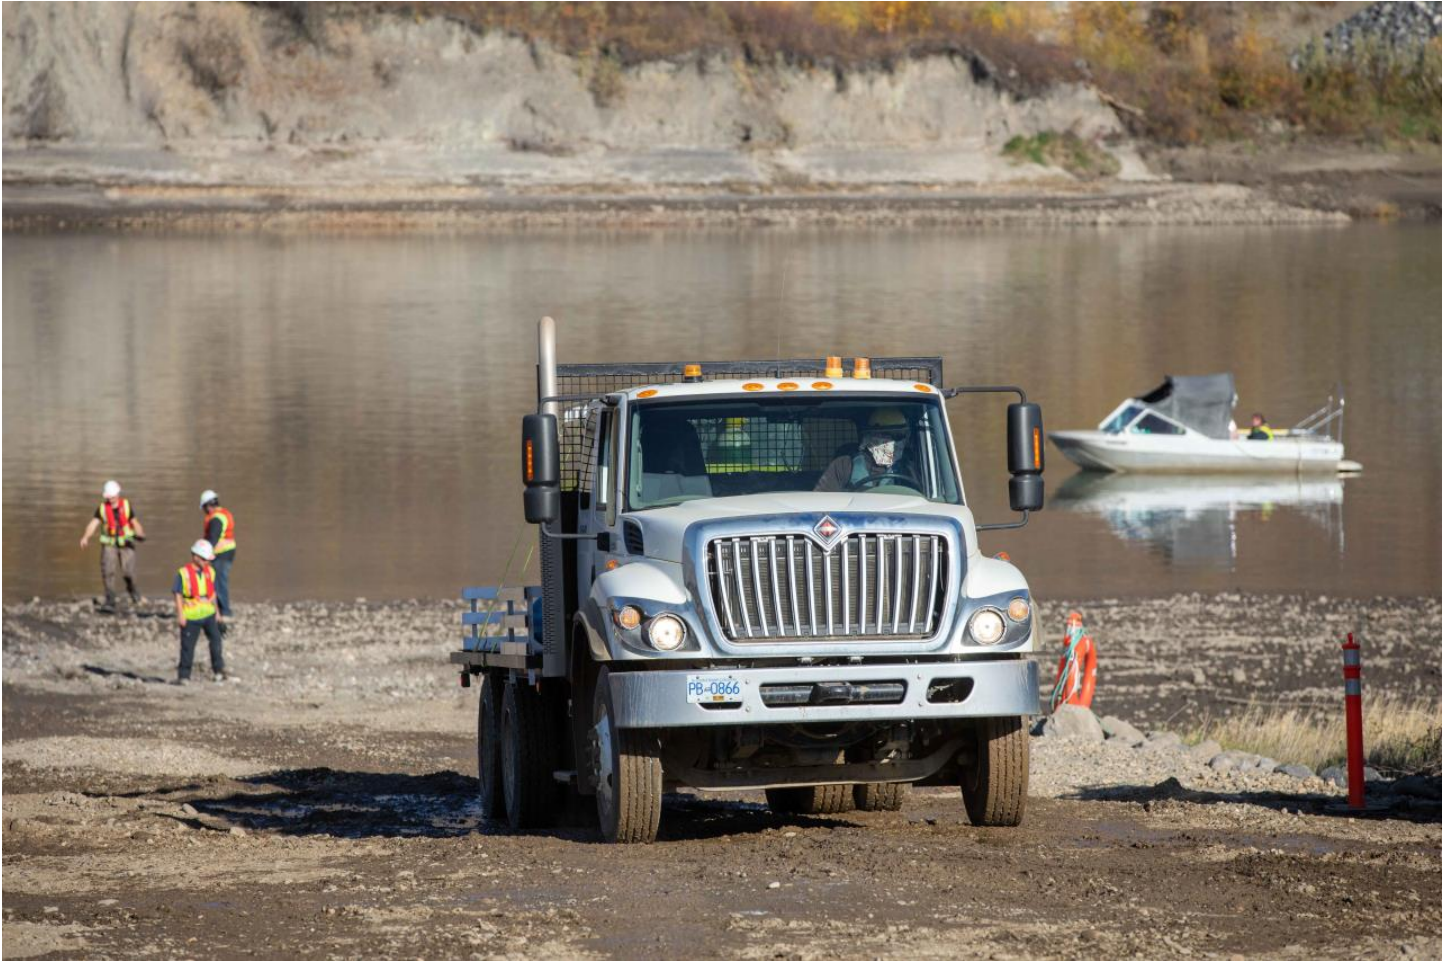
Photo 9. Transport truck is backed up to the release site 2 kilometers upstream of the dam site in the Peace River (October 2, 2020).
