*Fisheries and Aquatic Habitat
Management Plan
Annual Report:
Jan 1, 2020 to Dec 31, 2020*

*Site C Clean Energy Project
March 31, 2021*

Temporary Upstream Fish Passage Facility
Operations Report

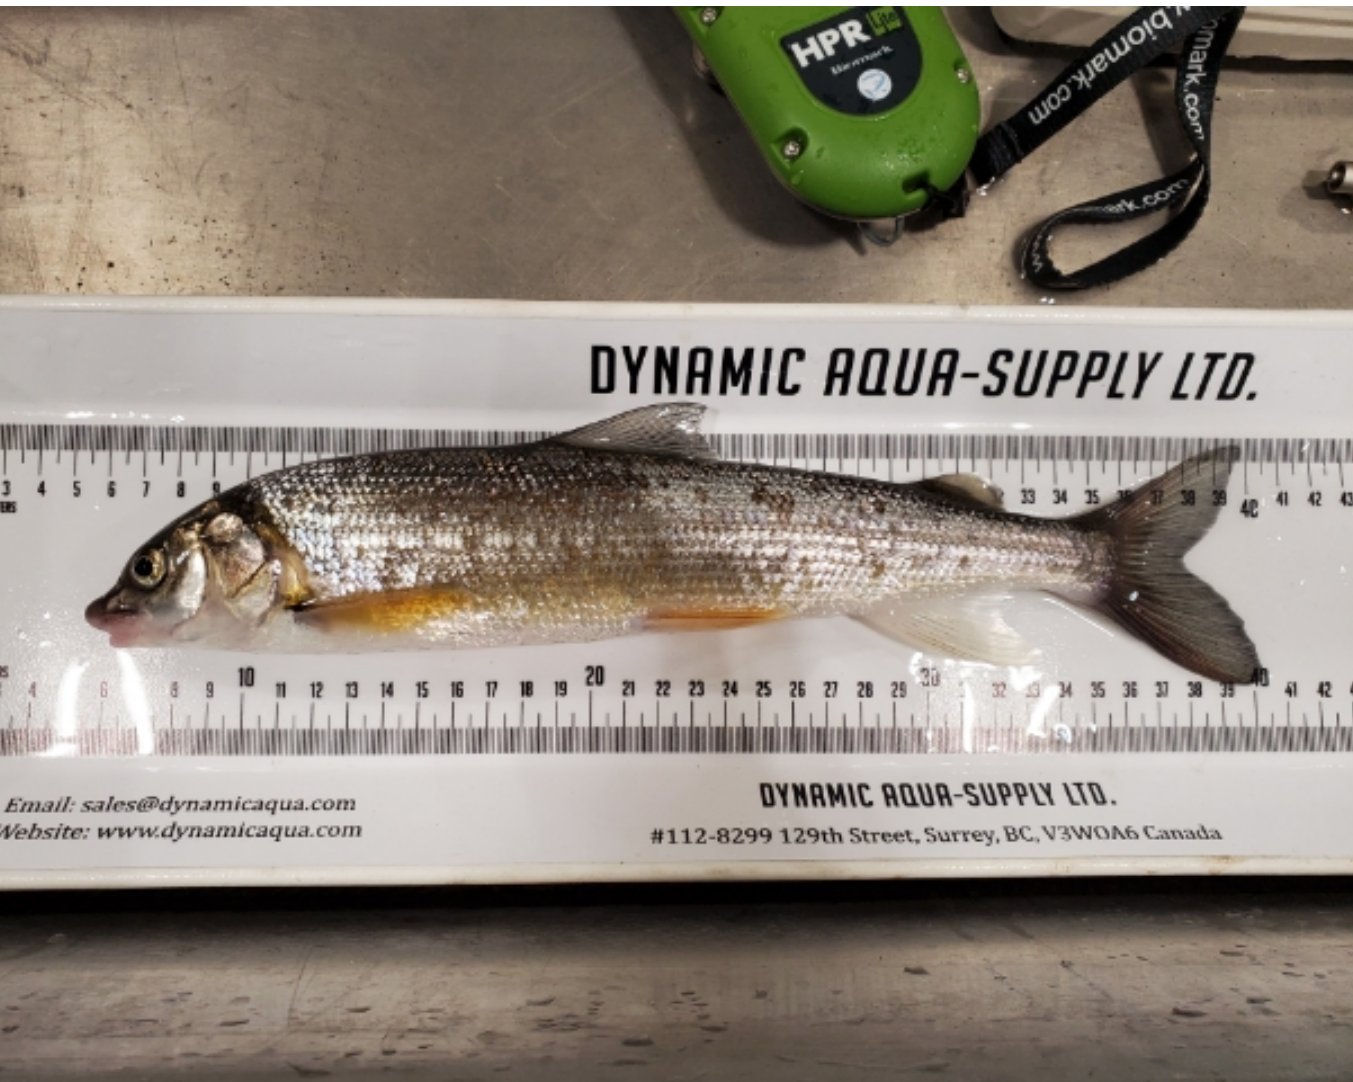
Photo 10. Workers sample a mortality (Mountain Whitefish) to confirm sex and collect otoliths for microchemistry and ageing analysis (October 10, 2020).

In total, 71 fish were sorted in the temporary facility during the reporting period (Table 1). Two mortalities – both Mountain Whitefish – were observed during the reporting period (3% of all fish sorted in 2020), which is in-line with the anticipated levels of mortality during operations⁵. One mortality was identified at release while the other occurred in the sorting facility during sampling.

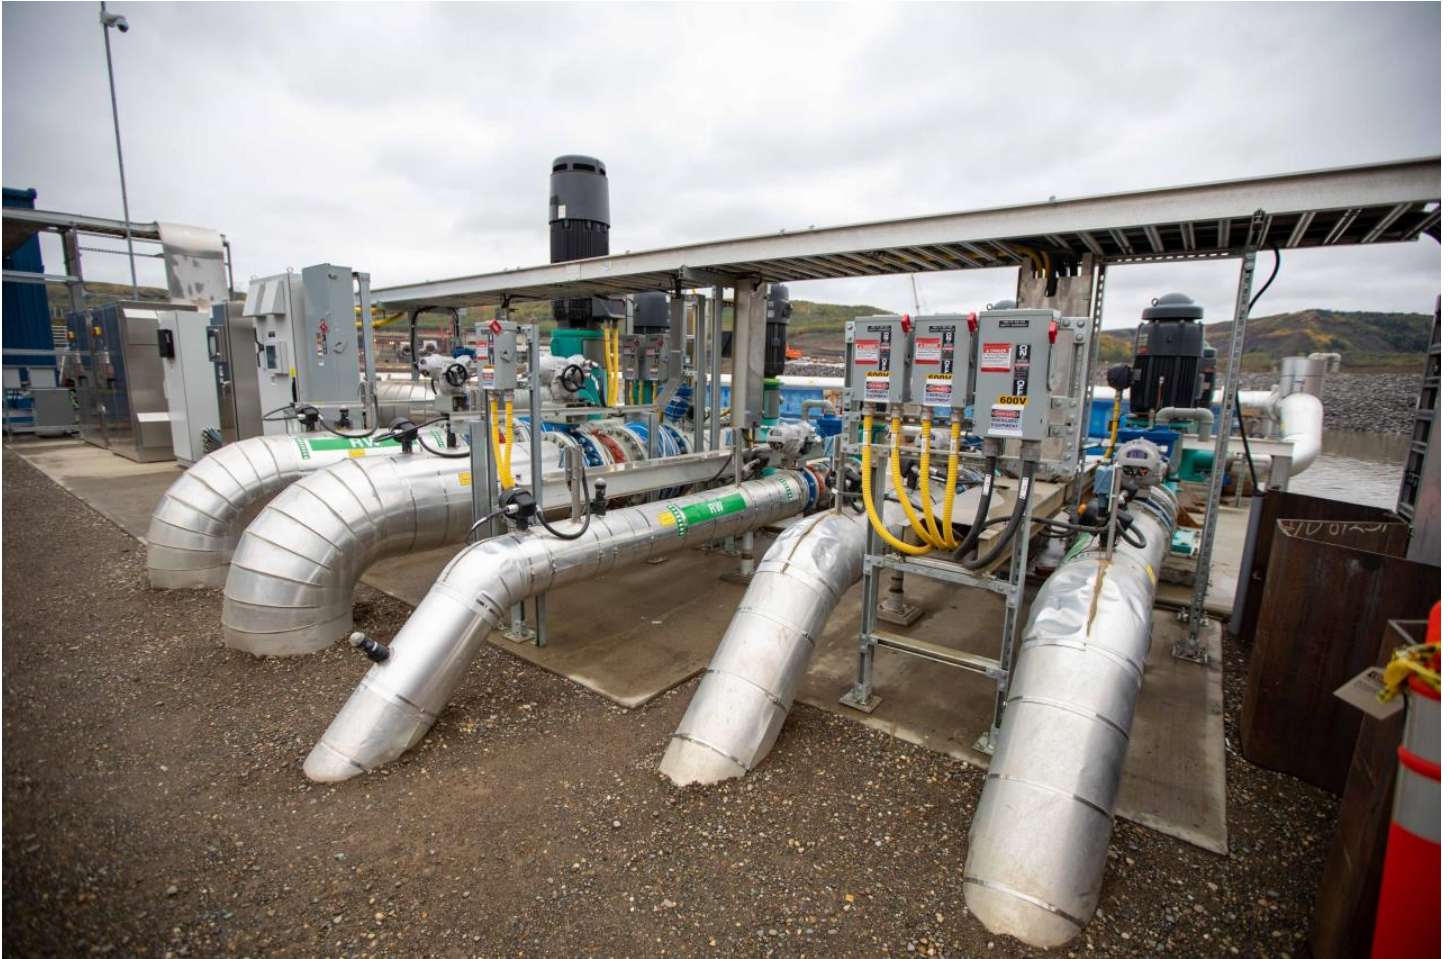
Photo 11. Ten pumps are located on site to provide flows to the fishway and the sorting facility (September 14, 2020).

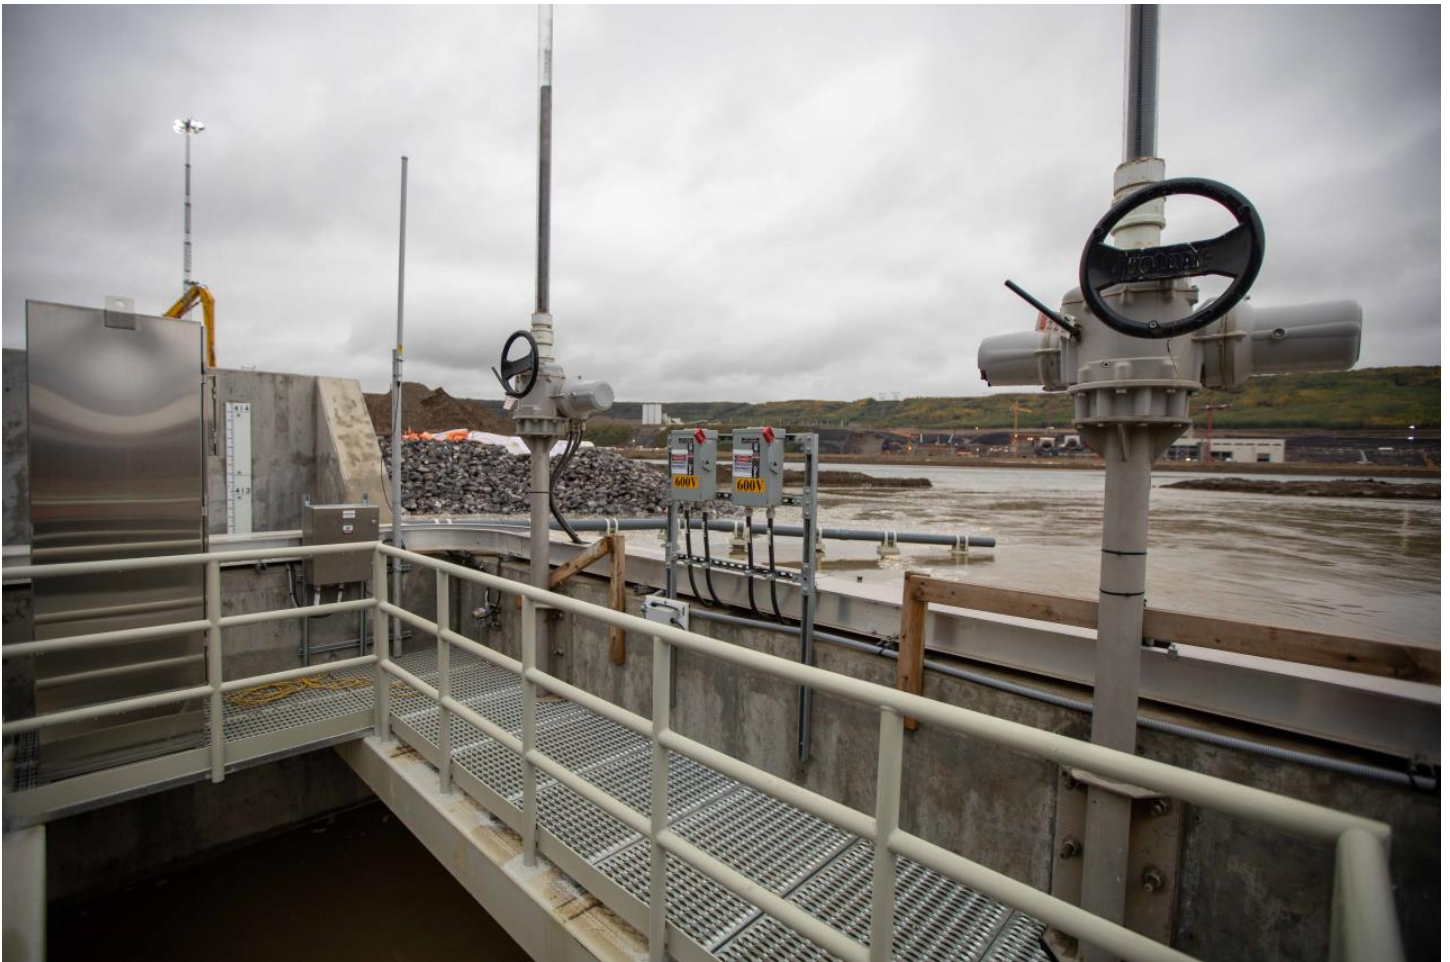
Photo 12. Two entrance gates provide the attraction flows at the fishway entrance. Gates are programmed to automatically adjust their position to maintain the same head differential between the entrance pool and the diversion tunnel outlet (September 14, 2020).

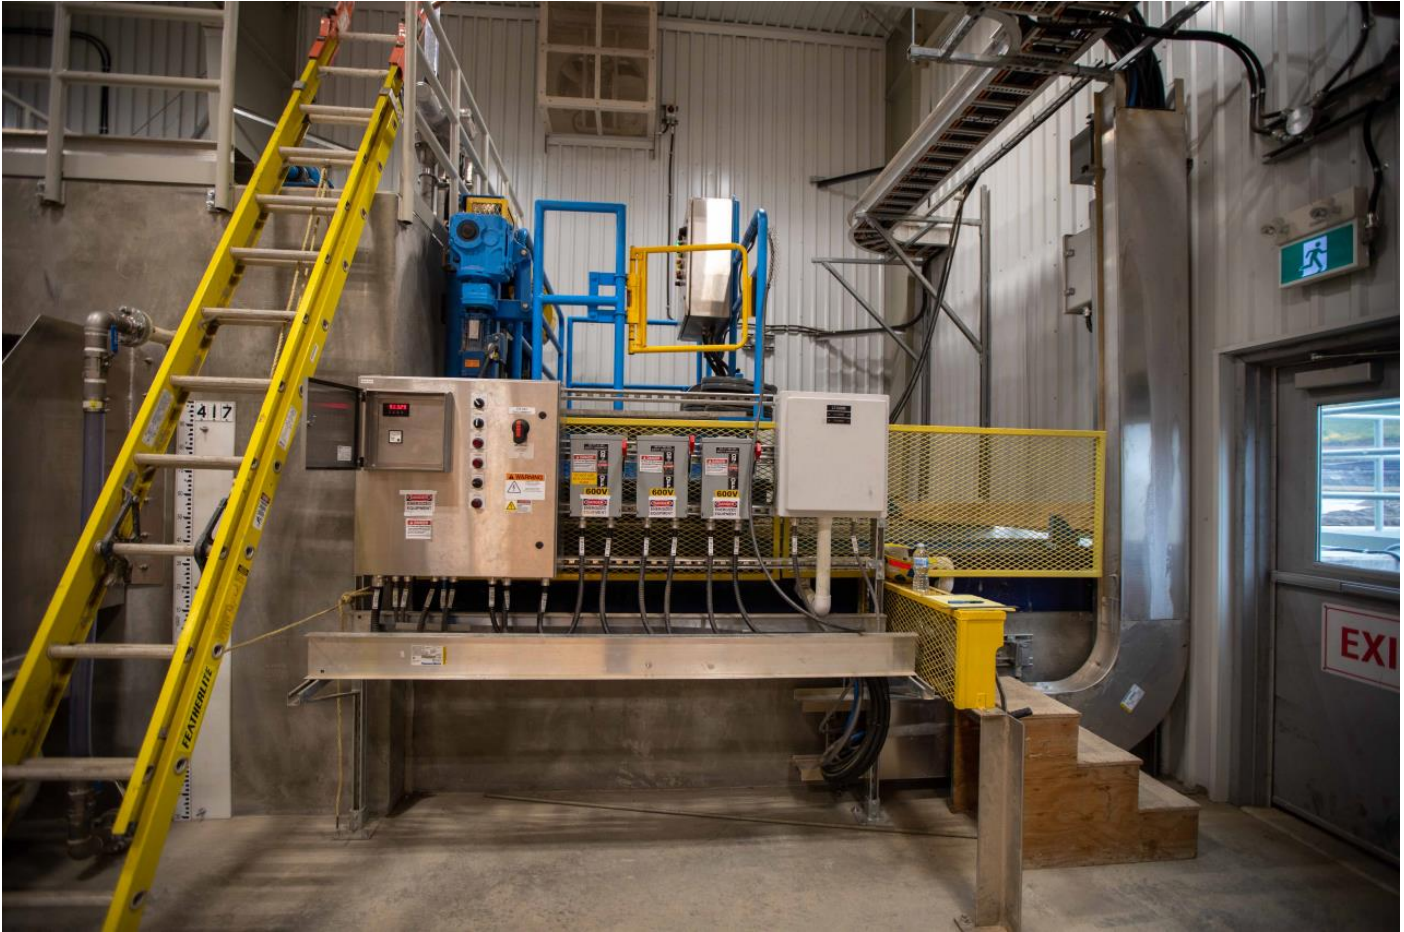
Photo 13. Fish enter the pre-sort holding pool (center) where they are crowded and raised to the elevation of the sorting facility through the use of the lock (left) (September 14, 2020).
