Site C Clean Energy Project

Temporary Upstream Fish Passage Facility Operations Report

Reporting Period: August 1 to 31, 2021

Prepared by BC Hydro

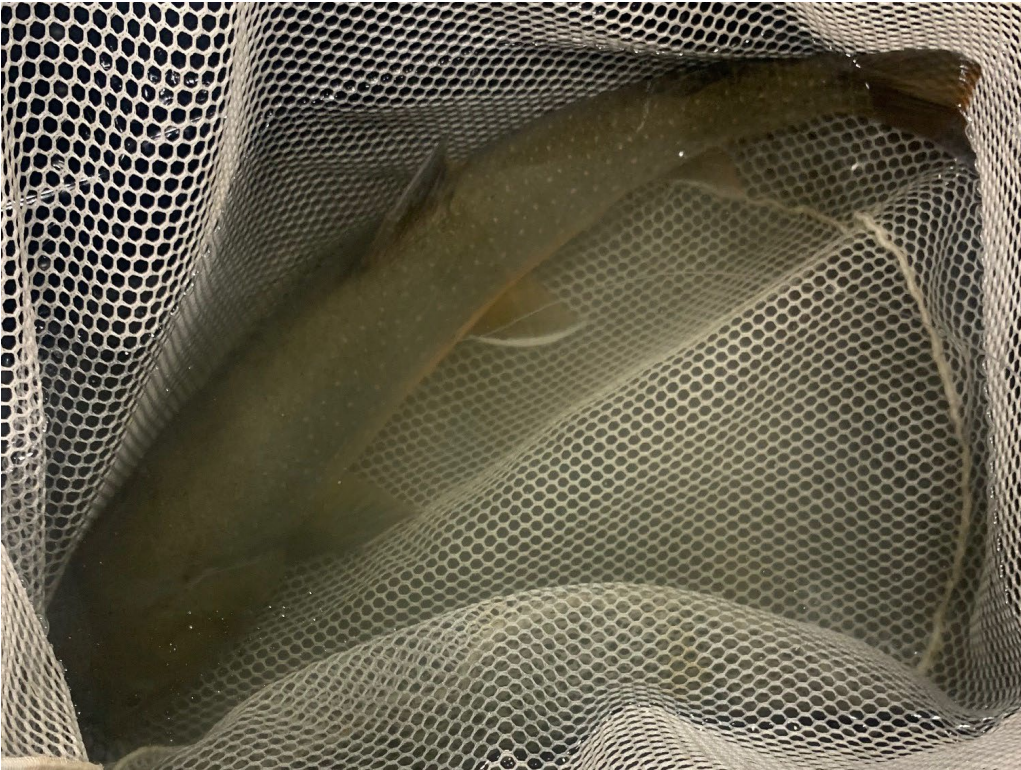
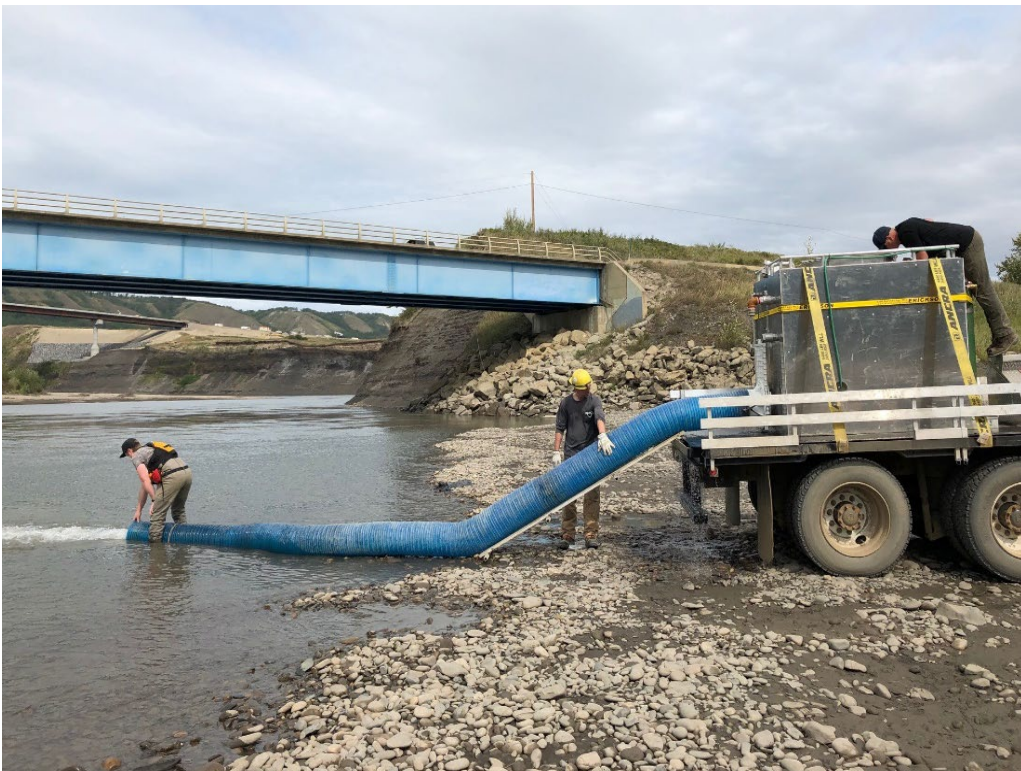
Photo 1. Three Bull Trout passed the facility on August 18, 2021 (top) and were transported and released later the same day at the Halfway River (bottom). In total eight Bull Trout passed the facility during the reporting period.

the proportion of fish at the top of the fishway (Pools 23, 24 and 25) that were subsequently crowded and sorted by the facility operator. Trapping efficiency is defined as the proportion of fish in the pre-sort holding pool that were subsequently crowded and sorted by the facility operator. BC Hydro used an overhead light system and additional flow in the pre-sort holding pool (Photos 4 and 5) to mimic the conditions fish would experience at other locations in the fishway. Ultimately the adjustments that were made, which are further described in Table 5, resulted in the capture of the first eight adult Bull Trout at the facility (Photos 1 and 6).

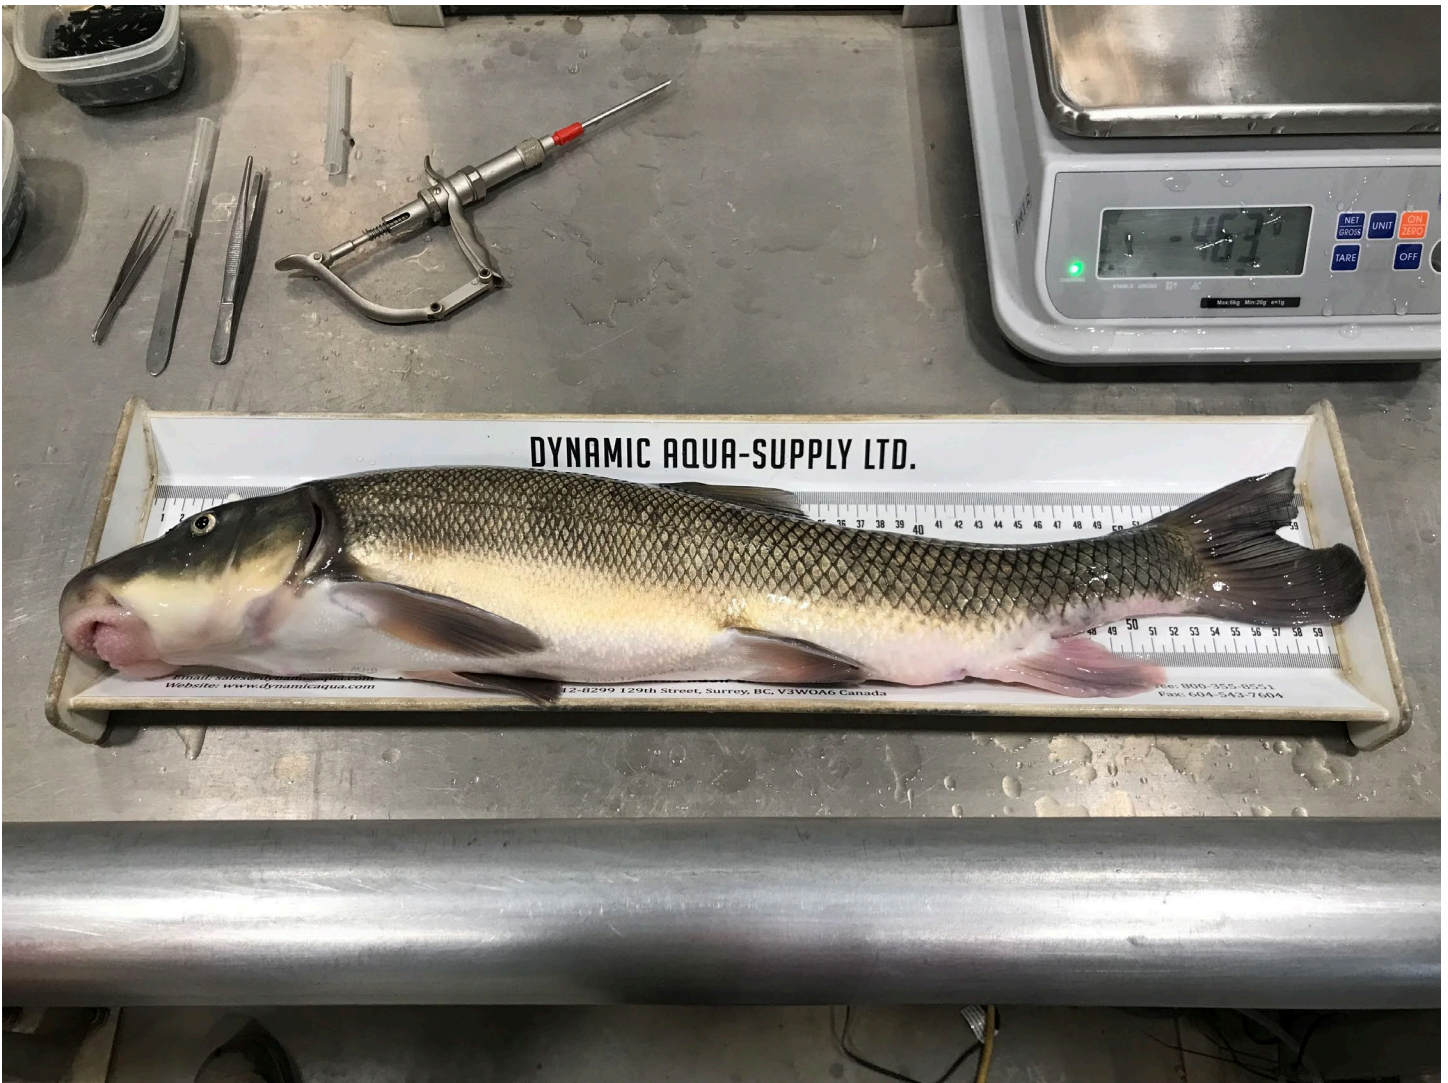
Photo 3. Facility operator processes a Largescale Sucker in the sorting facility (August 1, 2021).

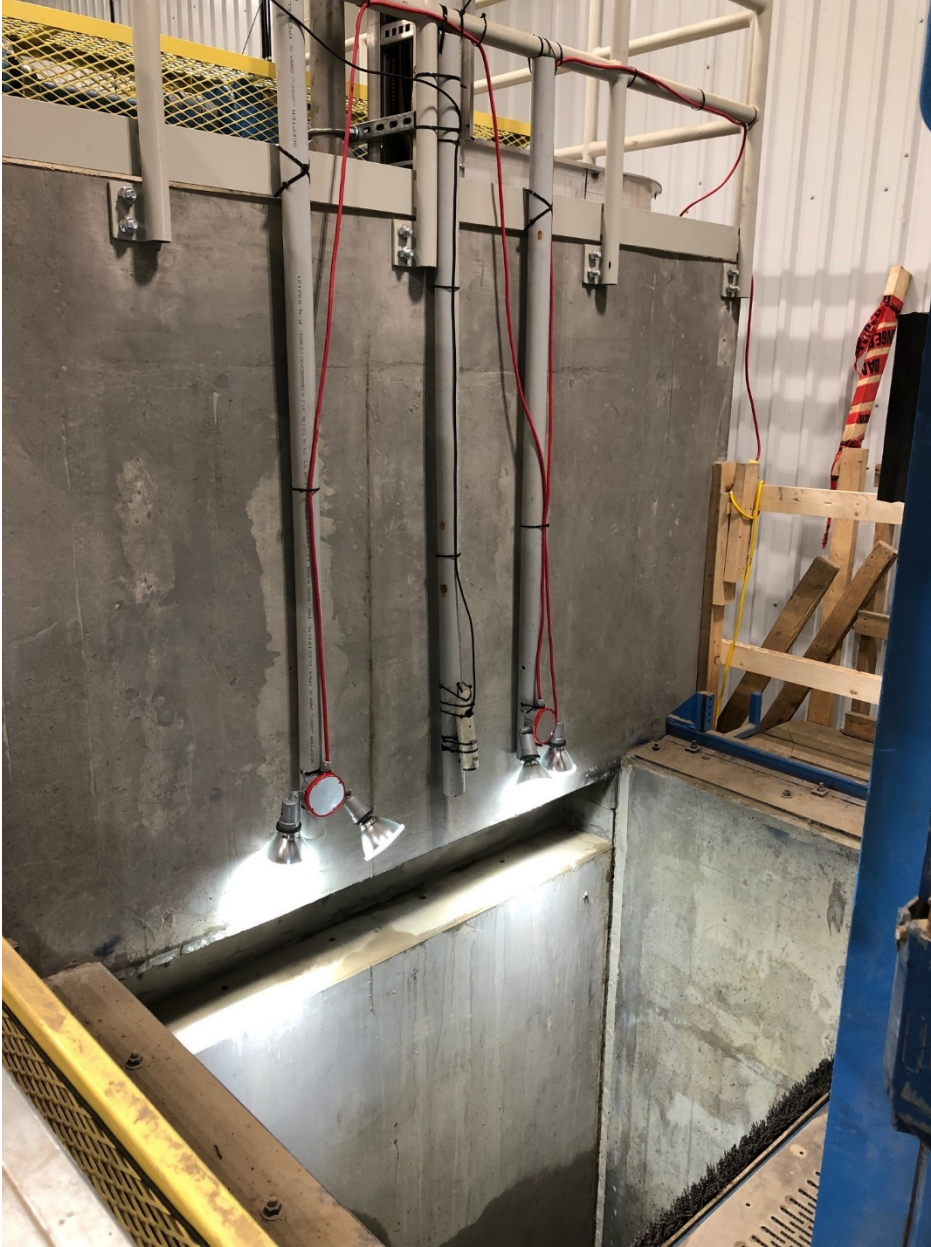
Photo 4. Overhead light and camera system at the upstream end of the pre-sort holding pool (August 16, 2021).

Component	Adjustment
Mechanical operation	<p>Following observation of large numbers of fish at the top of the fishway, the facility operator made several minor adjustments to the operating procedures of the facility to improve passage at the top of the fishway and increase trapping efficiency. Adjustments included:</p> <ul style="list-style-type: none"> • Overhead light system – consisting of four, 1300 lumen light bulbs plugged into a programmable timer – was installed at the upstream end of the pre-sort holding pool (Photo 4) to either (1) mimic daylight conditions in the pre-sort holding pool, or (2) keep the lights on at night to attract certain species of fish into the pre-sort holding pool; • Overhead camera system was installed in the pre-sort holding pool adjacent to the overhead light system to observe fish behaviour and confirm entry into the pre-sort holding pool (Photos 4 and 6); • Underwater camera system was installed in the last pool of the fishway and at the vee-trap to observe fish behaviour and confirm entry into the pre-sort holding pool; • Sprayers (via valve 050-FF-RW-26) located at the upstream end of the pre-sort holding pool were turned on to create disturbance on the water surface and the illusion that water was flowing from an upstream source (Photo 5); • A hose was installed to release a jet of flow aimed at the vee-trap opening; • Pump 9 – which supplies water to the fish lock – remained running at all times to increase the amount of flow passing through the pre-sort holding pool during trapping; and • Vee-trap gate closed by the facility operator at 04:00 to prevent fish that entered the pre-sort holding pool during the night from moving back downstream at dawn. <p>All of the above factors were experimentally manipulated and monitored to determine the conditions that maximize passage and trapping efficiency.</p>

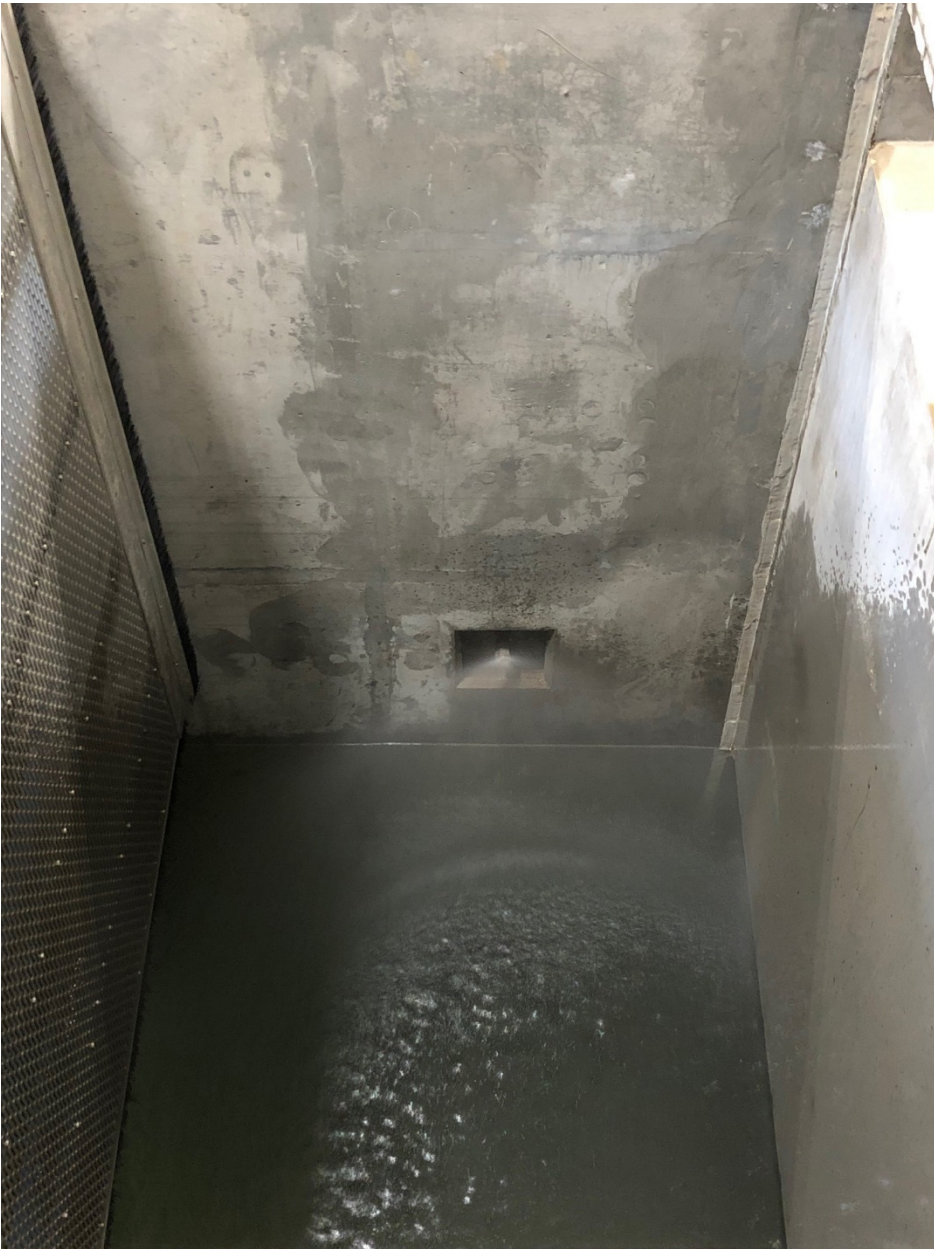
Photo 5. Sprayers located at the upstream end of the pre-sort holding pool (August 16, 2021).

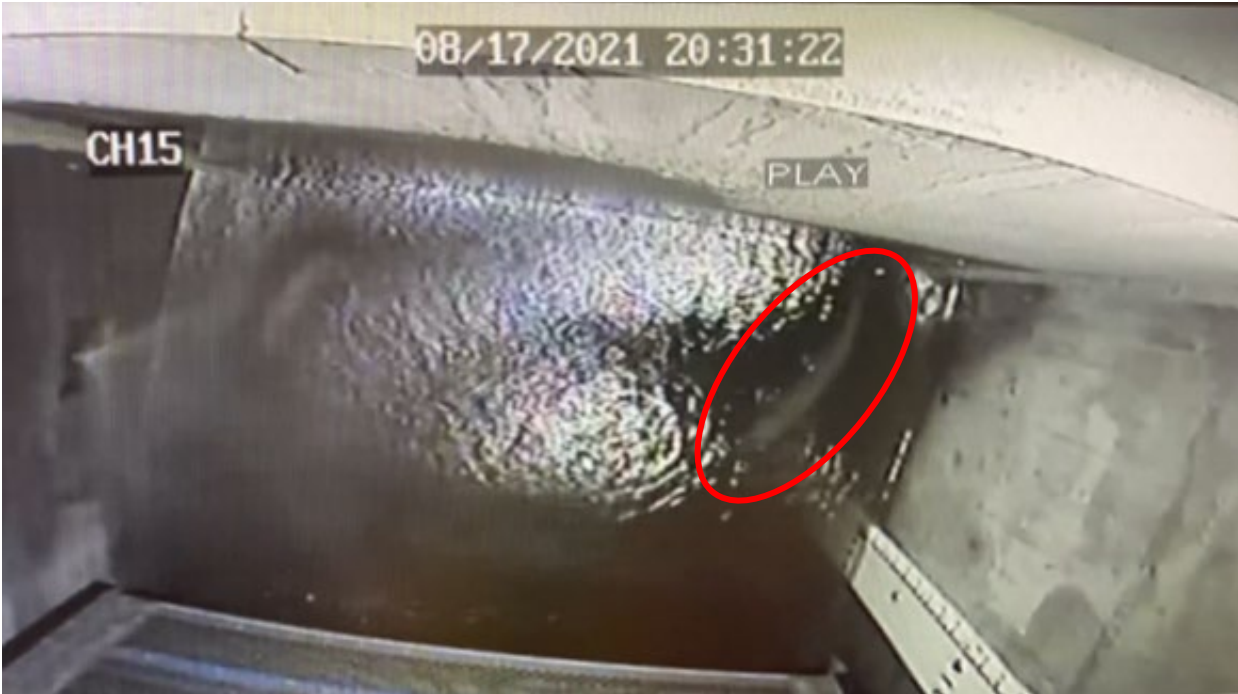
Photo 6. Screenshot from the overhead camera system of the first adult Bull Trout (circled red) trapped in the pre-sort holding pool (August 17, 2021).
