Site C Clean Energy Project

Temporary Upstream Fish Passage Facility Operations Report

Reporting Period: August 1 to 31, 2024

Prepared by BC Hydro

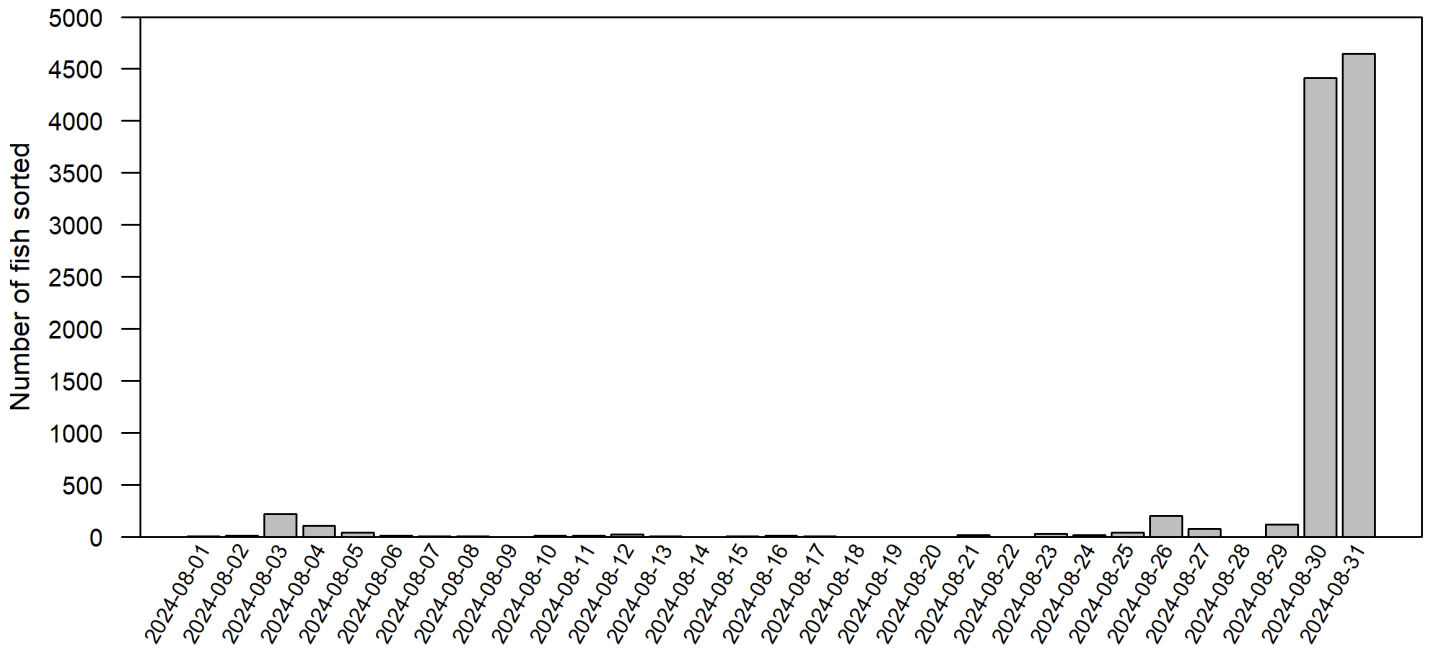
Figure 1. Daily number of fish sorted in the temporary facility during the reporting period.

In total, 10122 fish were sorted in the temporary facility during the reporting period (Table 1; Figure 1). Eight mortalities were observed during the reporting period (0.7% of all fish sorted in 2024), which is in-line with the anticipated levels of mortality during operations⁶.

Between zero and 4645 fish were sorted daily during the reporting period (Figure 1).

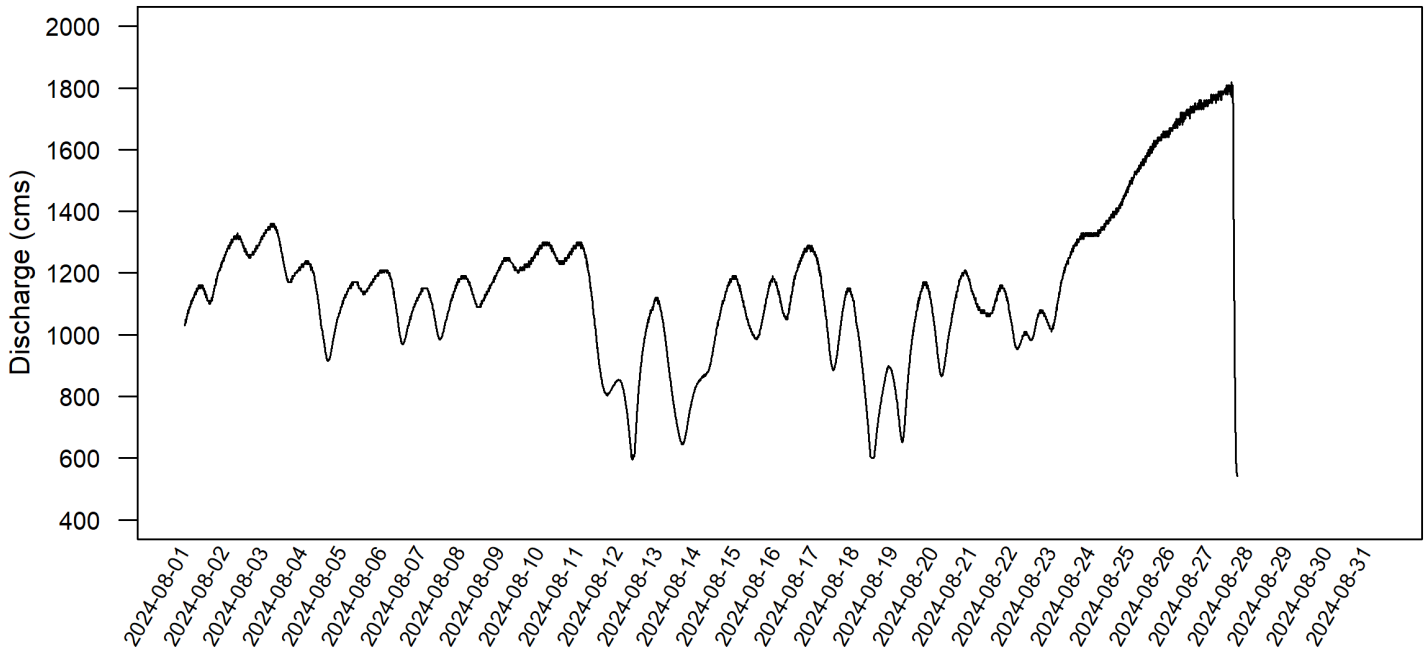
Figure 2. Discharge in the Peace River during the reporting period as measured at the Peace River above Pine River (07FA004) Water Survey of Canada (WSC) hydrometric station. Data were downloaded from the WSC on September 10; the downloaded data were provided at 5-minute intervals and were listed as provisional by the WSC.

Discharge in the Peace River fluctuated during the reporting period from a low of 543 cms on August 28 to a high of 1820 cms on August 28 (Figure 2). Flows were reduced on August 28 to allow the closure of Diversion Tunnel #1 and to facilitate filling the Site C Reservoir. No data were available from August 28 to 31.

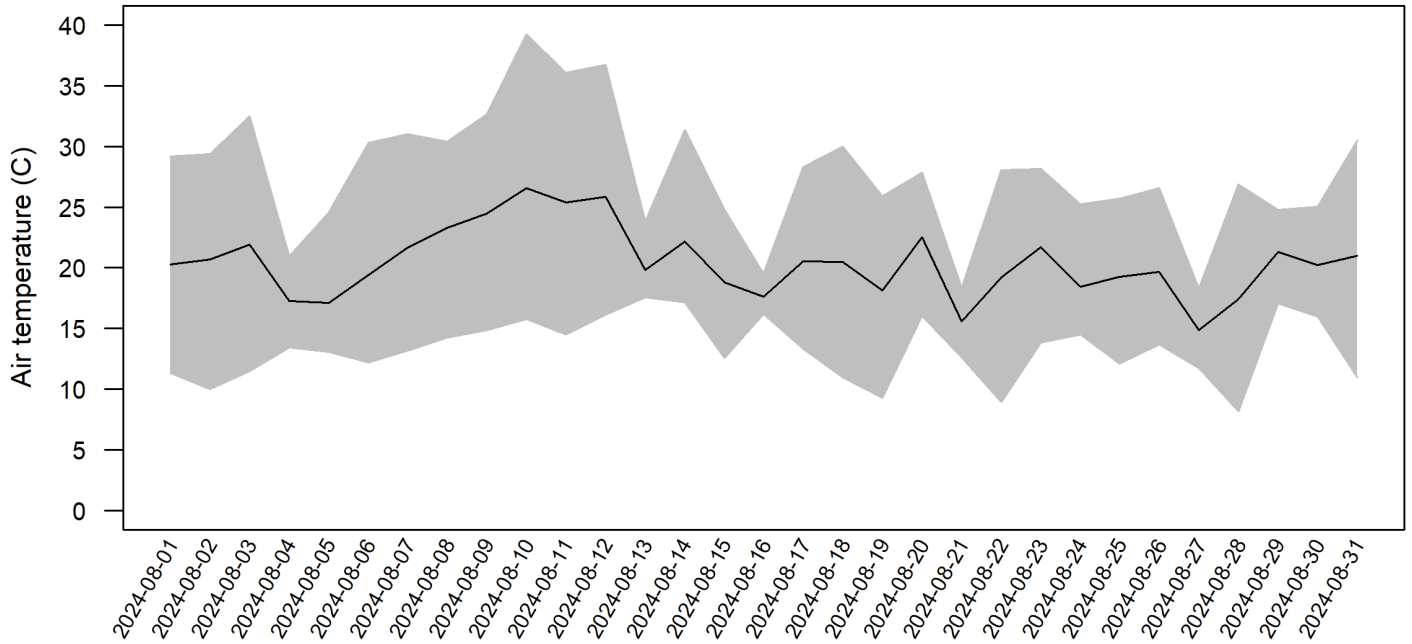
Figure 3. Mean daily air temperature (black line; °C) during the reporting period as measured by a temperature sensor at the temporary facility (TT-602). Shaded area represents the minimum and maximum daily air temperatures.

Air temperature fluctuated during the reporting period from a low of 8.2°C on August 28 to a high of 39.2°C on August 10 (Figure 3); this high is likely in response to direct sunlight on the temperature sensor.

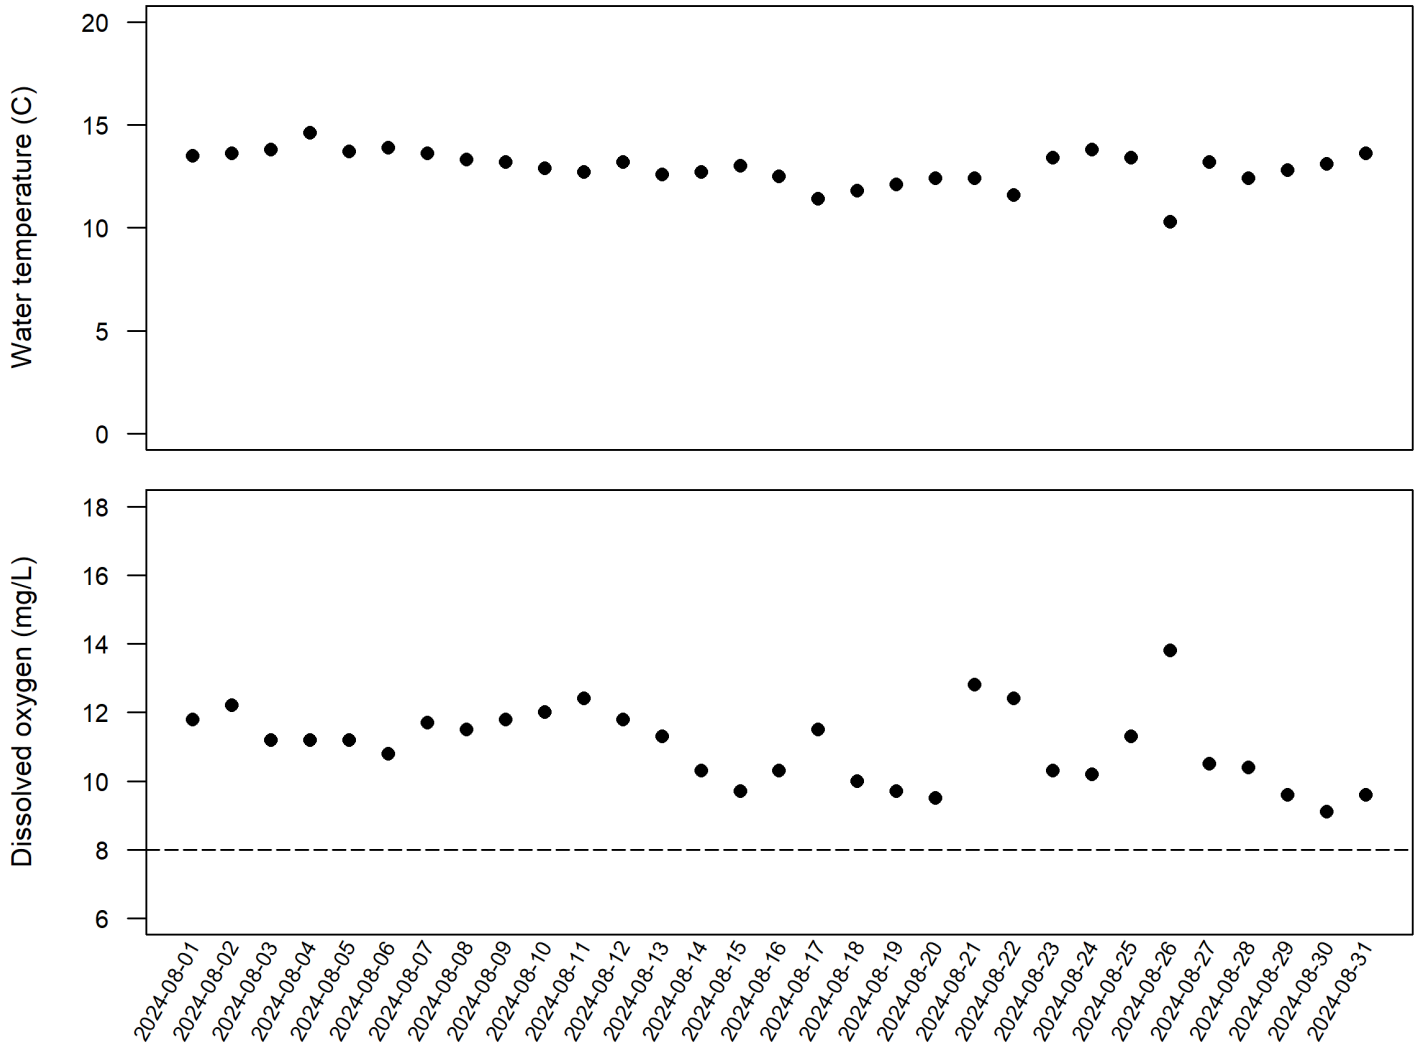
Figure 4. Daily water temperature (°C) and dissolved oxygen (mg/L) during the reporting period as measured in Pool 25 of the temporary facility.

Water temperature remained stable during the reporting period (Figure 4). Dissolved oxygen remained above the minimum dissolved oxygen level (8.0 mg/L) described in the design report of the temporary facility.

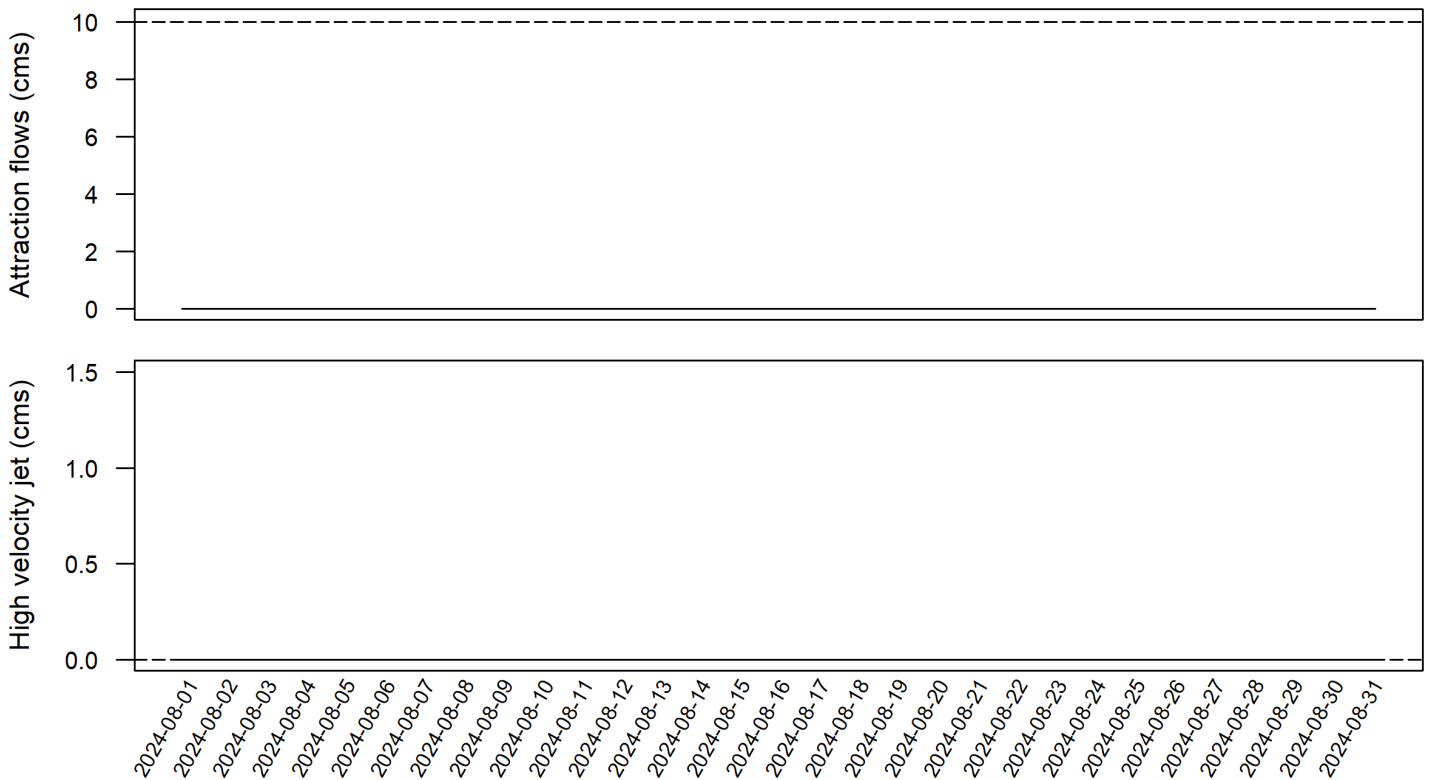
Figure 5. Operation of the attraction flows and high velocity jet during the reporting period.

In 2024, BC Hydro intended to operate the attraction flows and high velocity jet at 10 cms and 0 cms, respectively (horizontal dashed lines in Figure 5). However, within the first week of operations, the attraction flows steadily declined and system alarms indicated electrical faults with the horizontal propeller pumps. BC Hydro 'turned off' the horizontal propeller pumps on April 5, 2024 and removed them from the pump station for a detailed inspection on April 15, 2024. As such, there were no attraction flows during the reporting period. BC Hydro turned off the high velocity jet on May 23 as water levels were not being maintained in the pump station to reliably operate the pump.

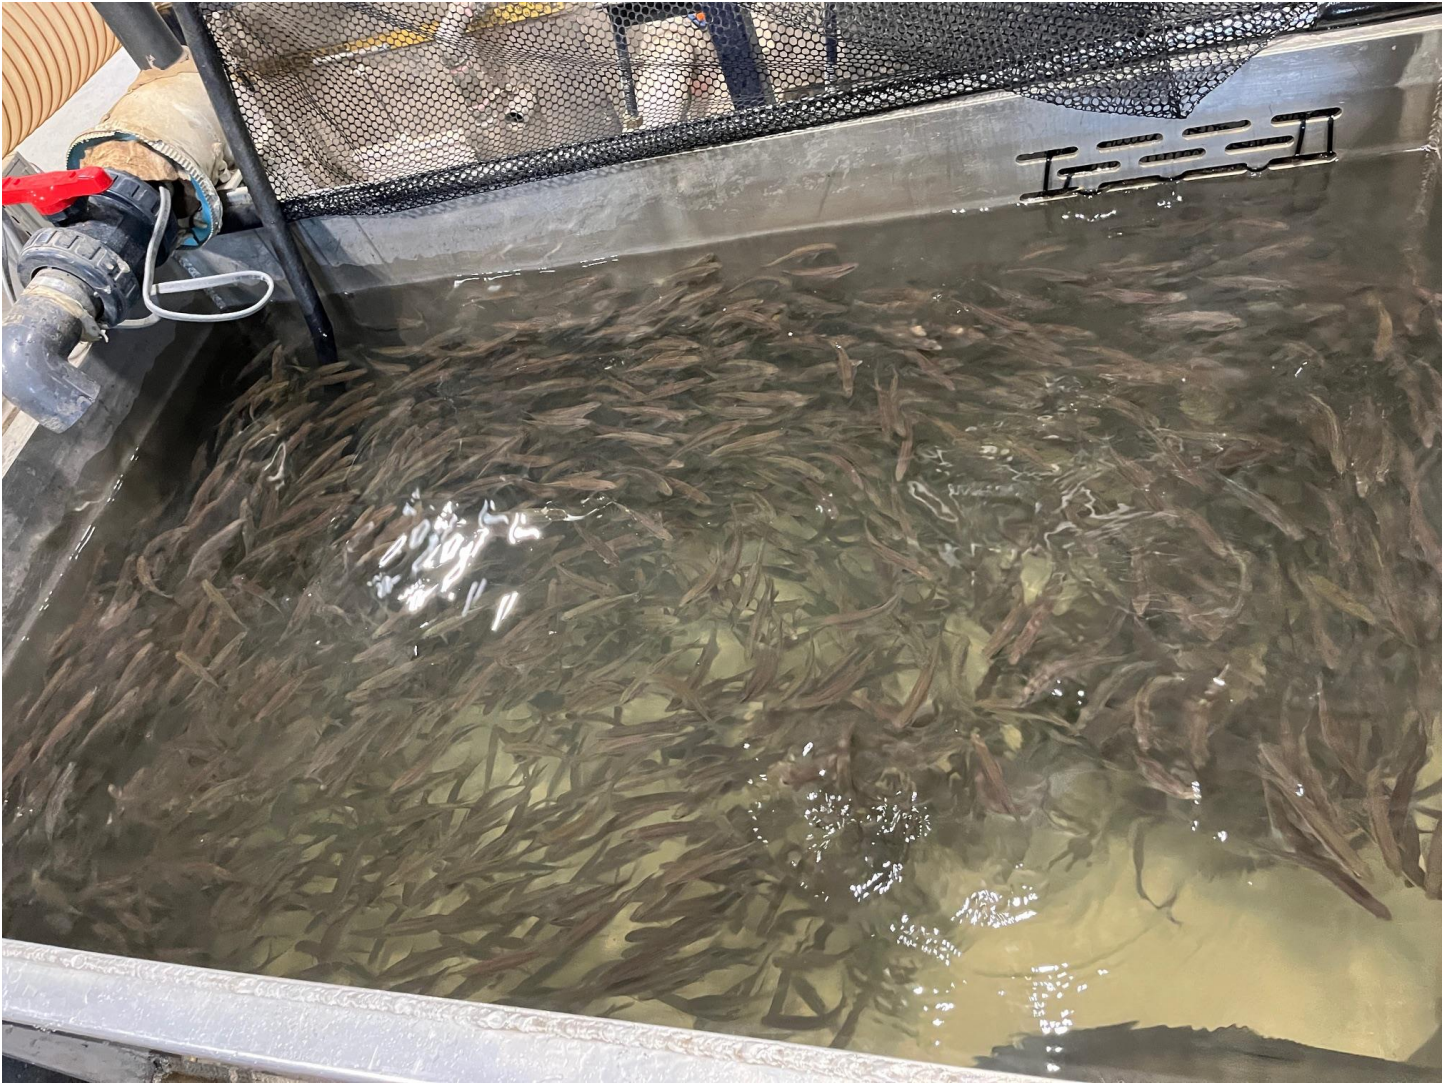
Photo 1. More than 9000 Redside Shiner were captured during the reporting period (August 30, 2024).

Ten thousand one hundred and twenty two fish – 9402 Redside Shiner, 254 Longnose Sucker, 167 Northern Pikeminnow, 139 Largescale Sucker, 77 Mountain Whitefish, 57 Sucker Species (Not Identified to Species), 8 White Sucker, 6 Bull Trout, 3 Prickly Sculpin, 2 Rainbow Trout, 2 Kokanee, 2 Peamouth, 1 Arctic Grayling, 1 Northern Pike, and 1 Slimy Sculpin – were sorted and sampled at the temporary facility, and transported and released into the Peace River upstream of the Project (Table 1, Photo 1).

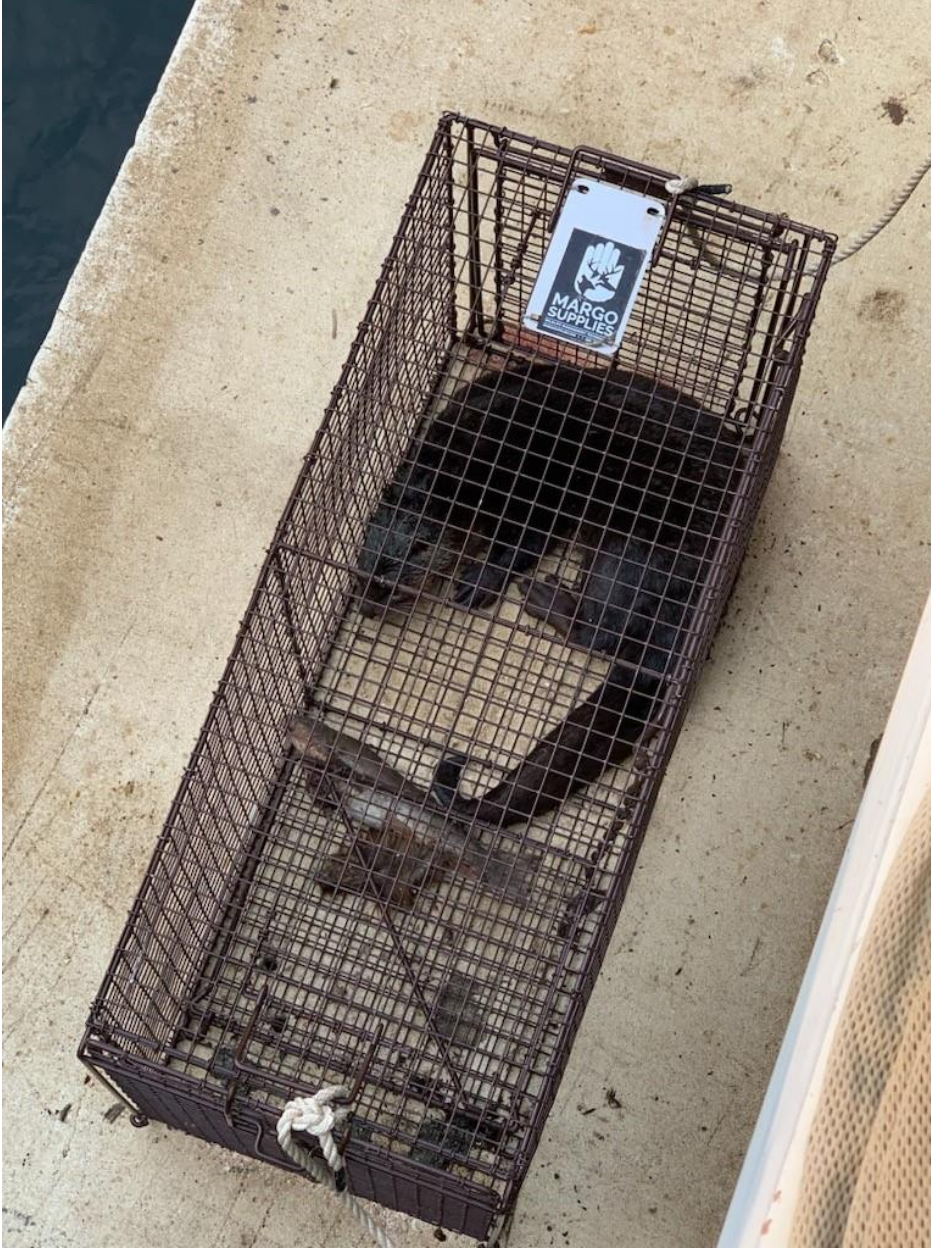
Photo 2. One river otter was trapped at the temporary facility during the reporting period and relocated to Dinosaur Reservoir (August 14, 2024).

River otters were observed throughout the reporting period. As such, BC Hydro continued live trapping efforts and captured and transported one otter to Dinosaur Reservoir (Photo 2).

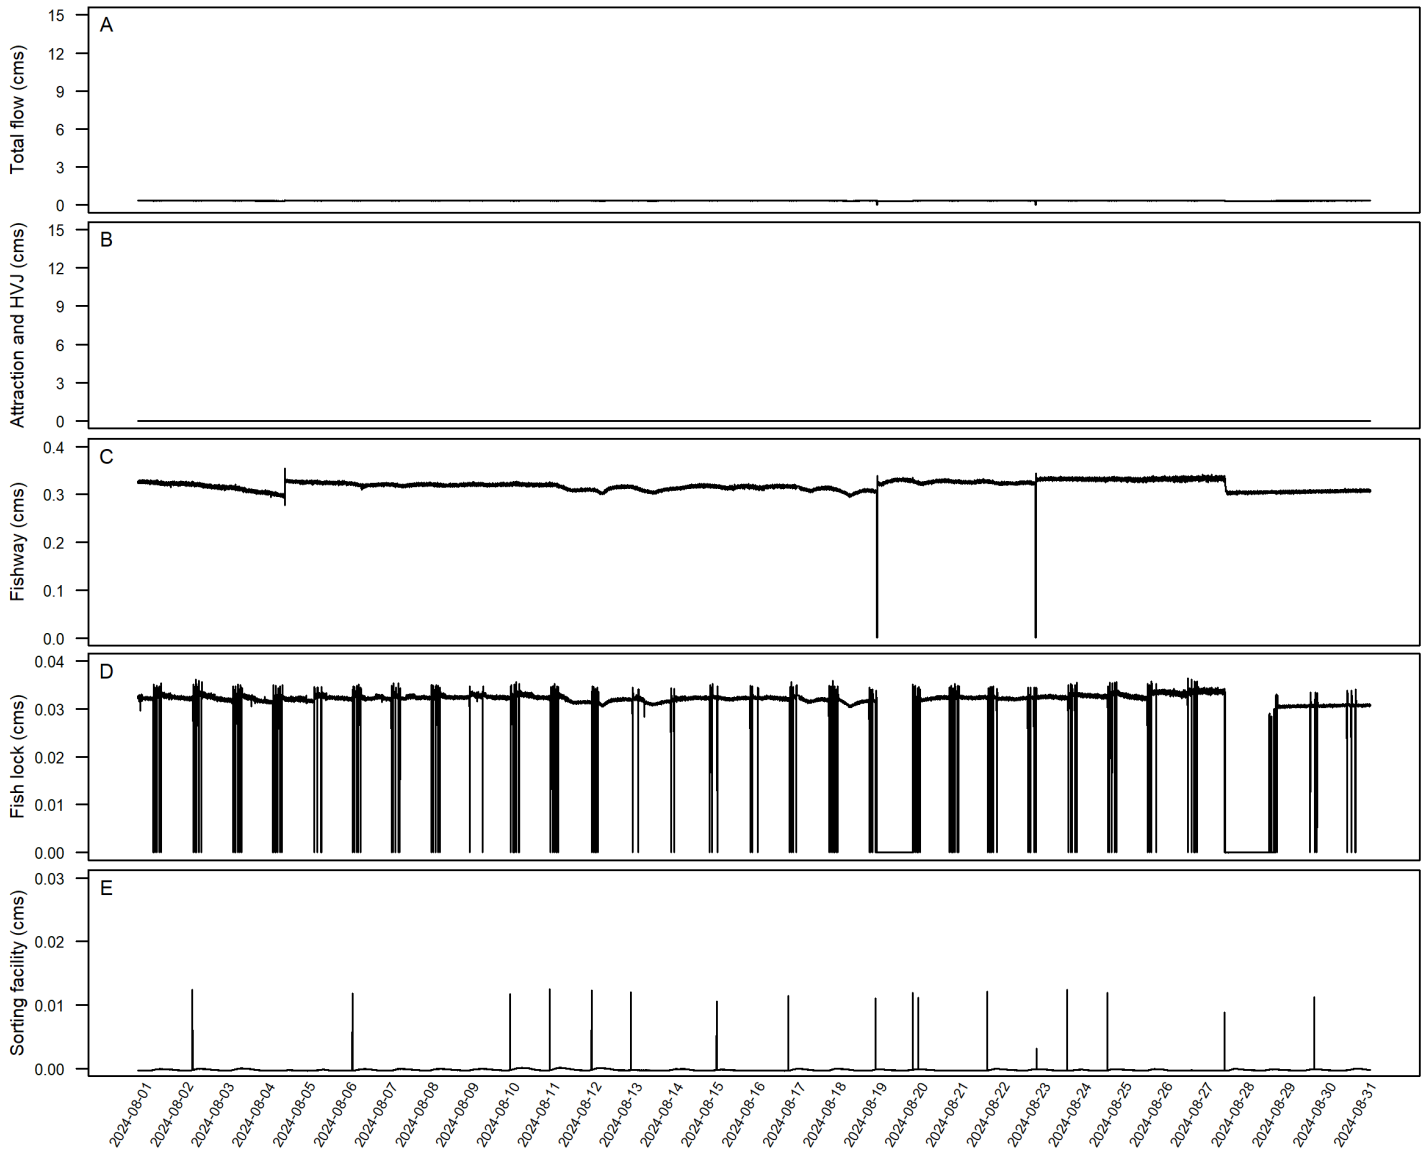
Appendix I. (A) Total flow (cms) diverted from the Peace River to operate the temporary facility during the reporting period. Total flow is a combination of flows used for the attraction flows and high velocity jet (B), fishway (C), fish lock (D), and sorting facility (E), as described in T023 Plan for Measurement of Flow. Under Conditional Water Licence 133987⁷, BC Hydro is authorized to divert up to 15 cms of flow from the Peace River to operate the temporary facility; this authorized quantity was not exceeded during the reporting period (A).

Appendix I summarizes the total flow diverted from the Peace River to operate the temporary facility during the reporting period.
