Site C Clean Energy Project

Quarterly Progress Report No. 22

F2022 First Quarter

April 1 to June 30, 2021

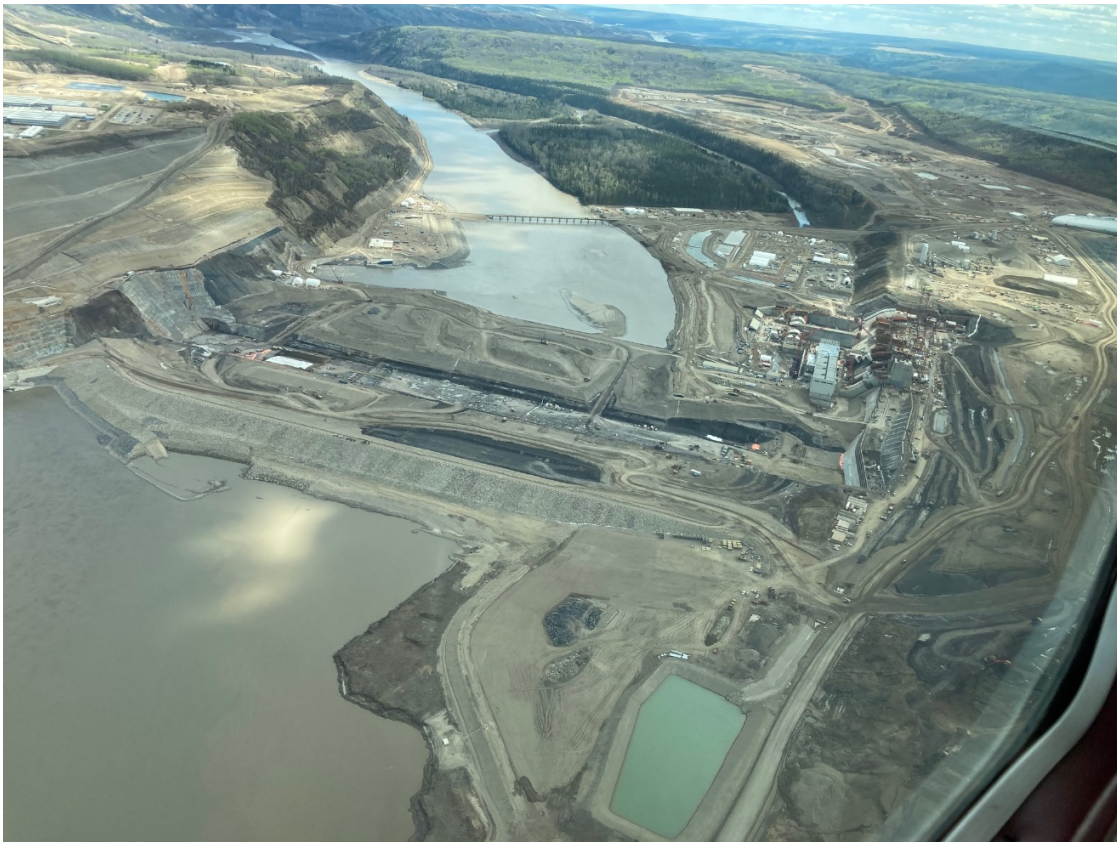
of 2020 and up to the present in 2021. Although held virtually, these meetings and workshops did keep the TAB up to date on the Project's progress. The focus of many meetings was concentrated on the Right Bank Foundation Enhancements as well as the improvements within and along the Approach Channel. A recent aerial photo of the project is shown below. The descriptions and updates below are concentrated on the Generating Station and Spillways (GSS) and Main Civil Works (MCW) areas.

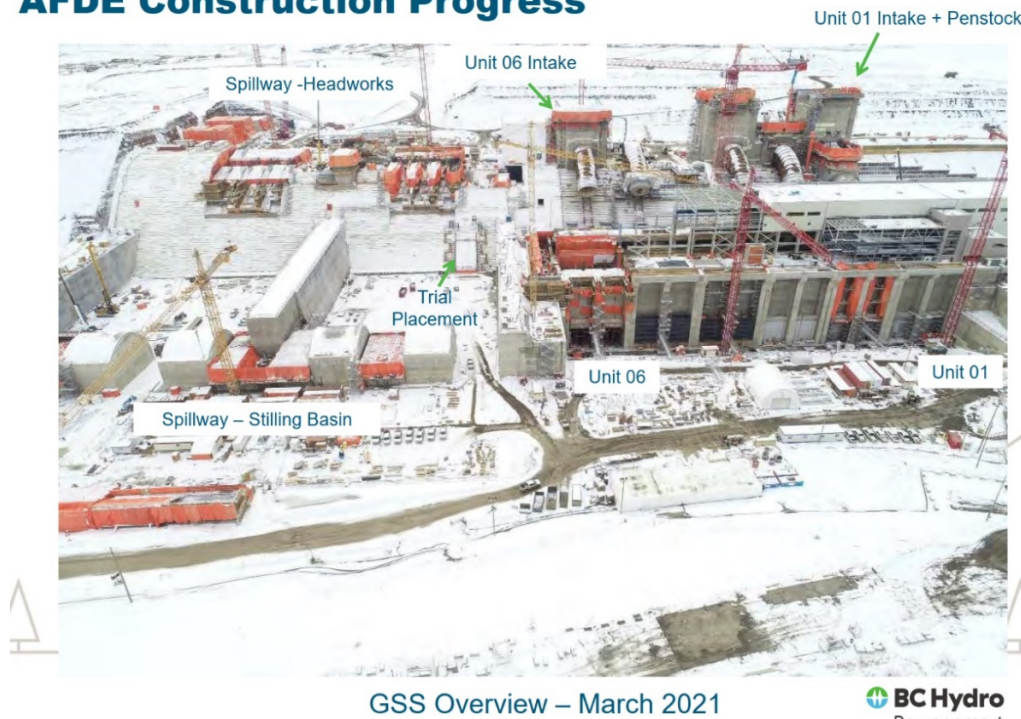
AFDE Construction Progress

The GSS Civil Works design and engineering is well advanced, with 99% of the drawings issued for construction (IFC) design. The photograph presented below illustrates the status of the activities.
