Site C Clean Energy Project

Site C Total Dissolved Gas Monitoring Program (Mon-11)

**Site C Total Dissolved Gas Monitoring Program
(Mon-11)**
2022 Feasibility Study

20136470-028-R-Rev1

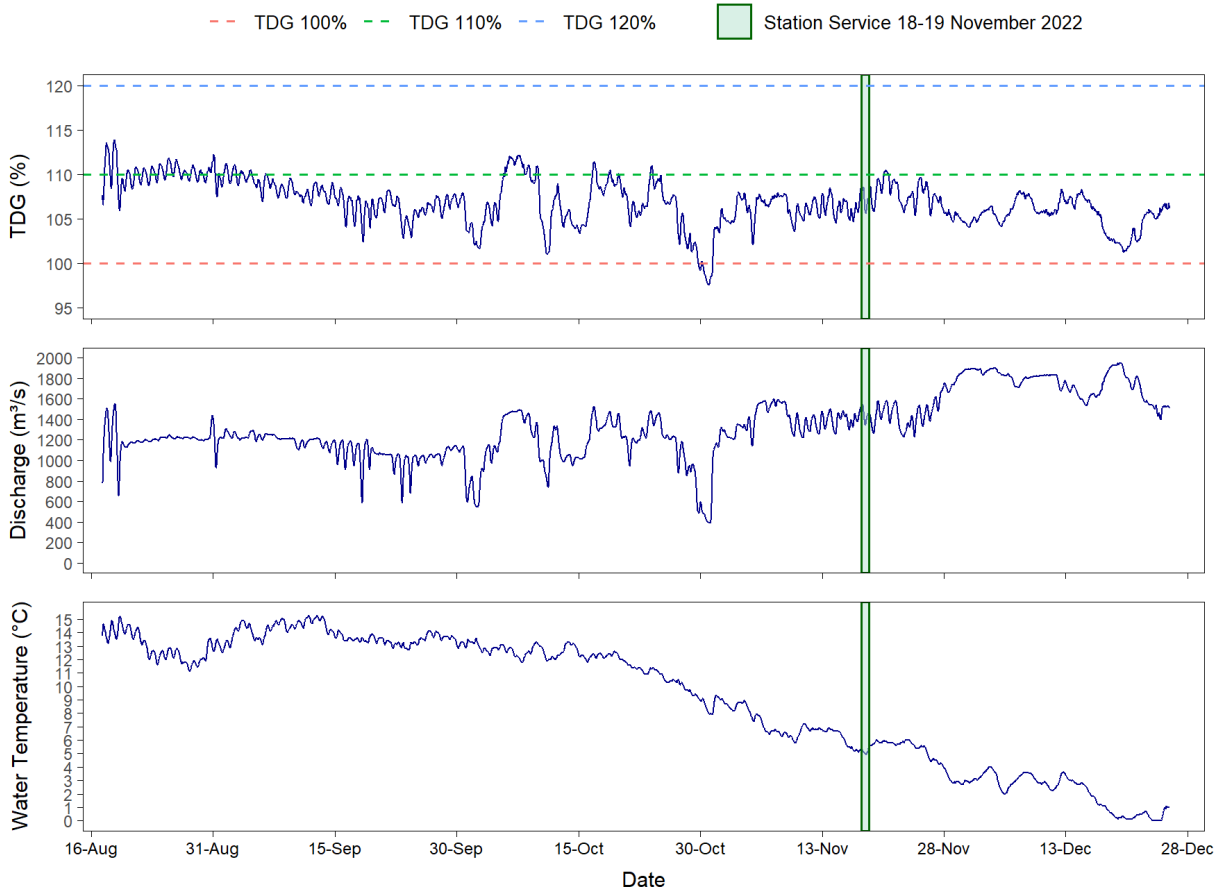
The average mean daily TDG over the monitoring period was 106.9 TDG% and ranged between a low of 98.8 TDG% on 31 October and 111.7 TDG% on 7 October. Mean hourly TDG ranged between a minimum of 97.5 TDG%, which was recorded on 31 October at 09:00, and a maximum of 113.9 TDG%, which was recorded on 19 August at 03:00 (Figure 4). From 30 to 31 October, TDG briefly decreased below 100 TDG%. These low values corresponded with a substantial reduction in total river discharge.

Figure 4: A hourly time-series comparison of percent TDG and water temperature recorded at Stn_112.5L in relation to Peace River total discharge, 17 August to 27 December 2022. The dash lines in the top panel correspond with BC Hydro TDG guidelines in British Columbia (BC Hydro 2014, 2022) in relation to the risk for gas bubble trauma in fish. The green vertical bar indicates the timing of the service visit to the station.

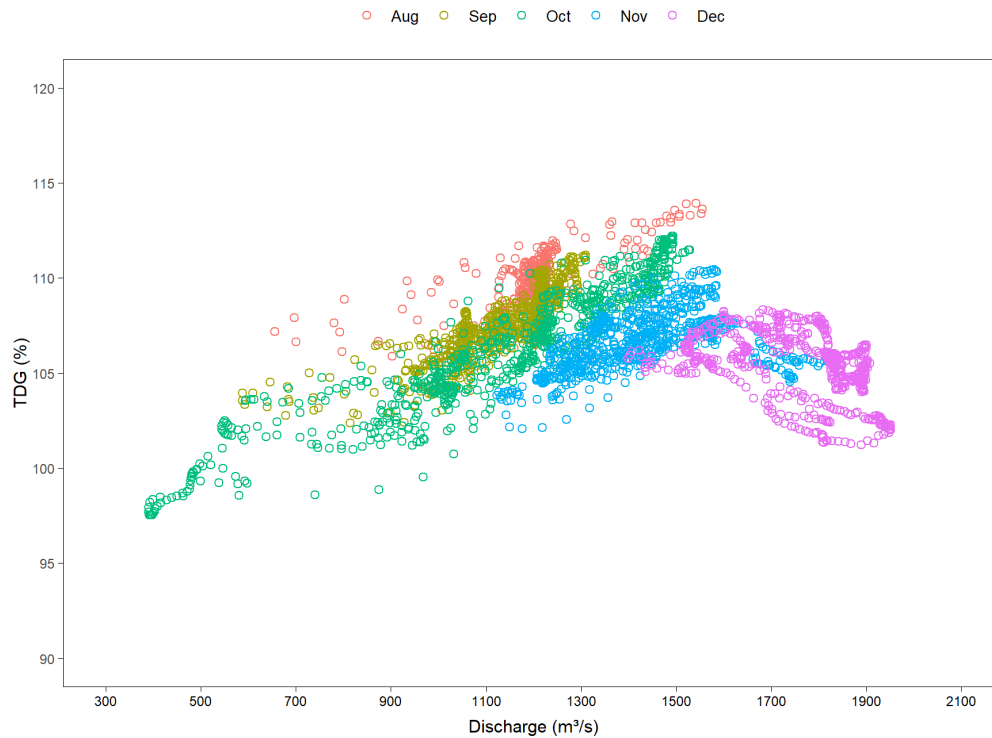
When Peace River discharge was between 300 and 1,600 m^3/s , there was a linear relationship between discharge and TDG, with higher TDG corresponding to higher discharge (Figure 5). When discharge exceeded 1,600 m^3/s , TDG decreased as discharge increased, resulting in TDG that was similar to TDG produced at lower discharges between 600 and 1,300 m^3/s .

Over the duration of the monitoring period, the TDG produced at a given discharge decreased over time, with the highest TDG recorded in August, followed by incrementally lower TDG recorded from September to December for the same discharge (Figure 5). Over this time, water temperature also gradually decreased; however, cumulative bio-fouling of the TDG membrane and other changes in the TDG station functionality also occurred over the same time period.

Figure 5: A comparison of TDG recorded at Stn_112.5L and Peace River total discharge recorded at the Water Survey of Canada’s “Peace above Pine” gauge station (Station 07FA004) from 17 August to 27 December 2022. Colour indicates the month the data were recorded.

Fluctuations in total river discharge resulted in the most notable changes in TDG. The highest TDG was associated with flows between 1,500 and 1,600 m³/s (see Figure 5). During high flow conditions in August, when flows approached 1,600 m³/s, a maximum TDG of 113.9 TGP% was recorded. At discharge levels above 1,600 m³/s, gas entrainment plateaued and then incrementally decreased as discharge approached 1,950 m³/s. When total river discharge was between 1,900 and 1,950 m³/s, the TDG recorded (i.e., approximately 102 TGP%) was similar to the TDG recorded when flows were between 600 and 800 m³/s. A decrease in TDG in response to increased discharge is atypical, and likely indicates some aspect of the diversion tunnels entraining more air under certain conditions. Due to the absence of TDG measurements upstream of the Project, the specific causes of these changes in TDG could not be identified.

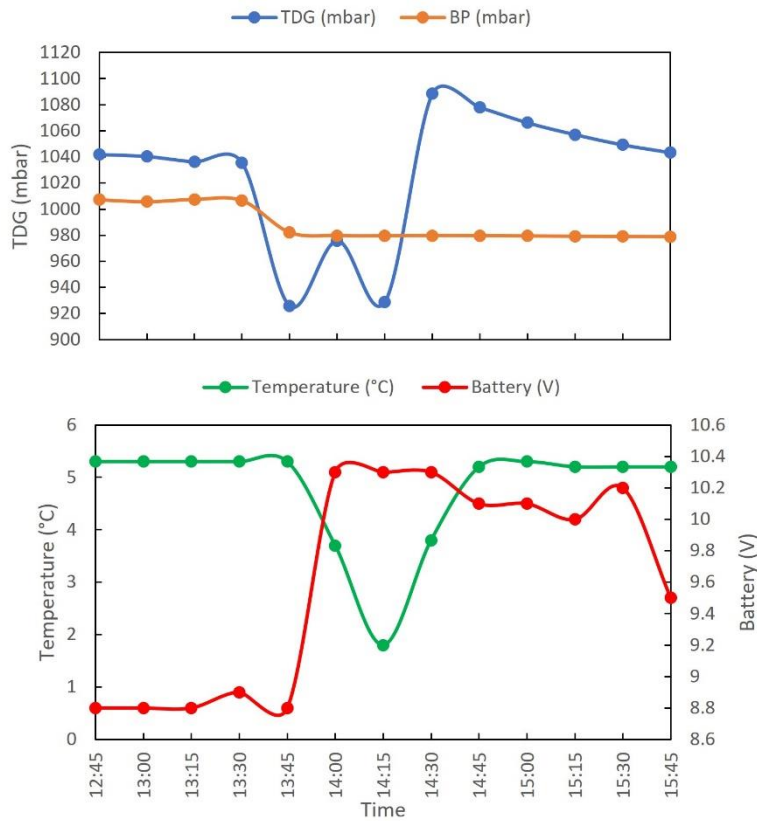
Substantial differences in TDG were recorded between the Solu-Blu portable meter and the TDG station on both 18 and 19 November (Table 1). TDG reported by the Solu-Blu portable meter (SN 3800083) were unrealistically high on both days (i.e., 112.6 TDG% and 117.3 TDG%, respectively) and did not correspond with either the TDG station or the Point Four meter when they were deployed at the same location and depth. The Point Four meter was similar to the TDG station on both service days, albeit slightly higher. A plot of TDG recorded during the 18 November site visit indicates that TDG was equal to barometric pressure at 14:00, when the station's probe was removed from the water and exposed to atmospheric pressure (Figure 6). These data provide evidence that the calibration of both the station's TDG probe and the station's barometric pressure sensor did not drift between station deployment and the site visit, and confirmed that both sensors were still responsive at the time of the visit. When the station was redeployed at approximately 14:45, TDG was initially elevated, but slowly approached a lower equilibrium over the 45 to 60 minutes immediately following redeployment. Reasons for the slow response time of the probe were not known at the time when the portable measurements were recorded, but were identified later (see Section 4.1).

Figure 6: Station Stn_112.5L TDG, barometric pressure (BP), temperature, and battery voltage during a station service visit conducted on 18 November 2022.

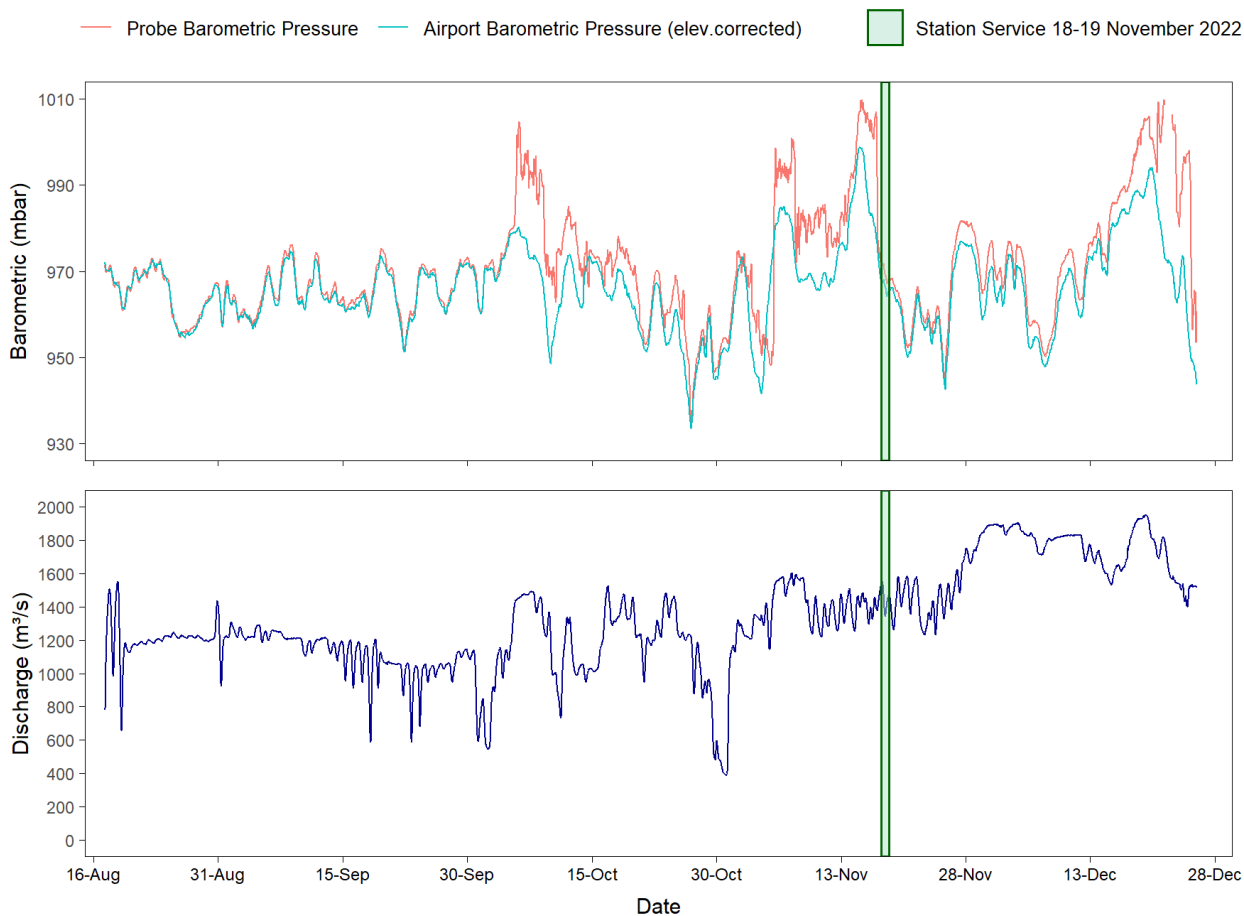
The station functionality remained unchanged from 6 October to the first required service on 18 and 19 November; however, increased variability in TDG data was evident when total river discharge exceeded 1,500 m³/s. Although the station had previously experienced flows of similar magnitude and higher and was not affected, the change in the TDG data suggest that the station had been displaced into deeper water or by higher current and was getting submerged. This assumption was later confirmed during the November service when field crews observed the station periodically becoming submerged by up to 0.5 m during their site visit. Periodic submersion, and possible entanglement of the station with floating woody debris, was assumed to be the cause

for the loss of the fabric station cover and saturation of the desiccant filter on the barometer air reference line (Figure 9; Panel A). Even though the station was still functioning at the time of the service, inspection of the battery compartment determined that the single O-ring waterproof seal had not been sufficient to prevent moisture from entering the case when submerged (Figure 9; Panel B). The DCP canister had a double O-ring seal and, as it was still transmitting, was assumed water-tight and was not removed or opened. Removal of the station from the water allowed direct inspection of the mooring connections, buoy, instrument tube, and the probe's TDG membrane. The inspection revealed that, despite the high turbidity of the water and the deployment of the probe to approximately 1.5 m depth, a small amount of bio-fouling (algae) covered most surfaces (Figure 9; Panels C and D). The extent of biofouling on the probe's TDG membrane was not substantial and subsequent comparisons between the station's barometric pressure and total pressure readings indicated that the TDG sensor was still responsive. Upon completion of the final service on 19 November, and in preparation to monitor over the winter, the field crew relocated the station mooring to a shallower location (~4.5 m deep) and installed a new battery pack, a new air reference desiccant filter, added additional flotation to the station, and installed a hard dome cover to protect the instrumentation from ice and snow build-up (Figure 9; Panels E and F). On re-deployment, crews confirmed that the station and mooring were shallow enough to have sufficient scope to self-adjust to future changes in water level.

Figure 8: Barometric pressure measured by the TDG station in relation to calculated barometric pressure at the station and total river discharge (Station 07FA004) from 17 August to 12 December 2022. Green vertical bar indicated the dates that service visits were conducted at the station.
